**Brammer Farm House and Arundel Cottage  
Mansfield Road  
King's Clipstone  
Nottinghamshire, NG21**

Standing Building Survey Report

April 2013

**Mercian**  
Archaeological Services CIC

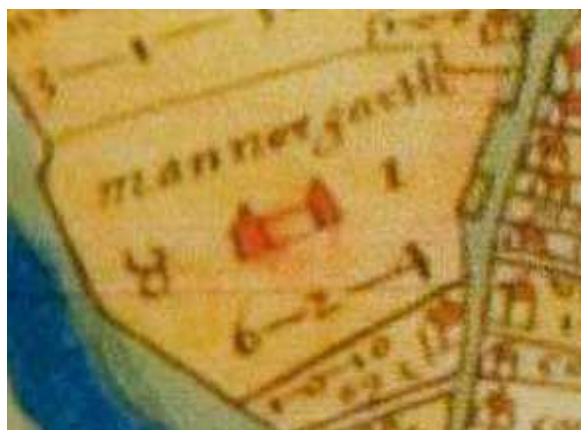
Fig 2 Clipstone in 1630 depicted by the Earl of Newcastle's cartographer William Senior. Note that west is at the top of the map. (Source: a private collection)

The 1630 estate map drawn for the Earl of Newcastle by William Senior (Fig 2) represents a building in a close to the north-east of the Manorgarth. The property sits in the same location as modern Arundel Cottage, Brammer Farmhouse and Maun Cottage. Prior to 1889 Maun Cottage (Fig 16) was the Fox & Hounds public house. The earliest mention of a public house in the village was The Gate which was recorded in the List of Friendly Societies for 1794 (Bealby 2001, 165). James Cutts was the landlord and was still there in 1813 (Bealby 2001, 165). Cutts died in about 1818 and the business was granted to Robert Lindley by his widow (UNA P1 E12/6/8/3/3). Lindley later passed over the tenancy to Cornelius Amos in 1829, however by this time the building was called the Fox & Hounds (UNA 4/2/6/8/3/4). It is suspected that the name change occurred when Lindley took over from Cutts and reflected the very active hunting community within the area of the Dukeries. Cornelius and then his son, James, and finally his daughter in law, Sarah, continued the tenancy until 1889 when the public house closed its doors for the last time and became a shop until the early 20th century (Bealby 2001, 166). The original name of the public house - The Gate - is considered to be significant as along with the map evidence, the property is known to contain substantial stone walls over a metre in thickness and of similar make-up to the ruin of King John's Palace (Bealby 2001, 165). High status 12<sup>th</sup> century stonework was found in the garden of Maun Cottage in 2007 (Wright 2007).

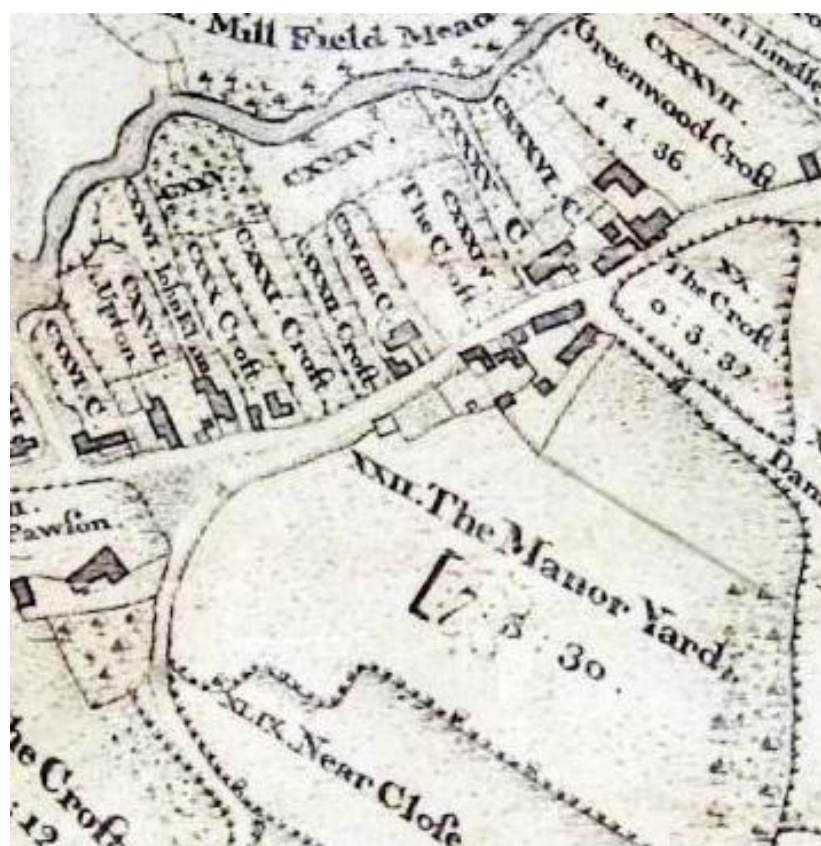
Fig 3 Clipstone Estate map of 1766 (Source: a private collection)

The original line of the northern and north-western boundary of the King's Houses is best understood from the 1766 map (Fig 3). A single curving line heads north and then north-east from Rat Hole along Mansfield Road where it intersects with a small rectangular enclosure. This is the village pinfold which is also shown in the same place (albeit larger) on the 1630 map. The line of the boundary then runs immediately to the south of Maun Cottage which is also on the same alignment as Brammer Farmhouse and the property to the east of what would become Arundel Cottage. The south elevation of these properties as depicted in 1766 therefore stood in front of what was originally the northern boundary to the King's Houses.

The 1766 estate map of Clipstone is therefore the earliest clear depiction of the site (Fig 3). The map was made shortly after the marriage of Clipstone's landowner William Henry Cavendish-Bentick, 3<sup>rd</sup> Duke of Portland to Lady Dorothy Cavendish, heiress of William Cavendish, 4<sup>th</sup> Duke of Devonshire. The purpose of the map seems to have been part of a mechanism to better understand the nature of the enormous estate created by the recent marriage. The core of the single cottage at the heart of the site is shown on plan as a square structure in the north-west corner of the easternmost enclosure to the south of Mansfield Road. No property number or acreage is recorded.

This enclosure to the north-east of the Manorgarth was eventually truncated and by 1766 (Fig 3) five discreet enclosures are depicted adjacent to Main Road along with a cluster of buildings. The easternmost enclosure is on the site of Brammer Farmhouse and Arundel Cottage. Given that the closes of the village crofts are laid out regularly on the north side of Main Road in both 1630 and 1766 it is apparent that the cluster of structures without regular closes on the south side of the road may have their origin as part of the palace complex. By 1835 (Sanderson 1835) this cluster of structures was

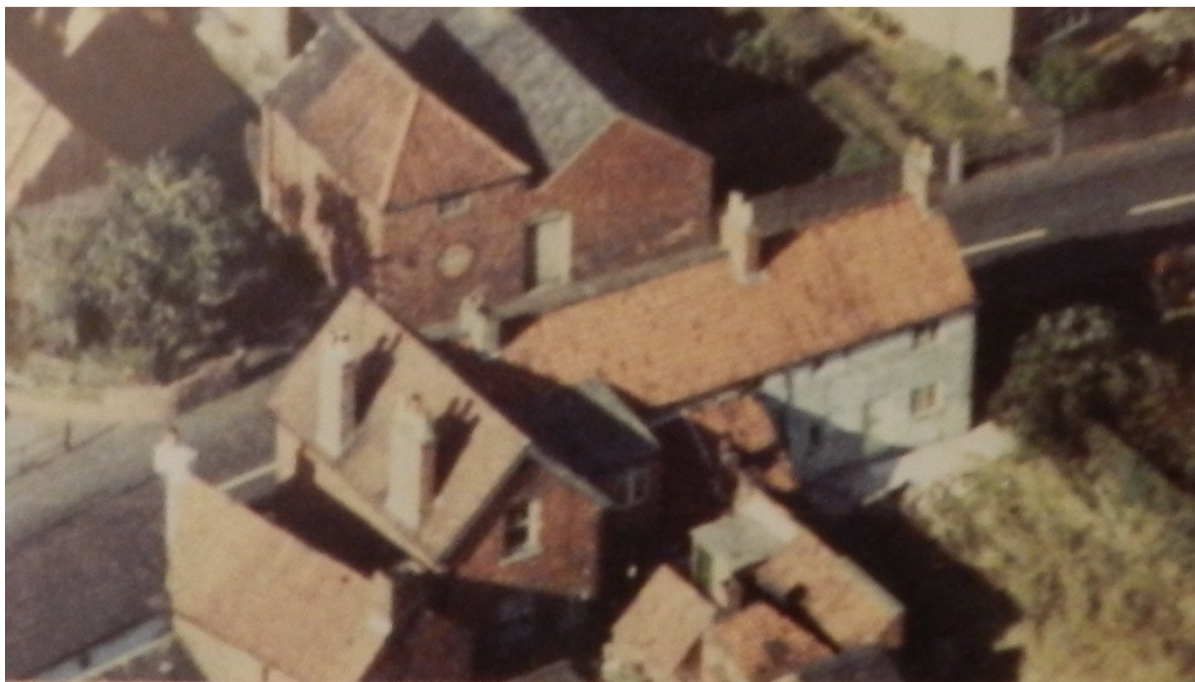
*Fig 5 Aerial photograph of the site taken in 1964 (Source: Jodi Govan)*

the oven constructed for Elizabeth Jepson by the Welbeck Estate a feature still visible on the 1964 aerial photograph (Fig 5).

The 1978 OS 1:2500 shows an L-shaped extension to the south of Arundel Cottage which was not present on the aerial photograph of the village taken in 1964 (Fig 5). The present owner has stated that the extension was constructed by her father at some point during the early 1970s (Jodi Govan pers. comm. 23/02/2013). This was the last significant addition to the site, although the brick oven at Brammer Farmhouse was also demolished around this time.

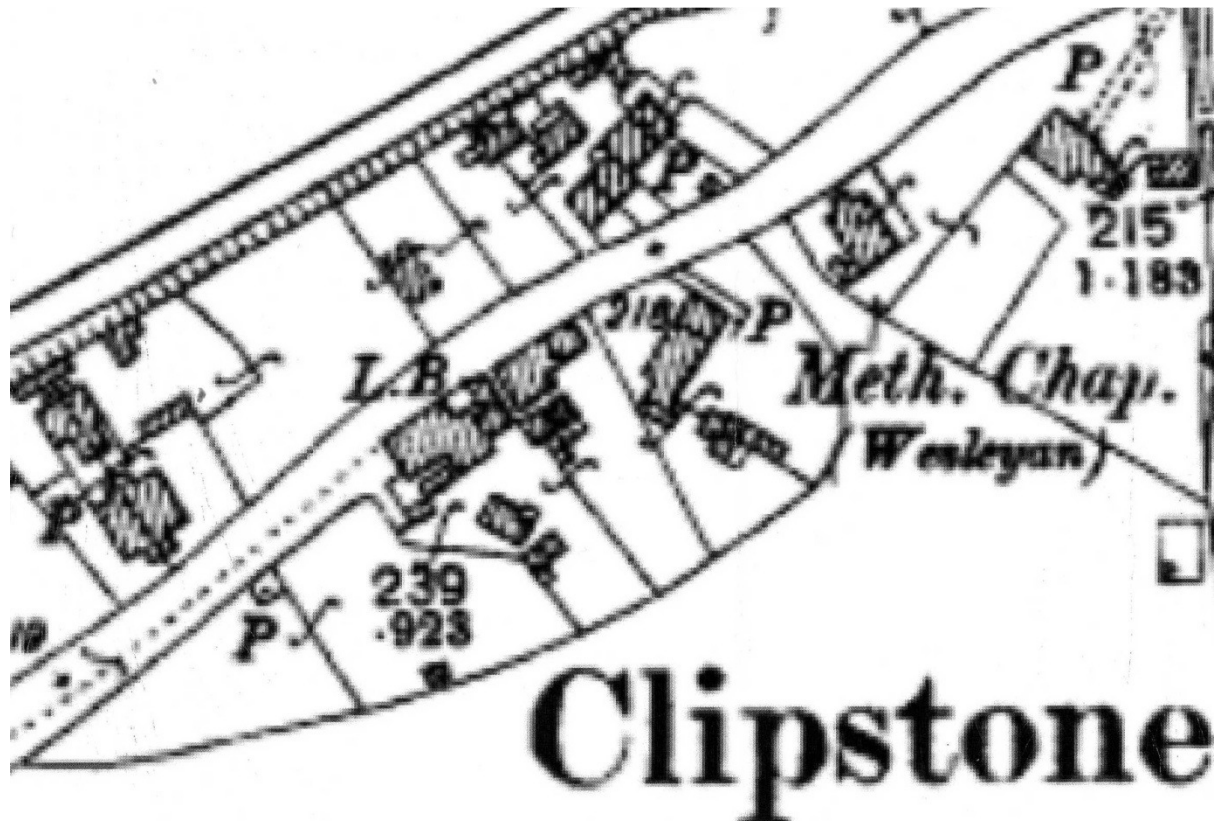
Fig 6 OS 1898 1:2500 edition map of Nottinghamshire (Source: Ordnance Survey)

1885 also marks the first edition Ordnance Survey map depicting Clipstone, however the scale of the mapping does not allow for accurate comments on the layout of the site until the 1898 1:2500 edition (Fig 6). An extension had been built to the west and south of Brammer Farmhouse in 1895 at the instigation of the nephew of the 5<sup>th</sup> Duke, Sir William John Arthur Charles James Cavendish-Bentinck, 6<sup>th</sup> Duke of Portland. Once again this was a demonstration of the benign landownership demonstrated by the Welbeck Estate towards their tenants at Brammer Farmhouse and was intended to provide accommodation for James and Hannah's three children (Bealby 2001, 174)

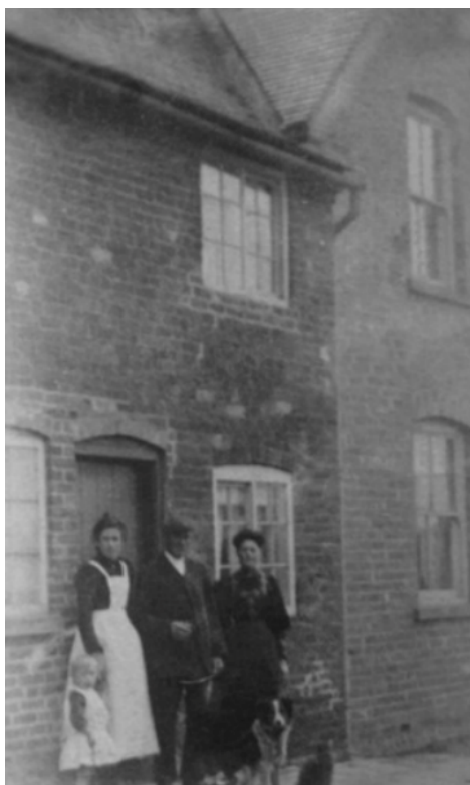
*Fig 7 Emma Bradley and family photographed outside of the north elevation of Brammer Farmhouse c 1915 (Source: A Celebration of King's Clipstone)*

The Brammer's were photographed outside the front door of the property in 1915 (Fig 7) and the twenty year old extension can clearly be seen in the background. Emma Brammer is shown wearing a black dress in Fig 7 and was the second child of James and Hannah. She had been schooled at Archway Lodge during her childhood, another philanthropic foundation by the Welbeck Estate after the 4<sup>th</sup> Duke of Portland had provided it for use as an educational institution in 1844 (Bealby 2001, 141-4; 153). Emma married John Bradley in 1915 and the pair took over the tenancy of Brammer Farmhouse along with the haulage firm and farm upon the death of her father in 1917 (Bealby 2001, 251). Another early 20<sup>th</sup> century photograph (Fig 8) shows the south elevation of the building with two small children in the foreground. Whilst there is now a single large uPVC window at this point there was a single smaller, rectangular timber window with a segmental head and a doorway immediately to the east. The photograph also shows a brick-built outhouse with pantile roof which is probably

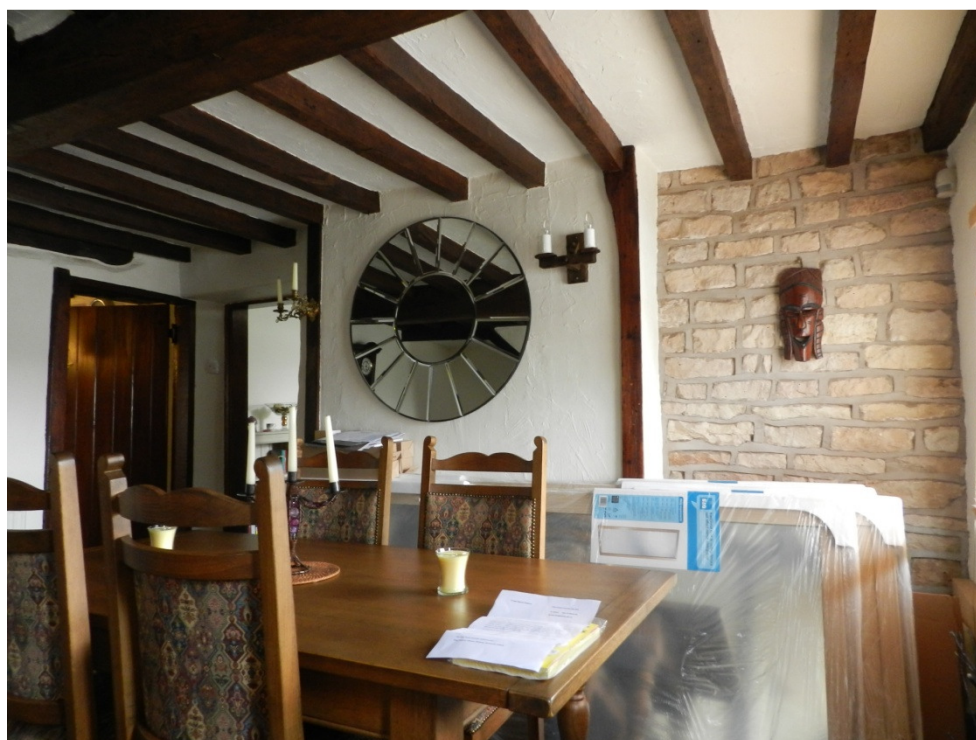
Fig 10 The dining room of Brammer Farmhouse, looking south-west

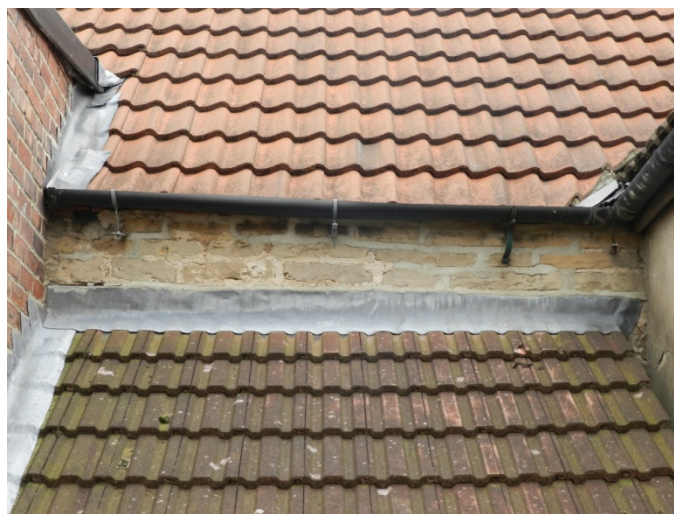
The wall is 0.51m in thickness along its entire length. Stonework is visible in two sections. Three courses of pitch-faced rubble stonework on the external south elevation of Brammer Farmhouse at first floor level above the lead flashing of the laundry roof and below the eaves of the main roof (Fig 11). The masonry is very similar in appearance to Stone Wall 1 and is also a mix magnesian limestones from the Linby/Bulwell and Mansfield White quarries. The mortar is a combination of modern cementitious and pale white-pink lime mortar made with washed sand.

Fig 11 Stone Wall 2 above the roof of the laundry of Brammer Farmhouse, looking north

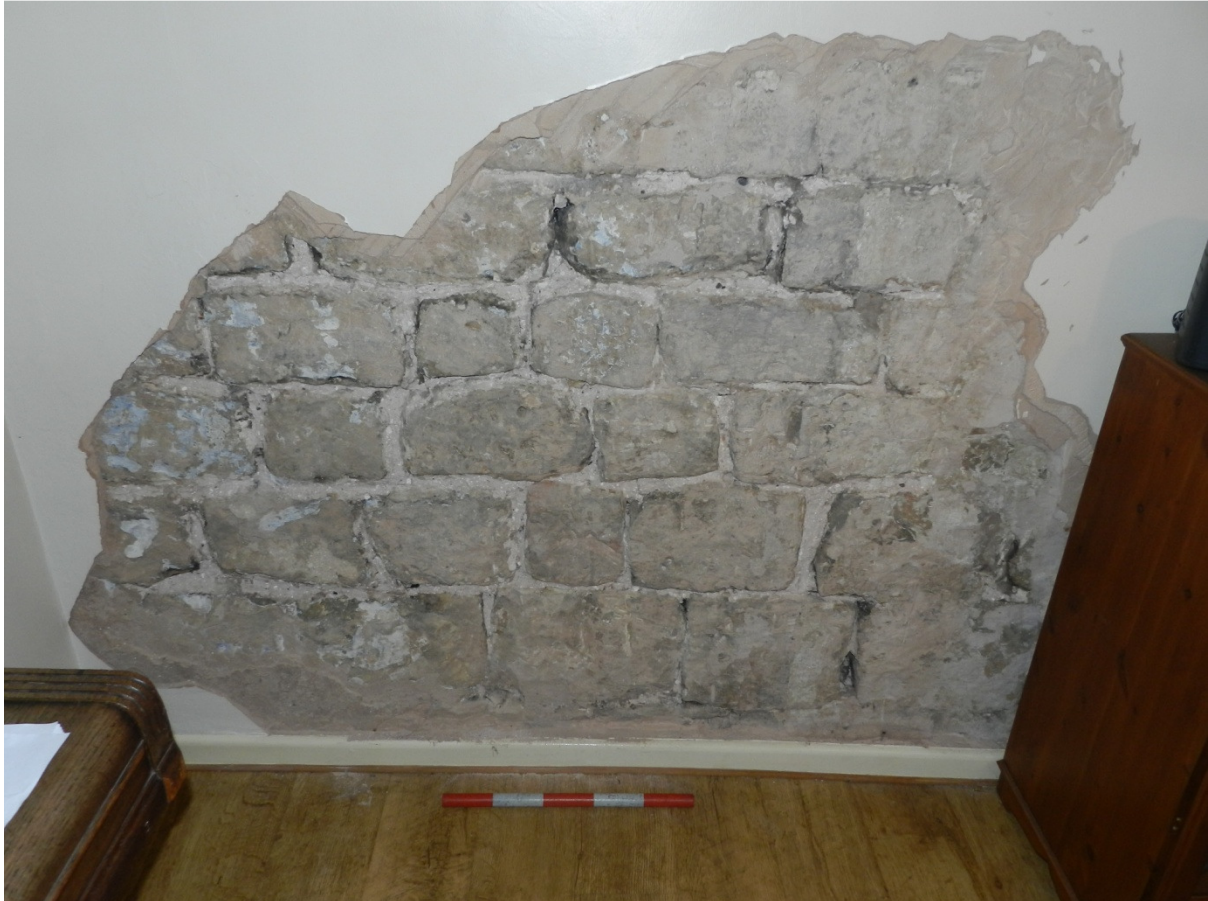
A second section of masonry is visible where plaster was stripped in 2011 on the north wall of the living room of Arundel Cottage (Fig 12). Whilst being petrologically from the same sources at Linby/Bulwell and Mansfield the coursed ashlar masonry is more massive in character due to a thicker bed-height. The mortar is a consistent mix of white-grey lime mortar made with washed sand and charcoal inclusions. The character of this mortar is very similar to that of the late 12<sup>th</sup> century rubble core of the ruin of King John's Palace. The mortar of the ruin was analysed in 2005 and found to contain 1 part carbonated lime to 2 parts aggregate comprising a quartz fine/medium sand with clay, very occasional soft red particles and the kiln fuel residue of charcoal ash particles (Ellis 2005).

*Fig 12 A section of removed plaster on the north wall of the living room of Arundel Cottage revealing the ashlar masonry of Stone Wall 2, looking north*

Until Phase 5 of the site the section of wall in the living room of Arundel Cottage was external (Fig 5) and bears traces of white limewash beneath a pale blue paint. Both are probably post-Mediaeval in date.

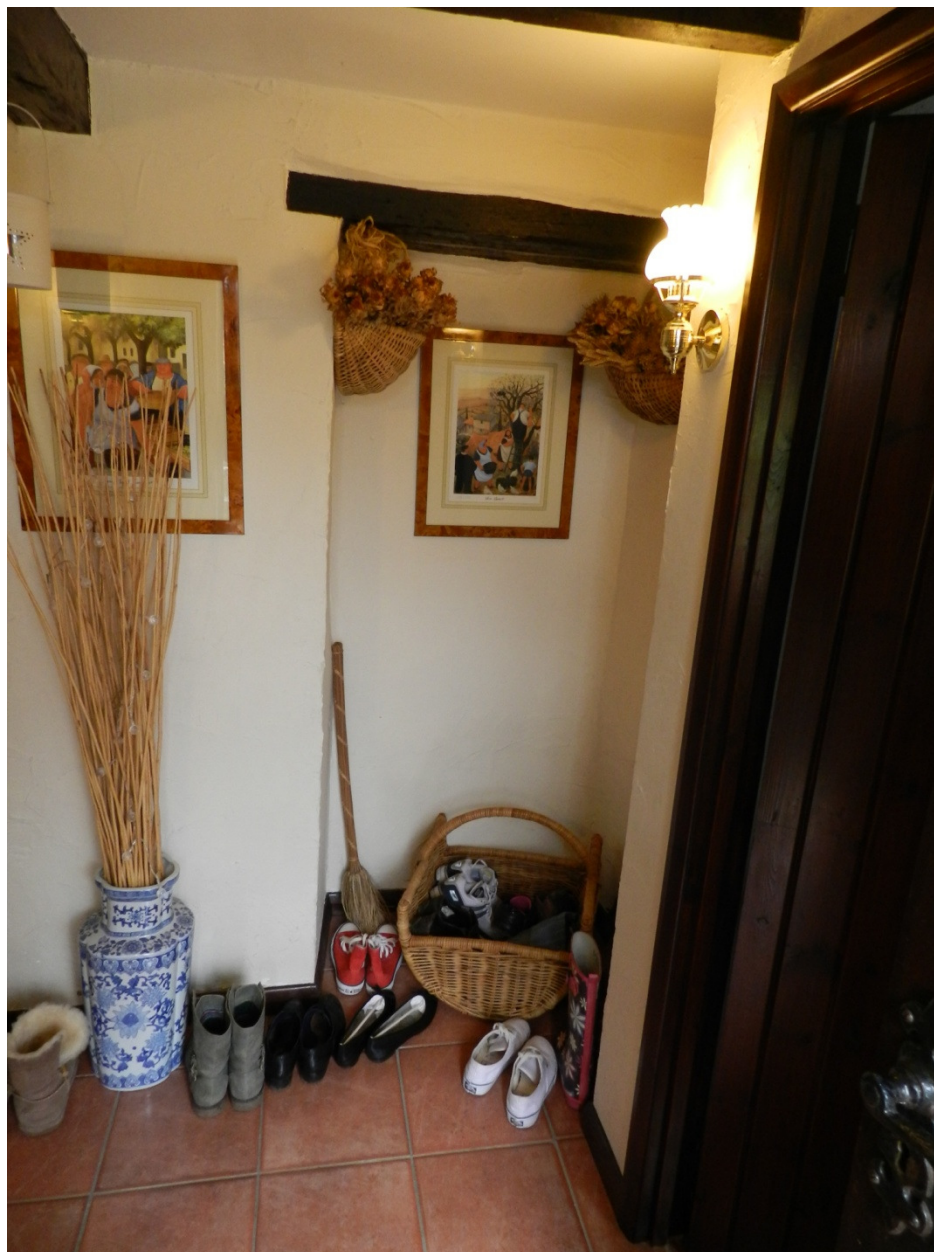
south. The blocking is 0.15m in thickness and is therefore interpreted to be post-Mediaeval brickwork. It is likely that the opening was blocked up during Phase 4 as the dog-leg north of the door between the hall and laundry partially obscures the access to the opening. The brickwork of the laundry matches that of the rest of the 1895 extension to the west of Brammer Farmhouse and is therefore dated to Phase 4.

*Fig 13 Blocked splayed opening in Stone Wall 2, looking north*

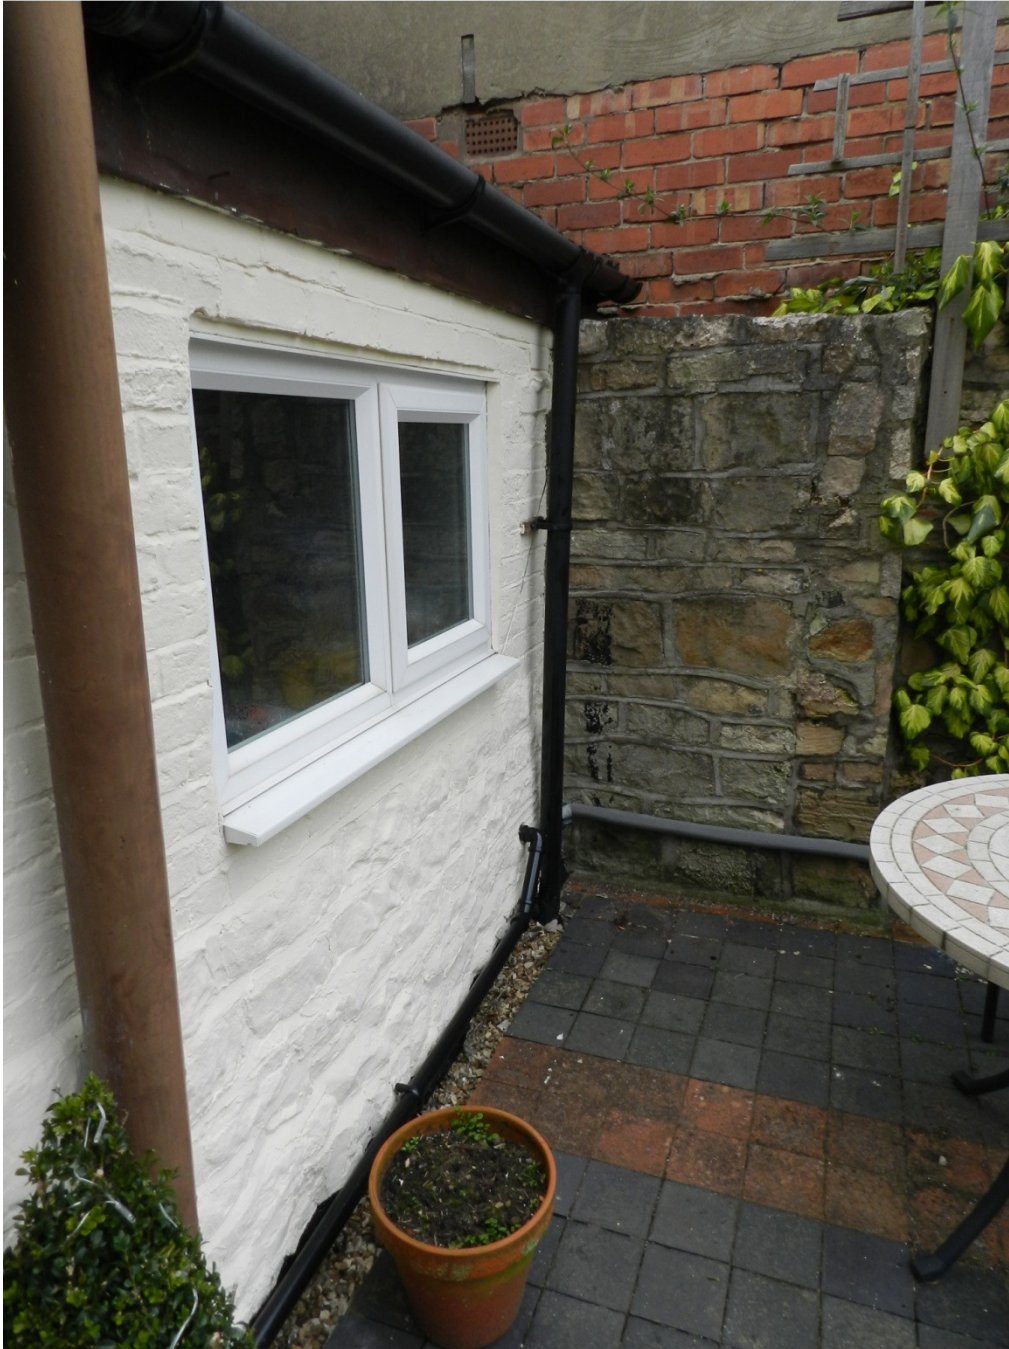
The wall is 0.4m in thickness and is therefore similar to the south end of Stone Wall 2. The section of wall in the garden to the south of the laundry is 1.78m in height and is constructed from both coursed pitch-faced rubble and ashlar masonry (Fig 14). The southernmost 0.13m of the wall has been rebuilt, probably after a collapse, and this is visible as a straight joint in the masonry. The stone only survives to a height of 0.6m in the east wall of the laundry and has been rebuilt in post-Mediaeval brickwork above this level. It appeared that the north end of Stone Wall 3 was bonded into the south elevation of Stone Wall 2 and can therefore be said to be contemporary. The stone is again a mix of stone from the Linby/Bulwell and Mansfield quarries. The mortar is a modern cementitious mix.

*Fig 14 South elevation of the laundry of Brammer Farmhouse and the west elevation of Stone Wall 3, looking north-east*

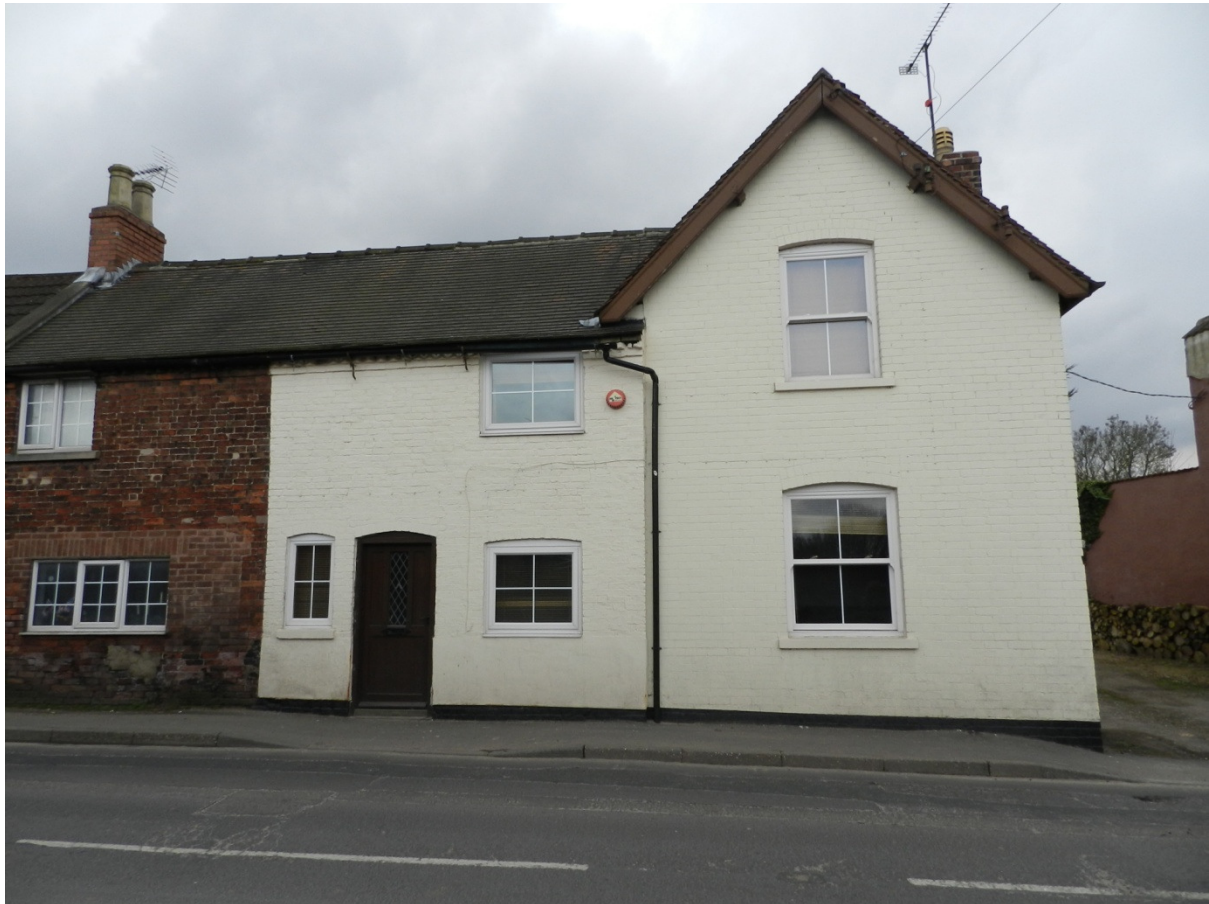
*Fig 15 The north elevation of Brammer Farmhouse, looking south*

A single modern timber door accesses the north elevation into what is now the dining room of Brammer Farmhouse (Drawing 1; Fig 15). This doorway has a single ring brick segmental arch and is flanked by two windows, also lighting the dining room, also with single ring brick segmental arches. The cill of the window is probably stone but as it is painted white it is not possible to be certain whether or not it is a modern concrete replacement of a stone original. The window at the east of the north elevation of the Phase 2 property is 1.84m in length but shows extensive modern brick remodelling above and to each side therefore it cannot be said for certain whether there was originally a window here or what its dimension may have been. The two first floor windows are flat headed and break the angled brick cornice directly below the eaves. All of the windows of Phase 2 are of modern uPVC although Fig 7 shows that in c 1915 they were timber casement windows.

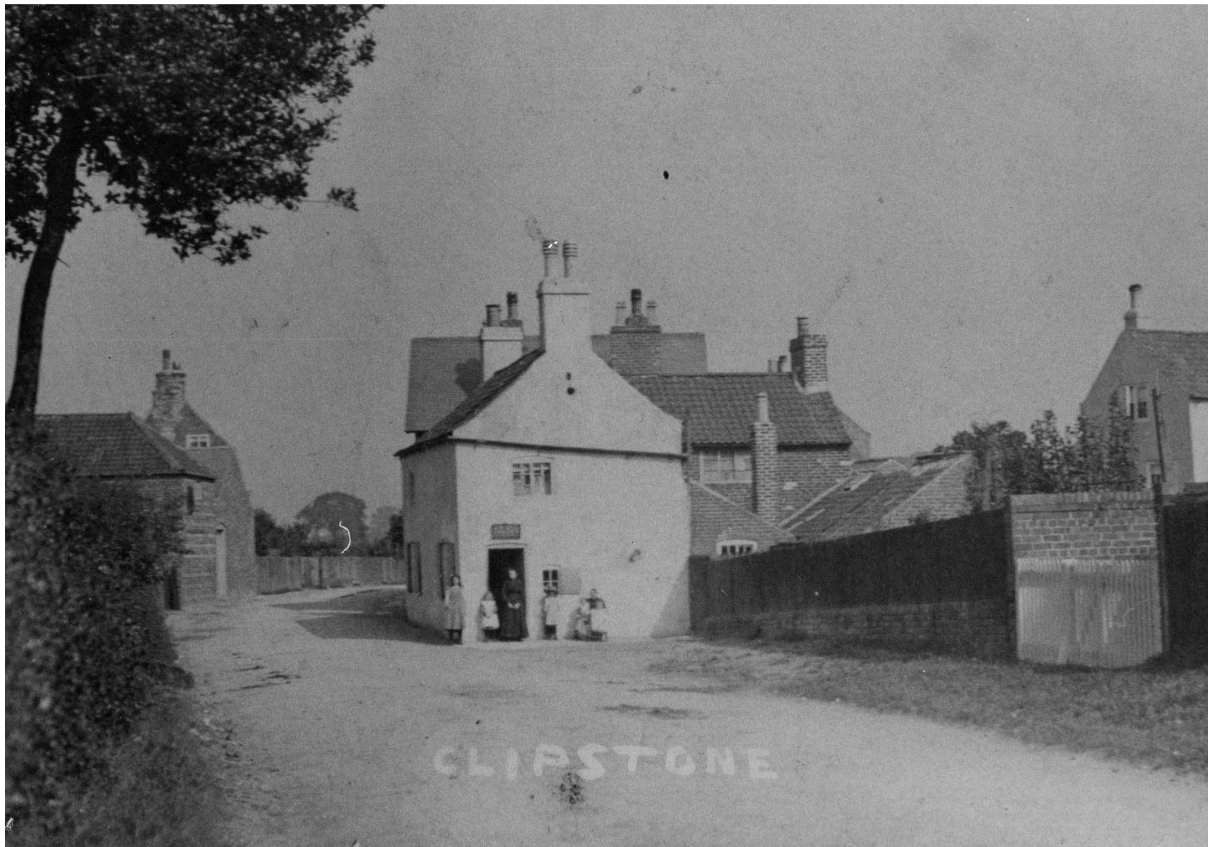
*Fig 16 Mansfield Road, King's Clipstone in c 1915, looking east. In the foreground is Maun Cottage, with the site immediately behind. Note the pantile roofs of the village properties.*

The roof to the north is of blue slate over a presumably timber structure which was not observed during this survey. To the south it is orange vernacular pantile. Originally the entire roof would have been in vernacular pantile, as would most of the properties in the village (Fig 16). A masonry firebreak was observed rising above the roofline to divide modern day Arundel Cottage from Brammer Farmhouse. A red brick chimney stack with two pots is still extant at the east end of the Phase 2 cottage, however the chimney stack has been removed above the corresponding chimney breast which rises internally at the west end of the Phase 2 property. The two chimney breasts would have sat at the east and west ends of the single cottage and, as they do today would have warmed two individual rooms linked by a single door adjacent to the south wall. This door is was blocked when the properties were divided in Phase 4 but is visible as a faint scar in the plasterwork in the kitchen of Arundel Cottage (Drawing 1).

Hannah's brother Fred Bradley and his wife Molly lived next door at Maun Cottage (Fig 16) and when the adjacent Waterfield Farm was offered for sale Fred purchased it although he allowed the previous tenant, Ernest Belfield, to remain there as his own tenant until 1955. Brammer Farm and Waterfield Farm were then worked as a single unit until Fred's retirement in 1981 when it was split between his son's Martin and Mark (Bealby 2001, 134-5).

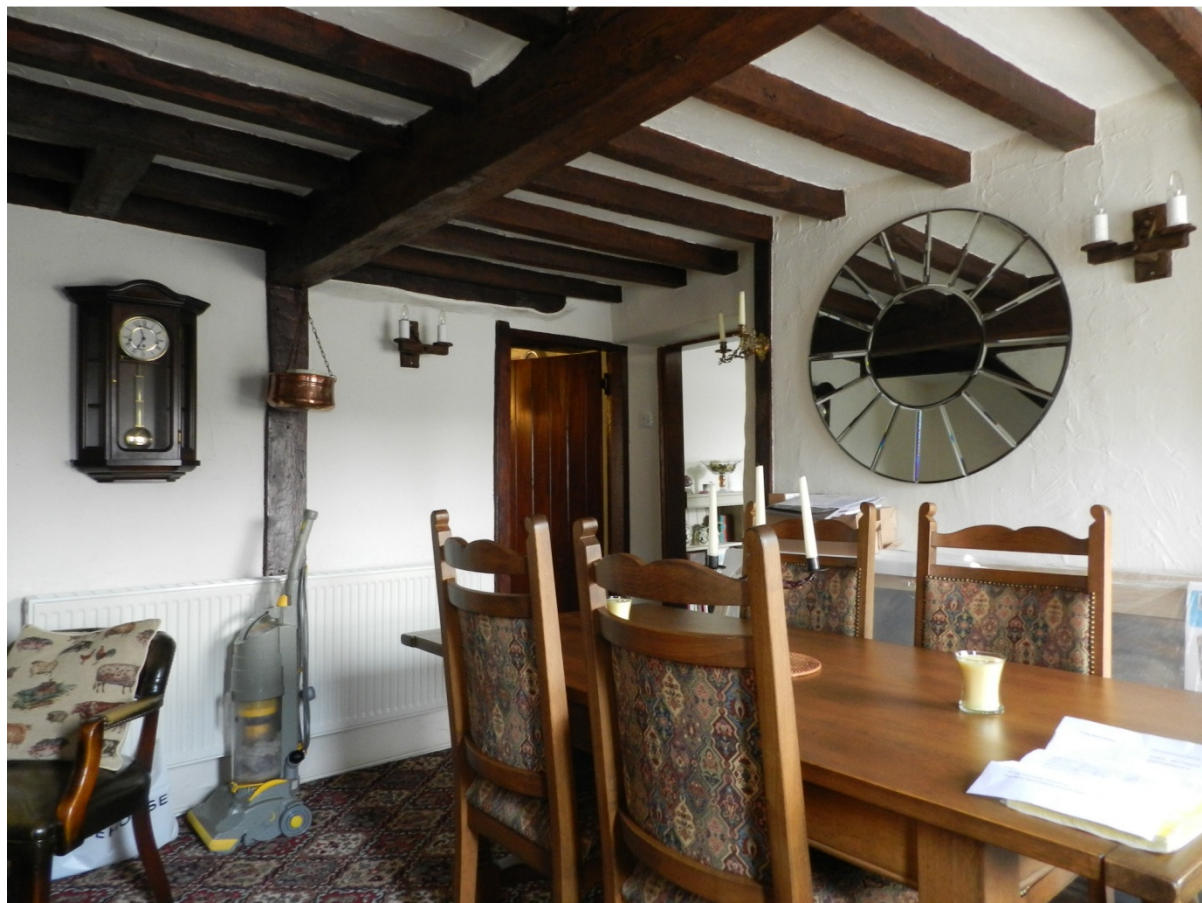
The dining room has eleven timber ceiling joists running east-west supported by a central timber beam orientated north-south (Fig 17) with a chamfer on the west side only. The single chamfer, which has no stops may indicate that this beam was re-used from another location

or building or that it is a replacement for an earlier beam which had failed. The timbers are manually sawn and hand hewn and must therefore date to before the invention of water and steam powered saw mills towards the end of the 18<sup>th</sup> century (Damian Goodburn, Museum of London Archaeology ancient timber expert, pers. comm.).

*Fig 17 The dining room of Brammer Farmhouse, looking south-west. Note the timber-framed ceiling joists and beam.*

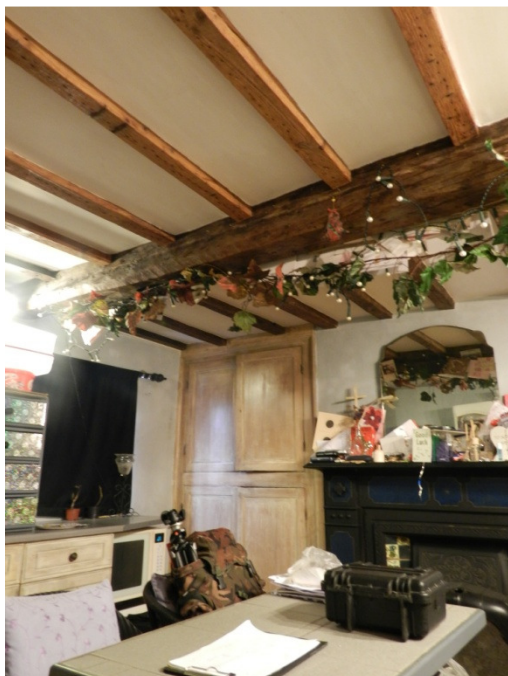
*Fig 18 The kitchen of Arundel Cottage, looking north-east*

The kitchen of Arundel Cottage has ten ceiling joists running east-west supported by a single central beam orientated north-south (Fig 18) with a chamfer on both sides. The chamfer has no stops and the beam now comes to rest over the centre of a large window in the north elevation. This structural weakening of the beam and the modern brickwork around the opening externally suggests that the window has been inserted. In common with the beam in

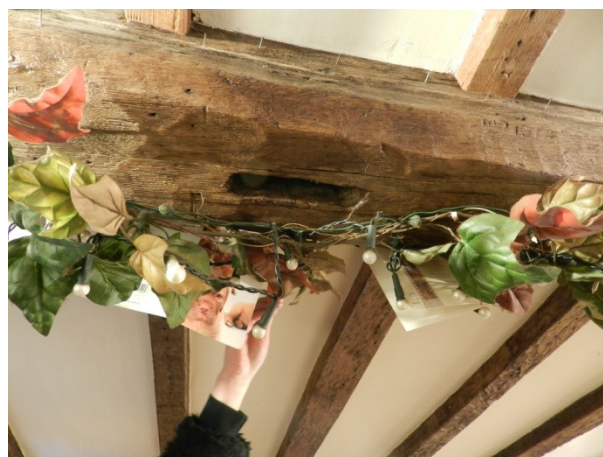
the dining room of Brammer Farmhouse this beam may be re-used as it has a single empty mortice hole (Fig 19) which does not seem to conform to any internal room division. There is also an inverted W chiselled onto the western chamfer to the south of the empty mortice (Fig 20) which may be a merchant's mark relating to the sale of the timber prior to re-use.

*Fig 19 Empty mortice hole in the beam of the kitchen of Arundel Cottage, looking south-east*

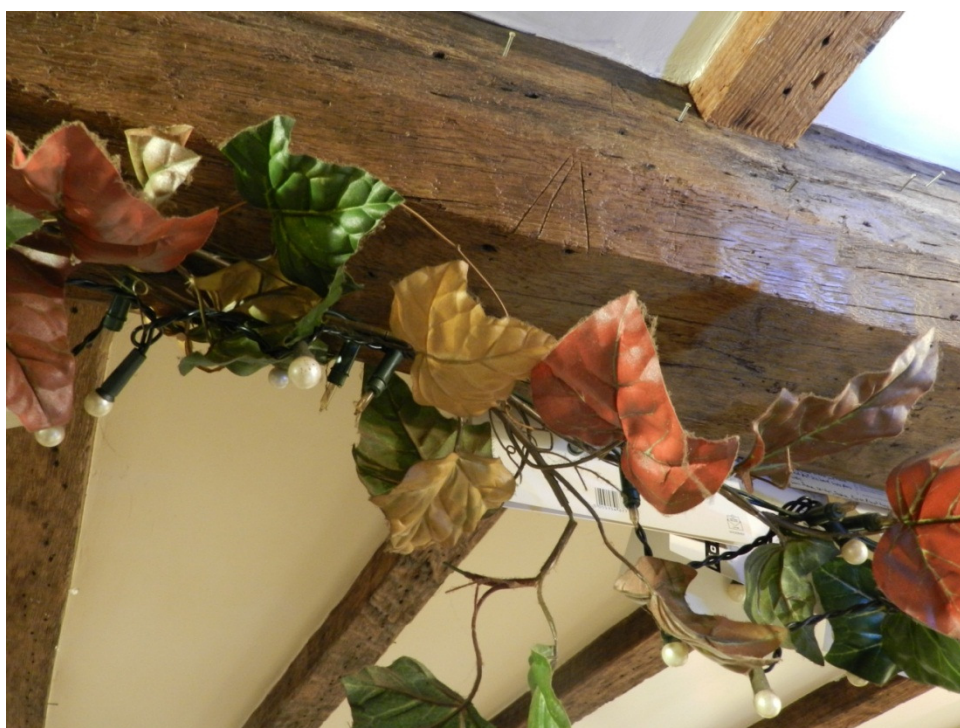
*Fig 20 Possible merchant's mark on the western chamfer of the beam in the kitchen of Arundel Cottage, looking south-east*

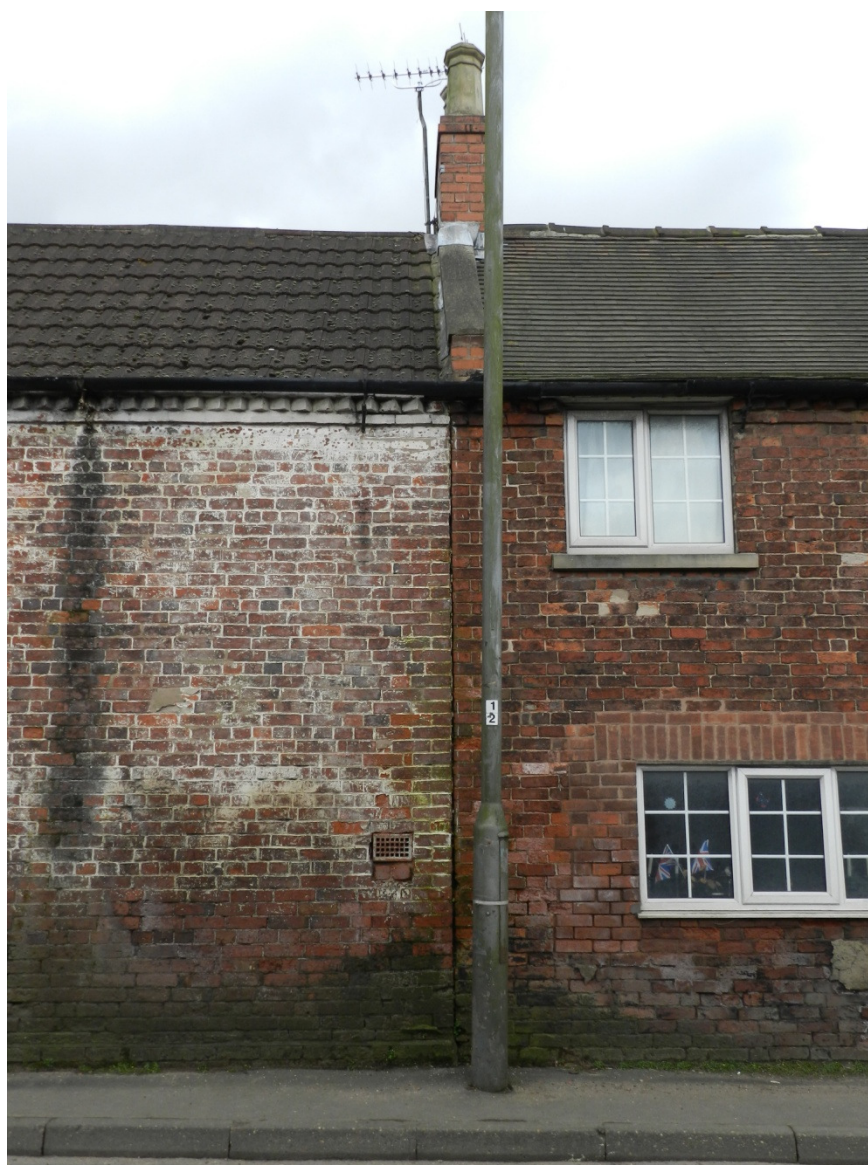
*Fig 21 Straight joint between the Phase 2 single cottage (right) and the Phase 3 extension (left) of Arundel Cottage, looking south*

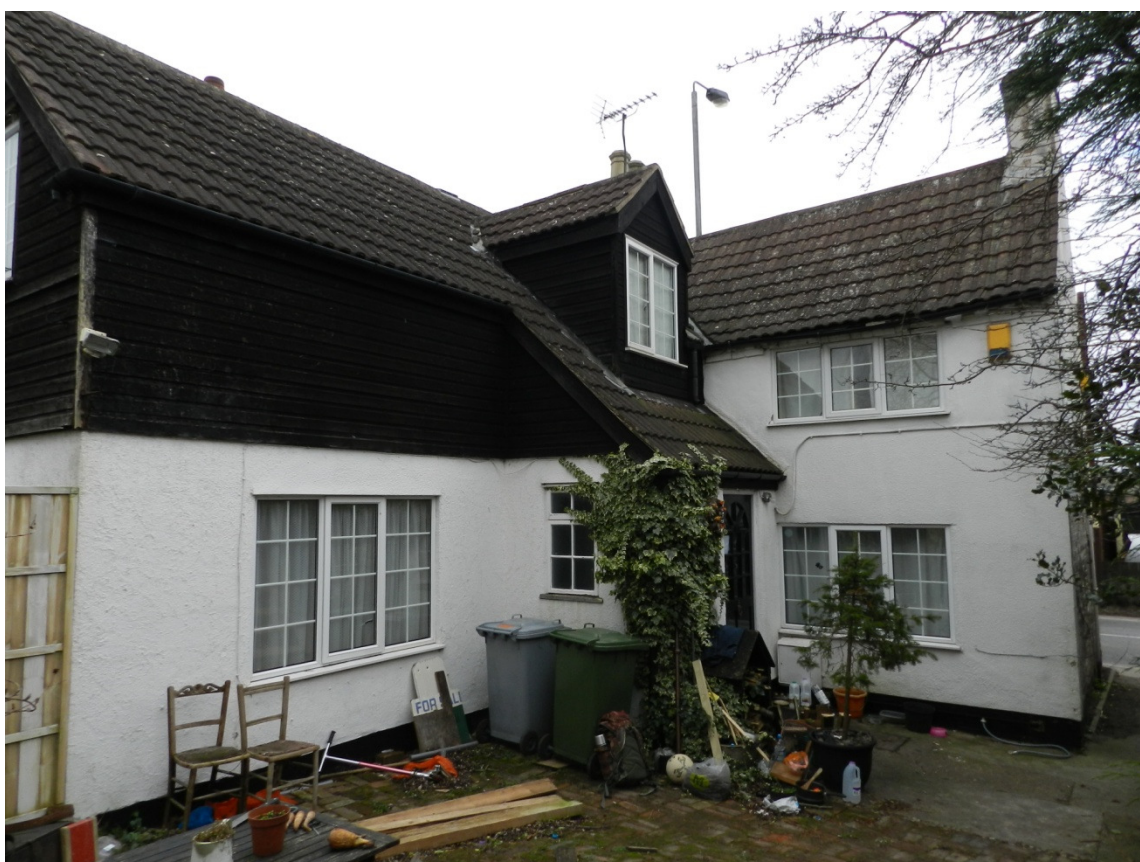
The original post-Mediaeval single cottage was extended to the east prior to the 1844 Tithe map of Clipstone. The new construction was 5.76m in length by 4.59m in width externally. It was constructed in red brick set in common bond (Fig 21) with a white-grey lime mortar which has been extensively repointed in a modern cementitious mortar. Until recently the entire extension was clad in render and painted white, however this has been removed from the north elevation and part of the east elevation (Fig 22). The extension is very clearly apparent externally as it shows as a straight joint in the masonry, a change in the brick bonding and the use of a longer brick of 0.235m dimension as opposed to 0.22m of the Phase 2 structure (Fig 21). The cornice of the extension mirrors the angled brick cornice of Phase 2 on the north extension, however the south extension has only a slightly jettied single brick course to mark its cornice (Fig 23).

*Fig 23 The south and east elevations of Arundel Cottage, looking north-west*

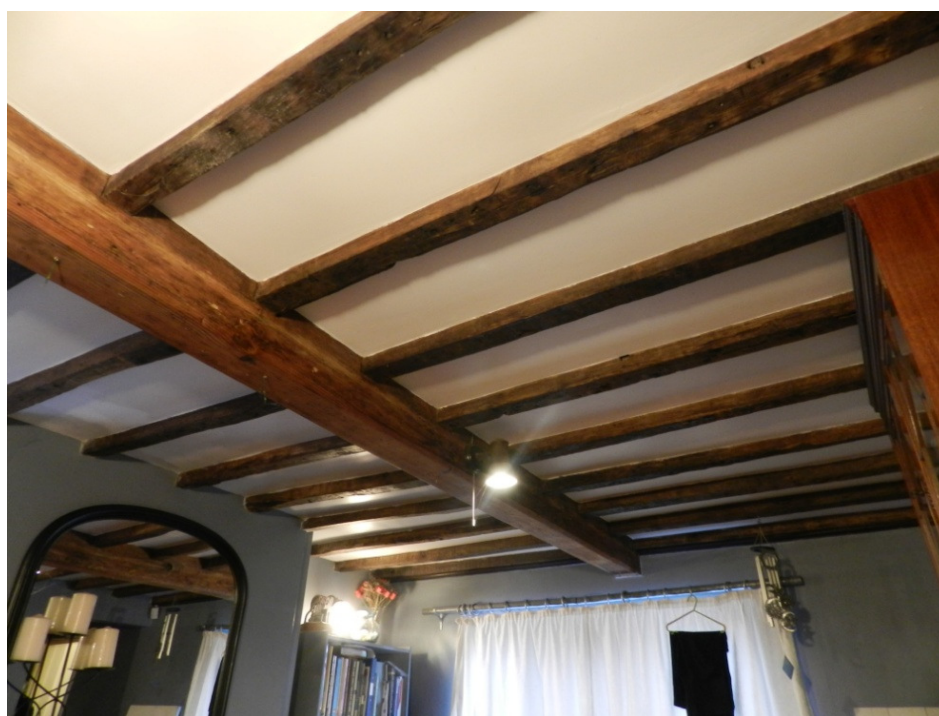
*Fig 24 Timber joists and beam in the dining room of Arundel Cottage, looking south-east*

The dining room has eleven timber ceiling joists running east-west supported by an original central timber beam orientated north-south (Fig 24) with chamfers and stops on the east and west sides. The beam has been sanded down which has removed much of the historic patina and eroded traces of how the timber was originally cut, however the joists are all manually sawn and hand hewn.

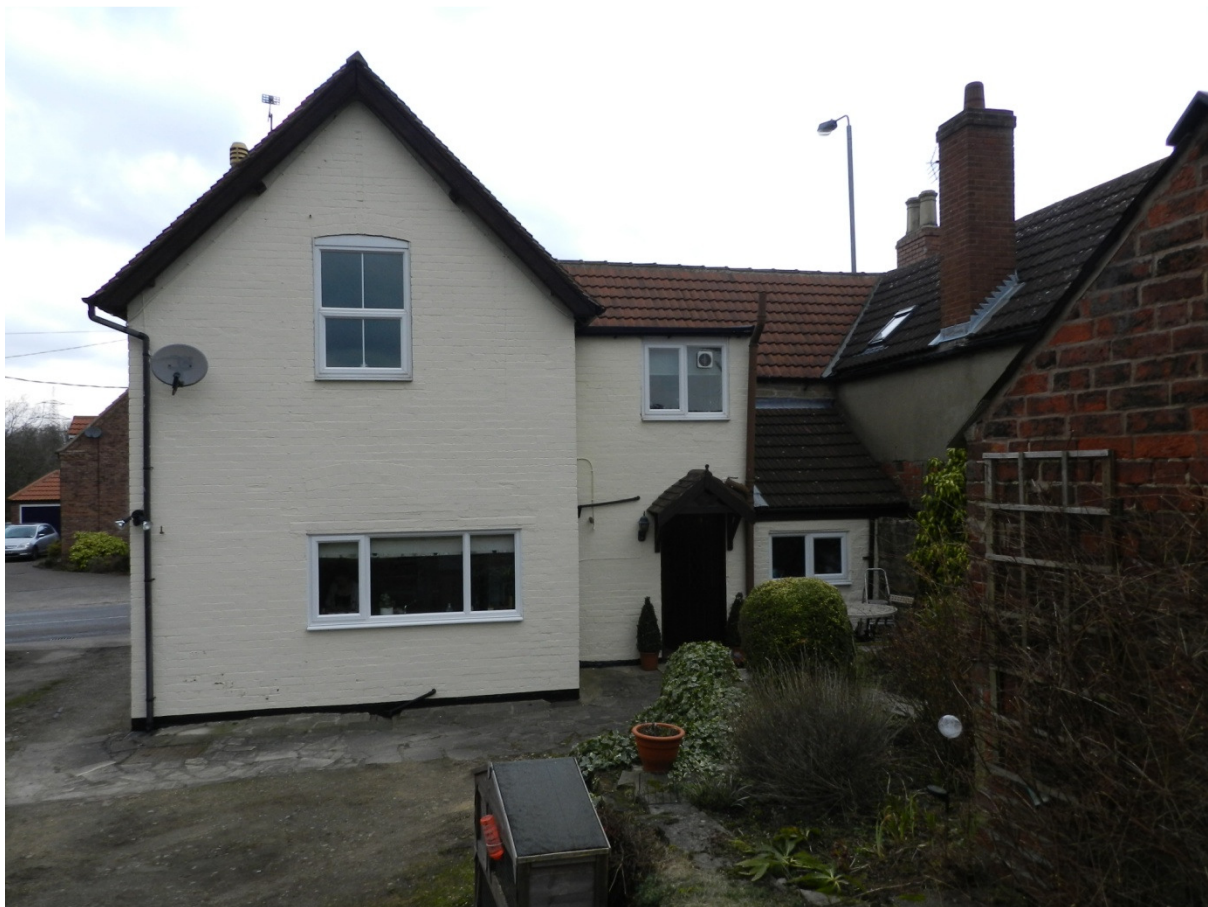
A single doorway to the south of the Phase 4 extension accesses what is now a hall between the kitchen and laundry of Brammer Farmhouse (Drawings 1 and 2). This doorway has a flat head and a small 20<sup>th</sup> century hood porch. Originally the hall had a lean-to roof which can just be seen in Fig 8 but was extended during the mid 20<sup>th</sup> century with a flat-roof and a flat headed window. The Phase 4 west extension is lit by sash windows at ground and first floor with segmental two ring brick arches to the north (Fig 25), a small segmental uPVC window in the south-west corner (Fig 25), a flat headed uPVC window at ground floor level and a segmental uPVC window at first floor on the south elevation, a segmental window lights the east elevation of the kitchen. The south elevation of the laundry also has a flat headed window (Fig 26). Originally the south elevation of the west extension had a twin ring brick segmental arched window and a door to the east (Fig 8), both are now blocked although the arches of both are still visible (Fig 26). The uPVC windows of the Phase 4 extension on the south and west elevations would originally have been timber sash windows as shown in Figs 7 and 8. The cills of the north and west elevations remain although it is not clear whether they are stone or concrete, those of the south elevation have been replaced with modern materials.

*Fig 26 The south elevation of Brammer Farmhouse, looking north*

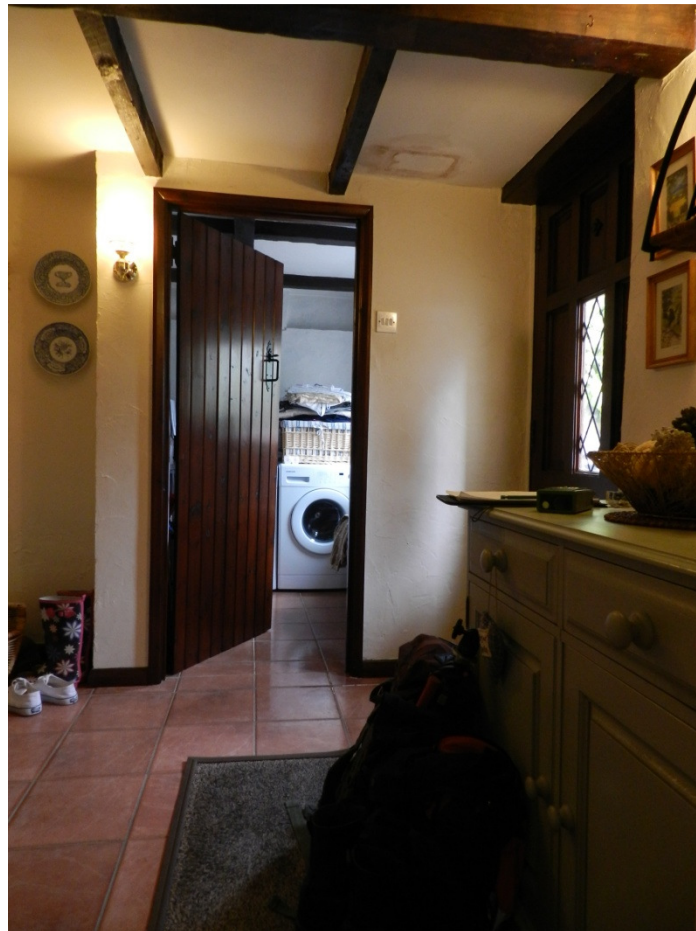
*Fig 27 The hall and laundry of Brammer Farmhouse, looking east*

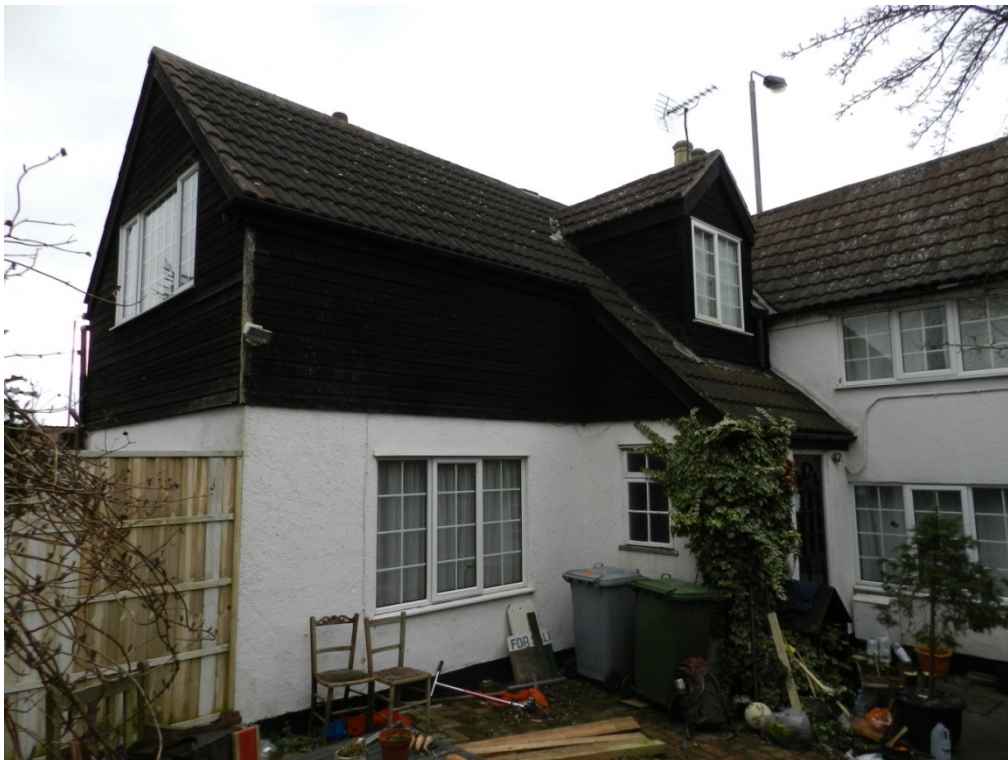
Internally the walls and ceilings are plastered and painted. The porch allows access to a WC to the south and a small hall to the west. The hall in turn allows access through the Phase 3 south door into a corridor to the north and into the living room to the south (Drawing 1). The north wall of the living room is Stone Wall 2 of Phase 1 although all other walls relate to Phase 5. A small gap divides the west elevation of the Phase 5 extension to Arundel Cottage from the Phase 1 Stone Wall 3 of Brammer Farmhouse.

Fig 28 The extension to the south of Arundel Cottage, looking north-west
