## Archaeological Survey of Cuckney Water Meadow System, Cuckney, Nottinghamshire (SK 56449 71559).

### Archaeological Survey Report

**Andy Gaunt**  
**Mercian Archaeological Services CIC**

31/05/2019

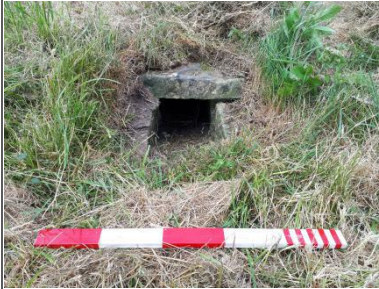
Feature	Description	Easting	Northing	Photograph
CUCK18WM001	Wood and Iron Sluice Gate	456323.127	371555.103	No Photograph - site inaccessible
CUCK18WM002	Water inlet from flood-dyke channel.	456359.722	371591.765

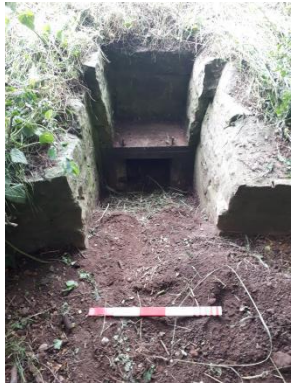
CUCK18WM003	Water inlet valve for main sluice through here into a buried pipe before emerging to the south in the main stone channel [CUCK18WM006].	456470.569	371633.745

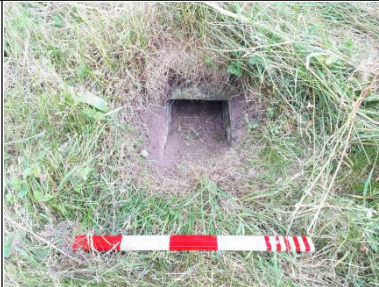
CUCK18WM004	Water inlet from flood-dyke channel.	456420.681	371644.130

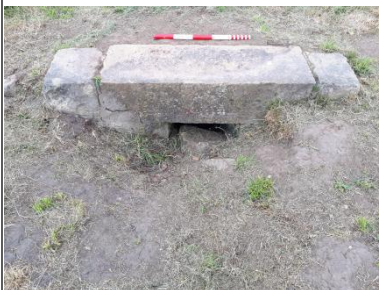
CUCK18WM005	Inlet for water into the stone sluice channel [CUCK18WM006], via an underground pipe from the flood-dyke channel to the north.	456471.901	371606.601

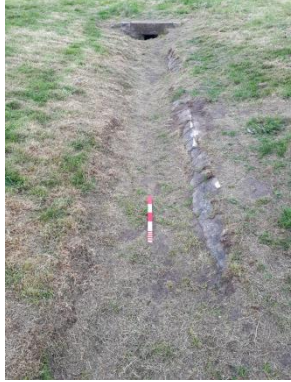
CUCK18WM006	Main stone sluice channel	456473.004	371602.184

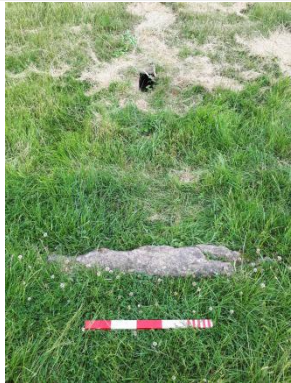
CUCK18WM007	Stone water inlet from flood-dyke channel, with limestone baffle.	456499.060	371610.475

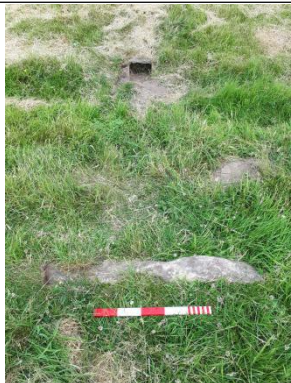
CUCK18WM008	Stone water inlet from flood-dyke channel, with limestone baffle.	456535.442	371592.234

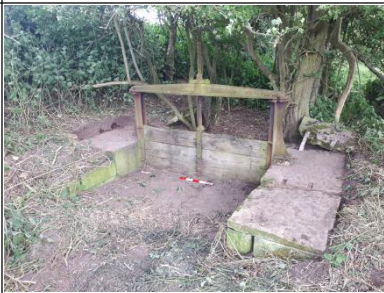
CUCK18WM009	Wood and Iron Sluice Gate	456649.019	371596.982

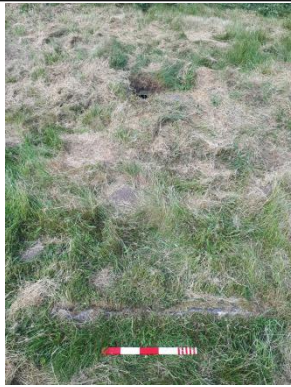
CUCK18WM010	Stone water inlet from flood-dyke channel, with limestone baffle.	456575.312	371581.093

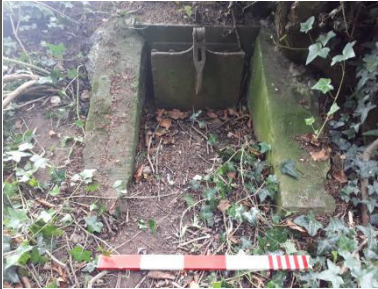
CUCK18WM011	Stone water inlet valve in flood-dyke channel, the iron paddle was opened to allow water to pass out of the flood-dyke channel to flood the water meadow panes to the south.	456576.696	371585.003

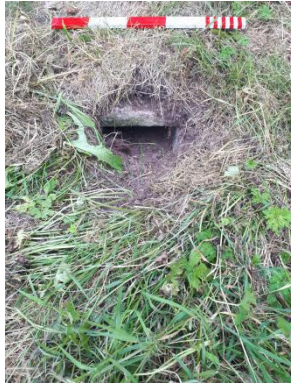
CUCK18WM012	Stone water inlet from flood-dyke channel.	456677.073	371575.593

To the east of Pane 7, Panes 8 and 9 were flooded directly from the flood-dyke channel via stone inlets [CUCK18WM012] and [CUCK18WM013] (associated stone inlet missing - see below). This section of the flood-dyke was filled by opening wooded sluice [CUCK18WM009], and by closing wooden sluice [CUCK18WM014] at the eastern end of the system, to allow water to build up (see figure 18).

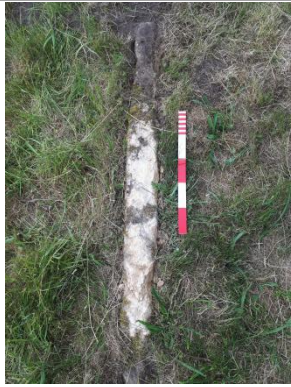
CUCK18WM013	Limestone baffle- no associated stone water inlet from flood-dyke channel (blocked by presence of later path).	456787.055	371473.449

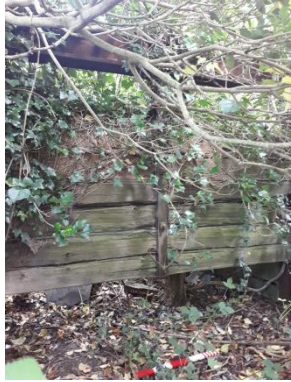
CUCK18WM014	Wood and Iron Sluice Gate	456891.688	371437.834

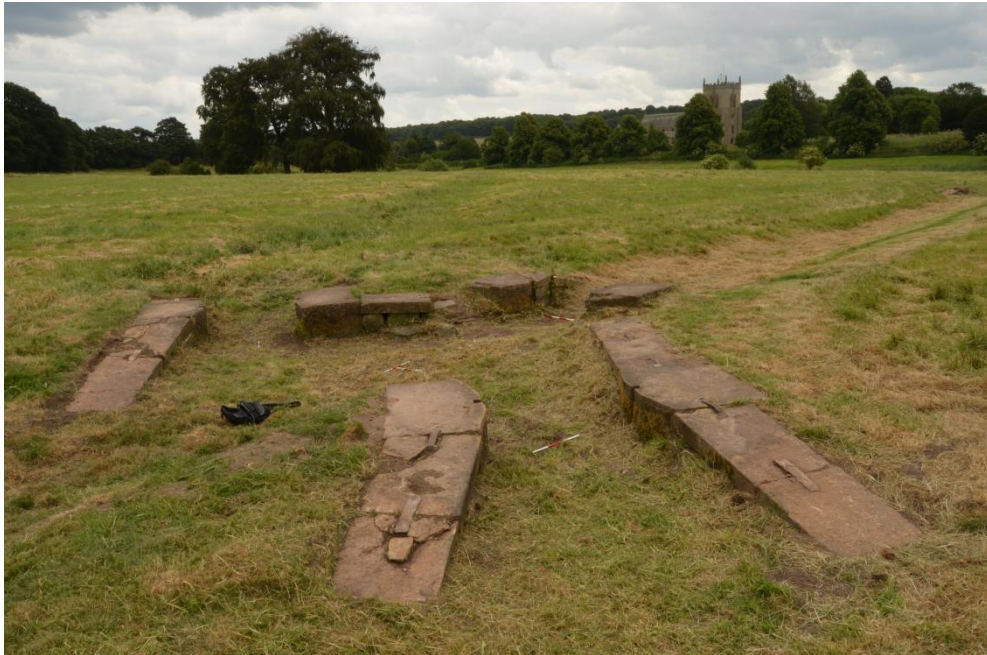
Photograph 8: Stone sluice SG1, photograph facing south-east. Taken during photogrammetric survey. Scales are in 0.2m divisions.

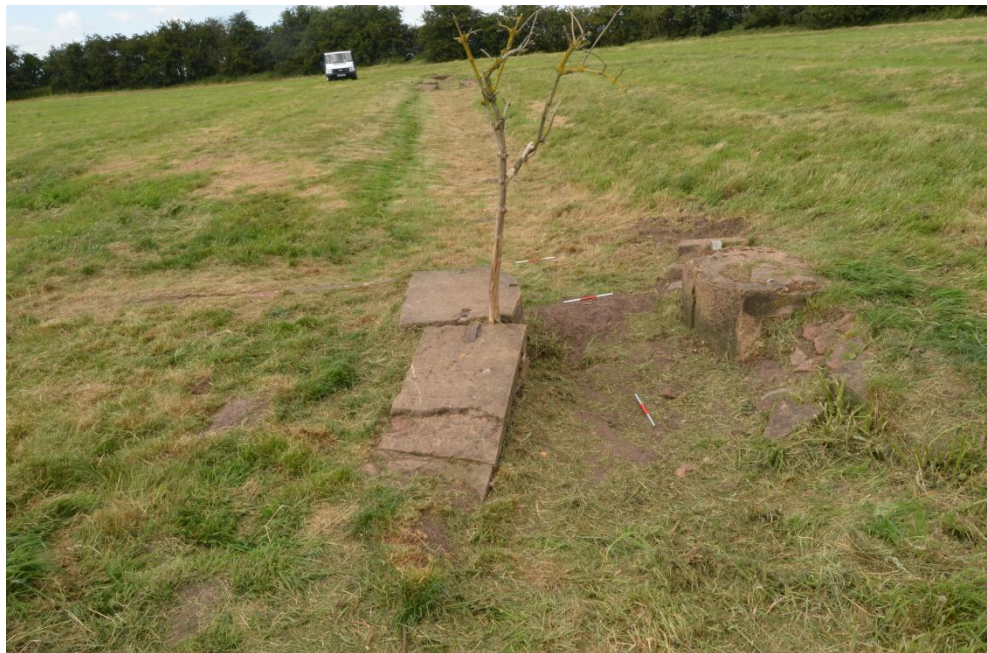
Photograph 9: Stone sluice SG2, photograph facing north. Taken during photogrammetric survey. Scales are in 0.2m divisions.

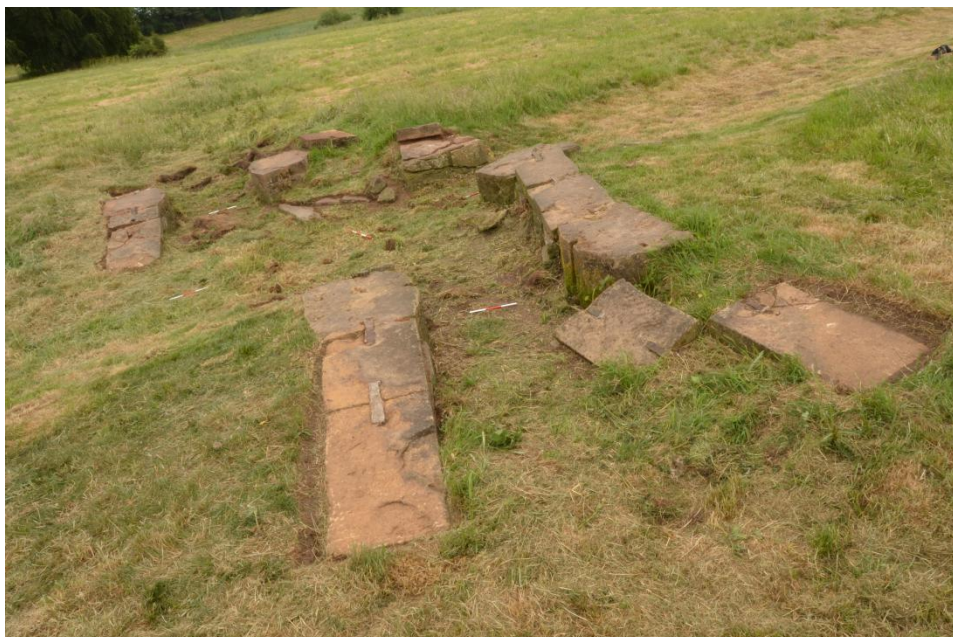
Photograph 10: Stone sluice SG3, photograph facing south-east. Taken during photogrammetric survey.  
Scales are in 0.2m divisions.

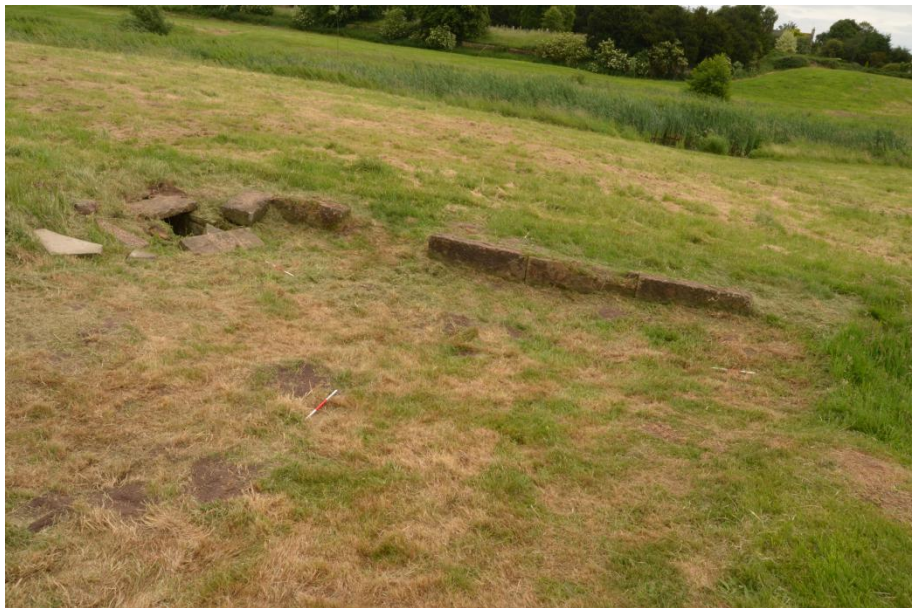
Photograph 11: Stone baffle 'CB' photograph facing south-south-east.

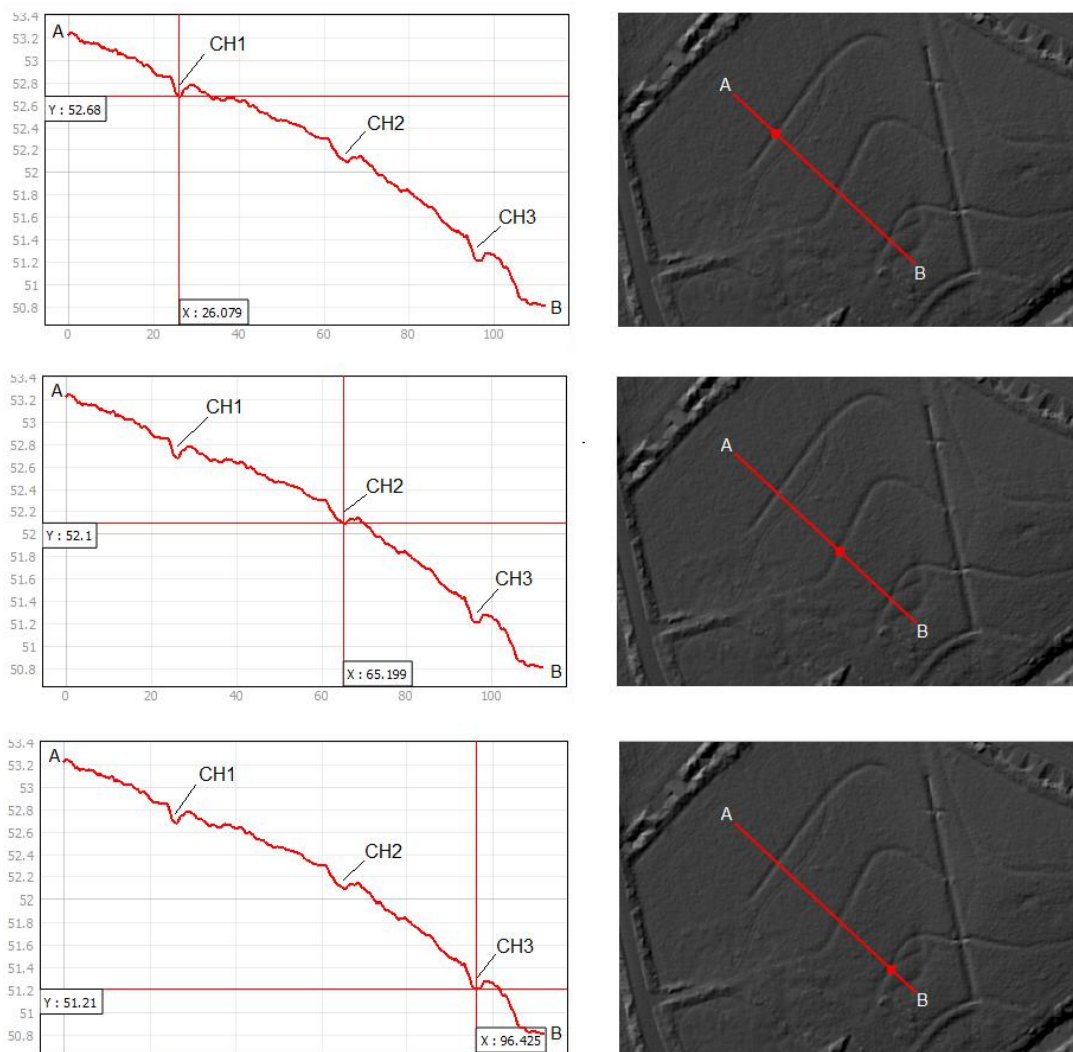
Figure 20: Cross-section 1. Cross section across panes 1-4 showing depths of the bottoms of channels CH1 - CH3. The graphs on the left hand side show the distance along the cross-section as the X Axis, with height above sea- level (ODN) on the Y Axis. The X and Y values displayed on each graph, are for the bottoms the channel CH1- CH3 respectively. The location of the readings on the graph are displayed on the ground on the associated image map to the right of each graph.

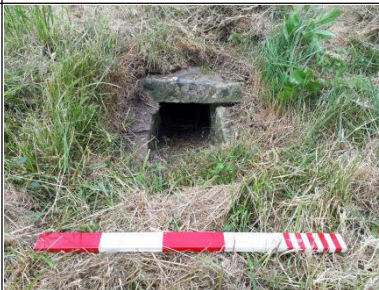
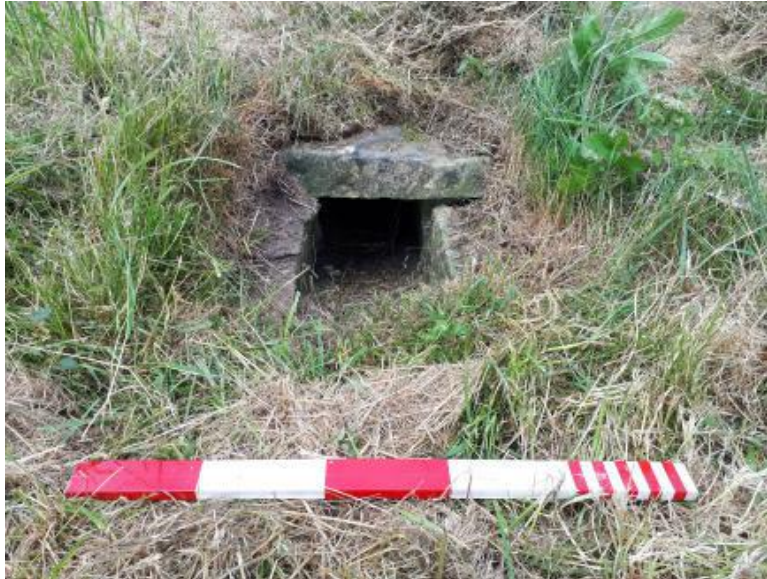
CUCK18WM002:

Feature	Description	Easting	Northing	Photograph
CUCK18WM001	Wood and Iron Sluice Gate	456323.127	371555.103	No Photograph - site inaccessible
CUCK18WM002	Water inlet from flood-dyke channel.	456359.722	371591.765

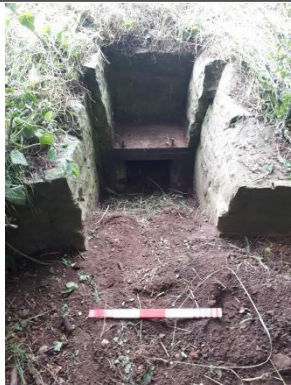
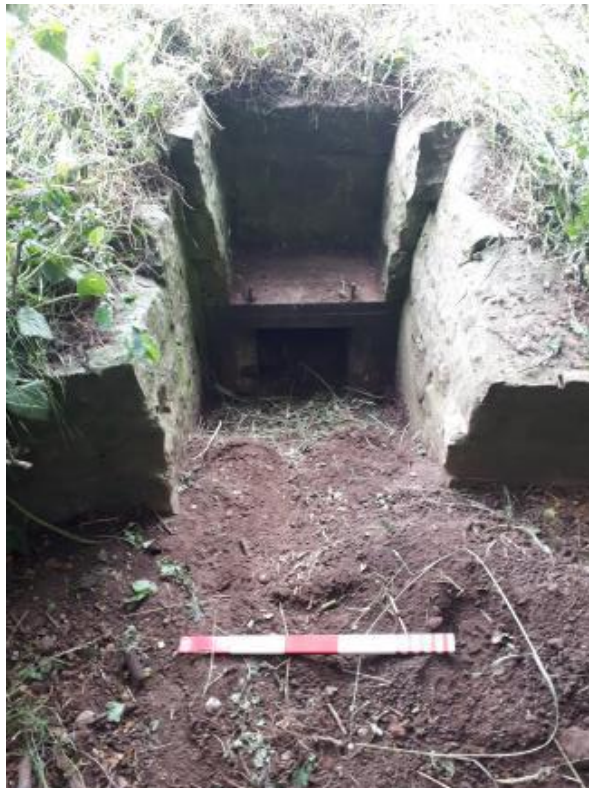
CUCK18WM003:

CUCK18WM003	Water inlet valve for main sluice through here into a buried pipe before emerging to the south in the main stone channel [CUCK18WM006].	456470.569	371633.745

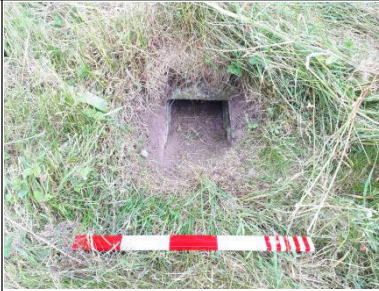
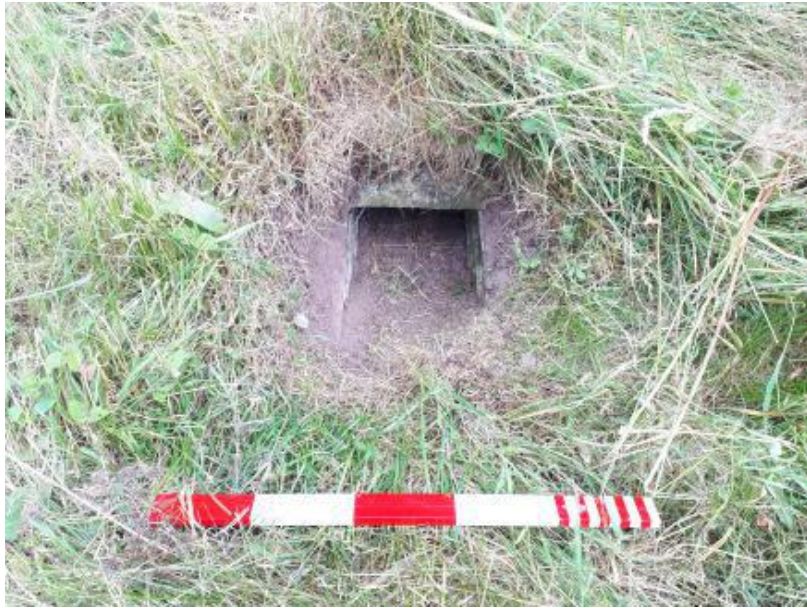
CUCK18WM004:

CUCK18WM004	Water inlet from flood-dyke channel.	456420.681	371644.130

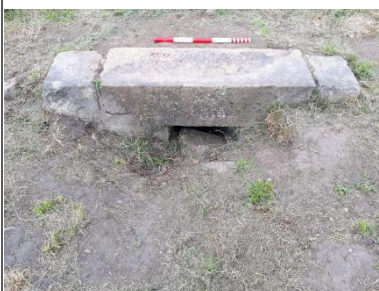
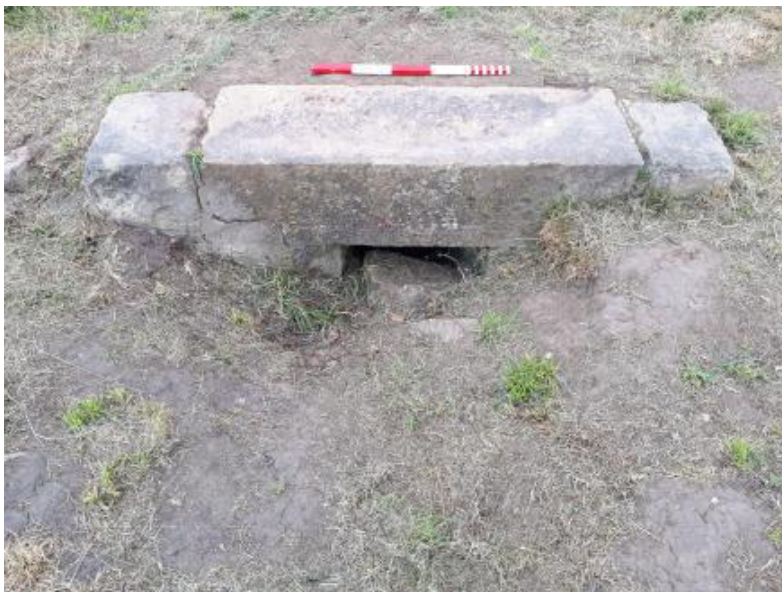
CUCK18WM005:

CUCK18WM005	Inlet for water into the stone sluice channel [CUCK18WM006], via an underground pipe from the flood-dyke channel to the north.	456471.901	371606.601

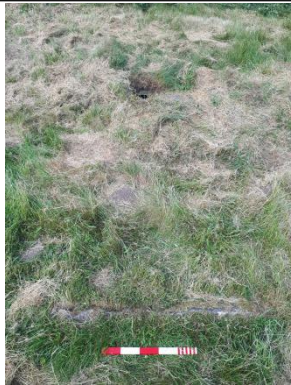
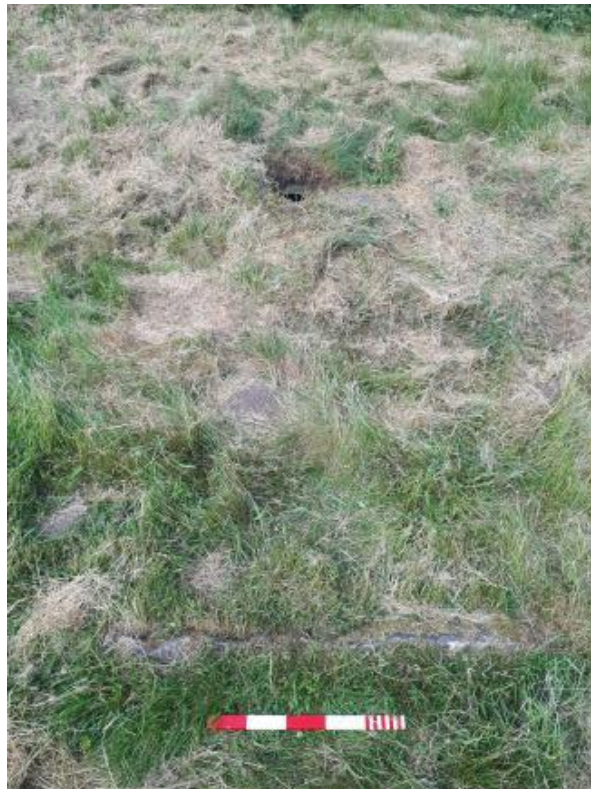
CUCK18WM010:

CUCK18WM010	Stone water inlet from flood-dyke channel, with limestone baffle.	456575.312	371581.093

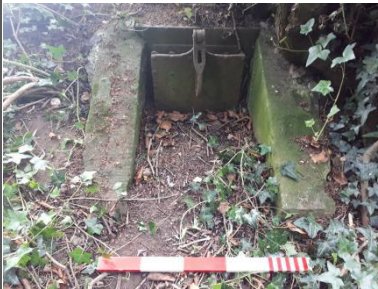
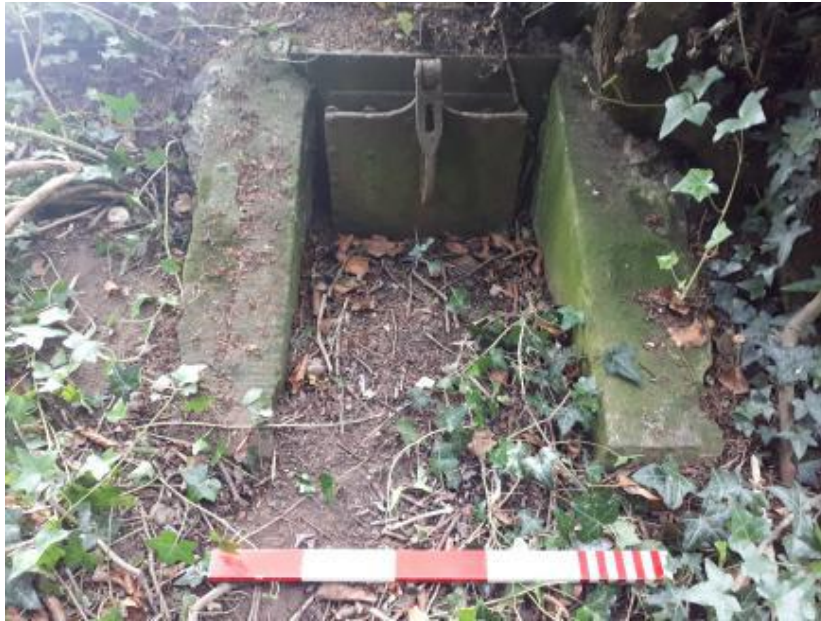
CUCK18WM011:

CUCK18WM011	Stone water inlet valve in flood-dyke channel, the iron paddle was opened to allow water to pass out of the flood-dyke channel to flood the water meadow panes to the south.	456576.696	371585.003

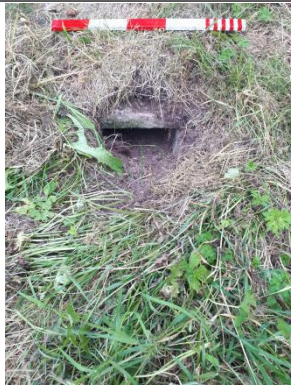
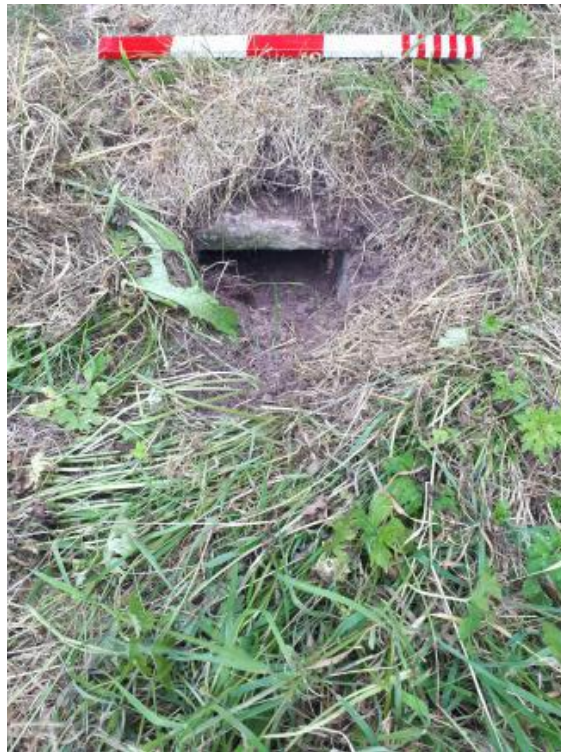
CUCK18WM012:

CUCK18WM012	Stone water inlet from flood-dyke channel.	456677.073	371575.593

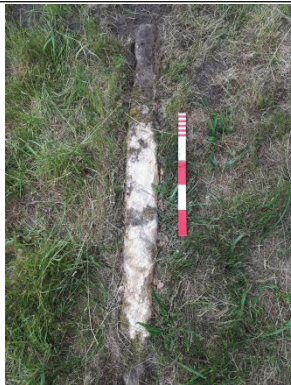
CUCK18WM013	Limestone baffle- no associated stone water inlet from flood-dyke channel (blocked by presence of later path).	456787.055	371473.449

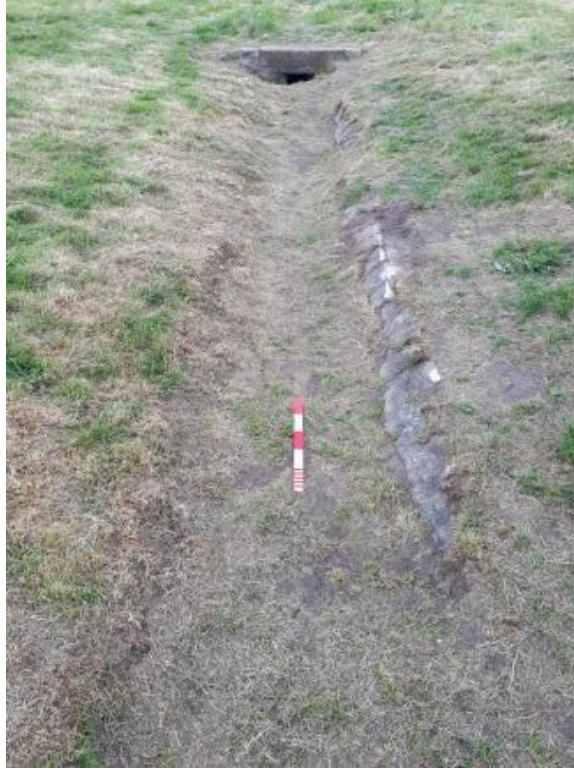
CUCK18WM006:

CUCK18WM006	Main stone sluice channel	456473.004	371602.184

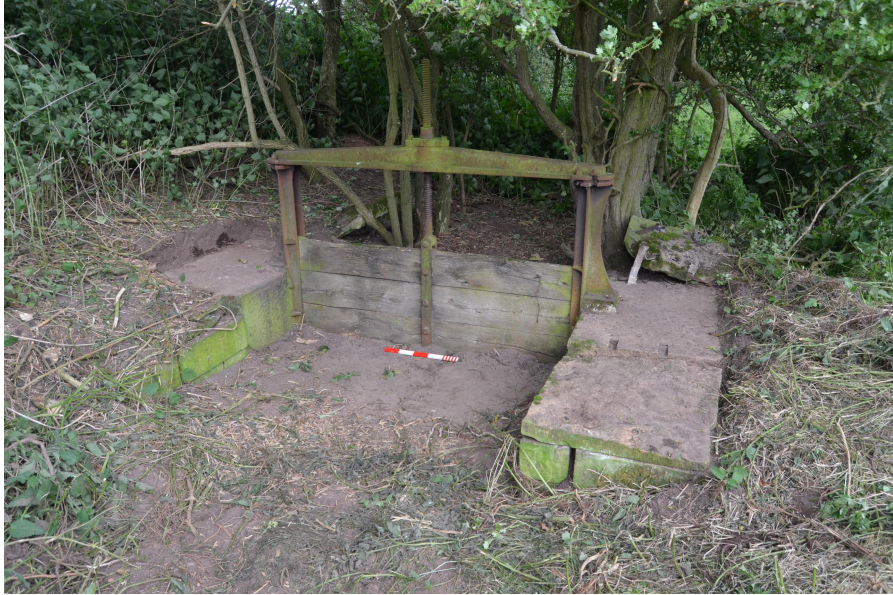
Photograph of wooden sluice gate CUCK18WM009, facing north-east.

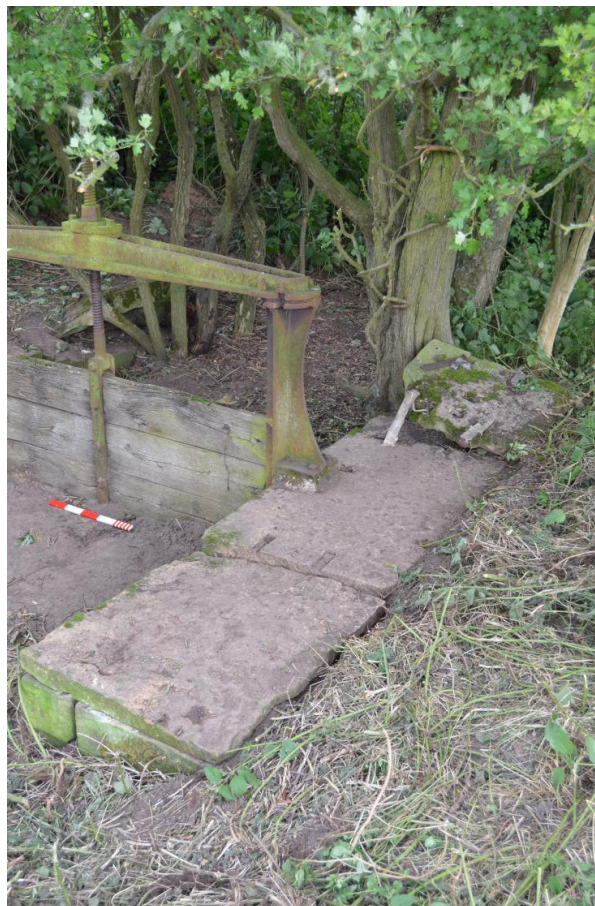
Photograph of wooden sluice gate CUCK18WM009, facing north-east.

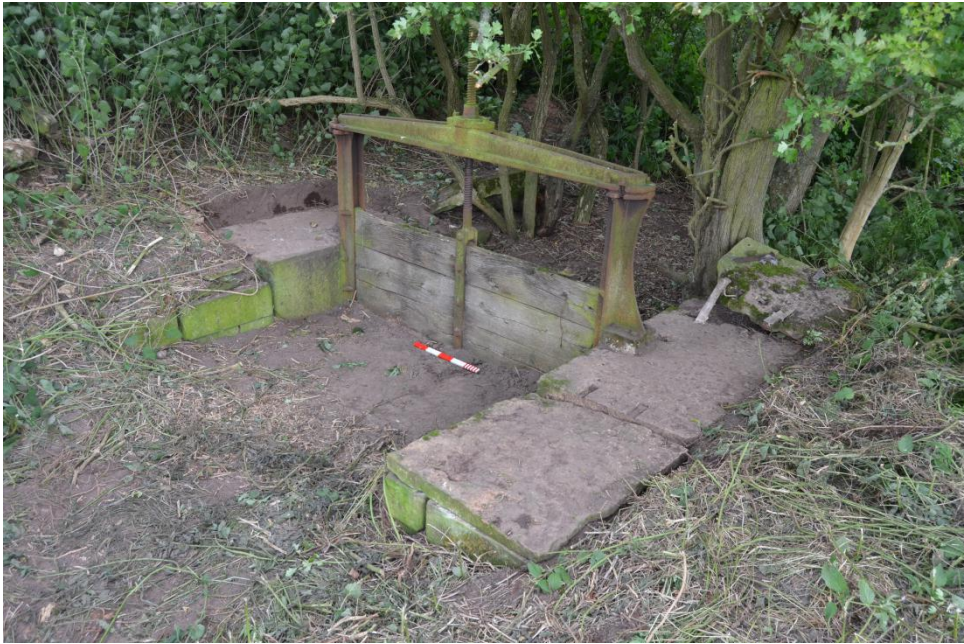
Photograph of wooden sluice gate CUCK18WM009, facing north-east.

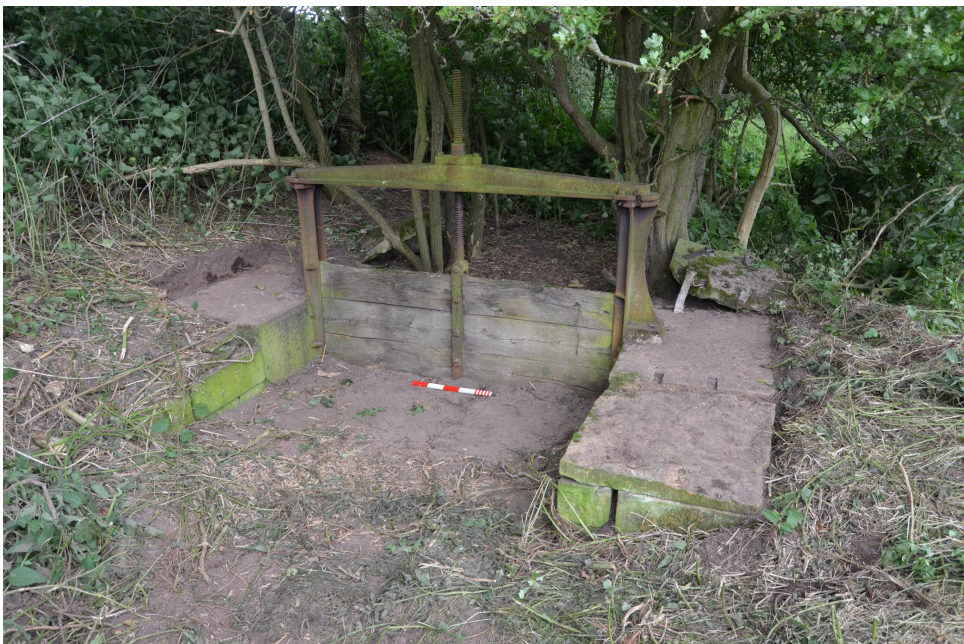
Photograph of wooden sluice gate CUCK18WM009, facing east-north-east.

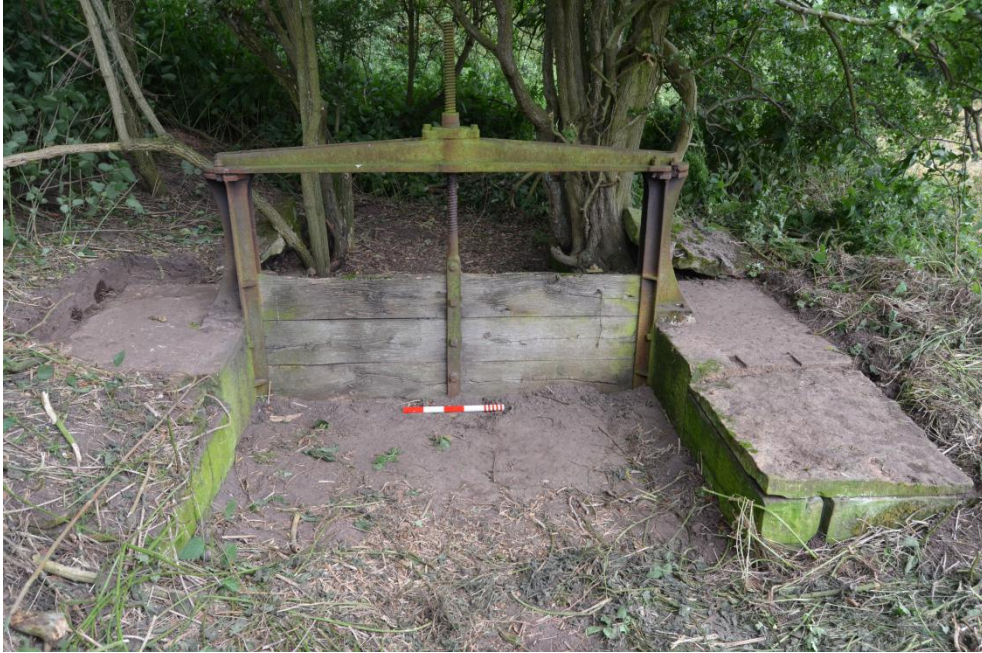
Photograph of wooden sluice gate CUCK18WM009, facing east.

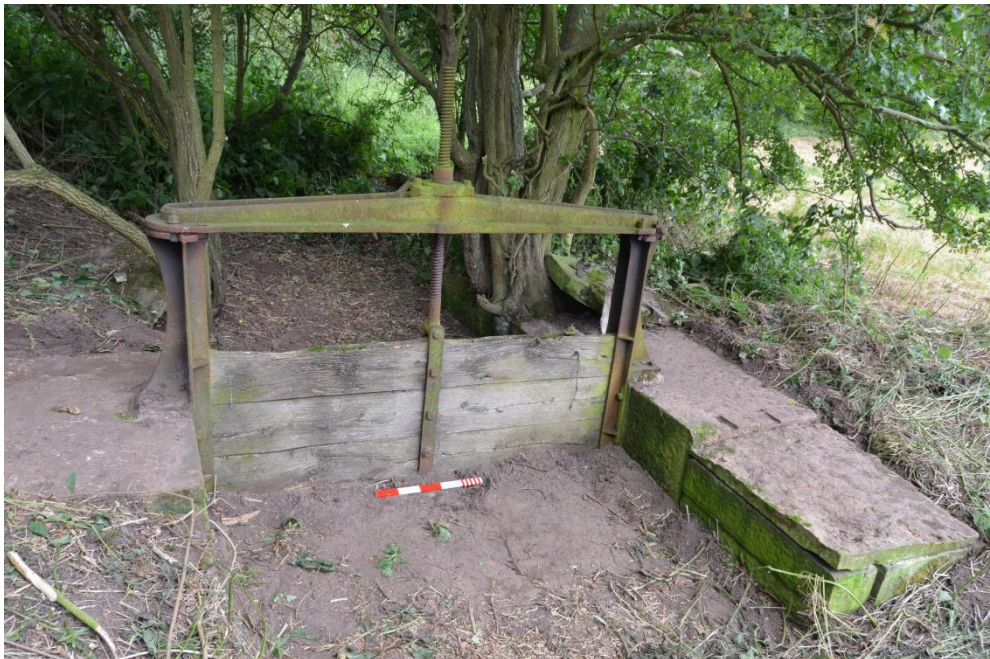
Photograph of wooden sluice gate CUCK18WM009, facing east-south-east.

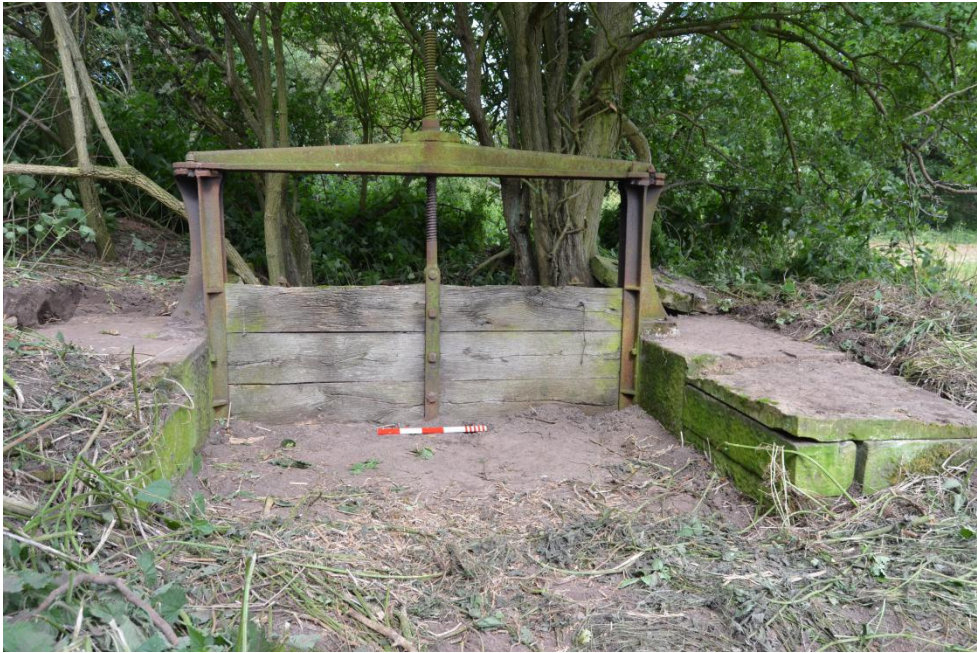
Photograph of wooden sluice gate CUCK18WM009, facing east.

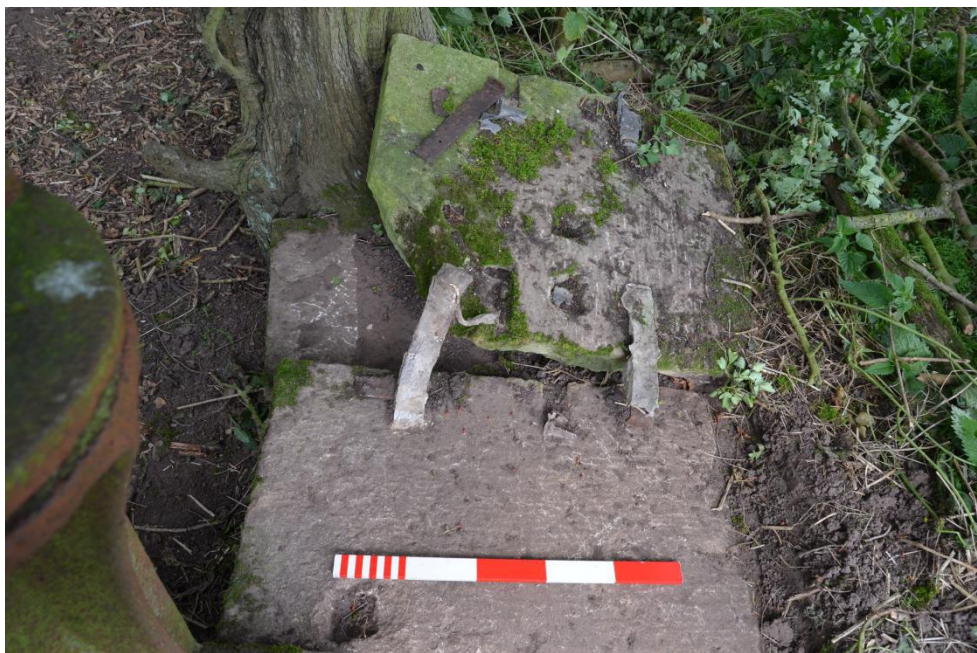
Photograph: Stones forming channel side adjacent to wooden sluice gate CUCK18WM009, on southern side of channel, facing east.

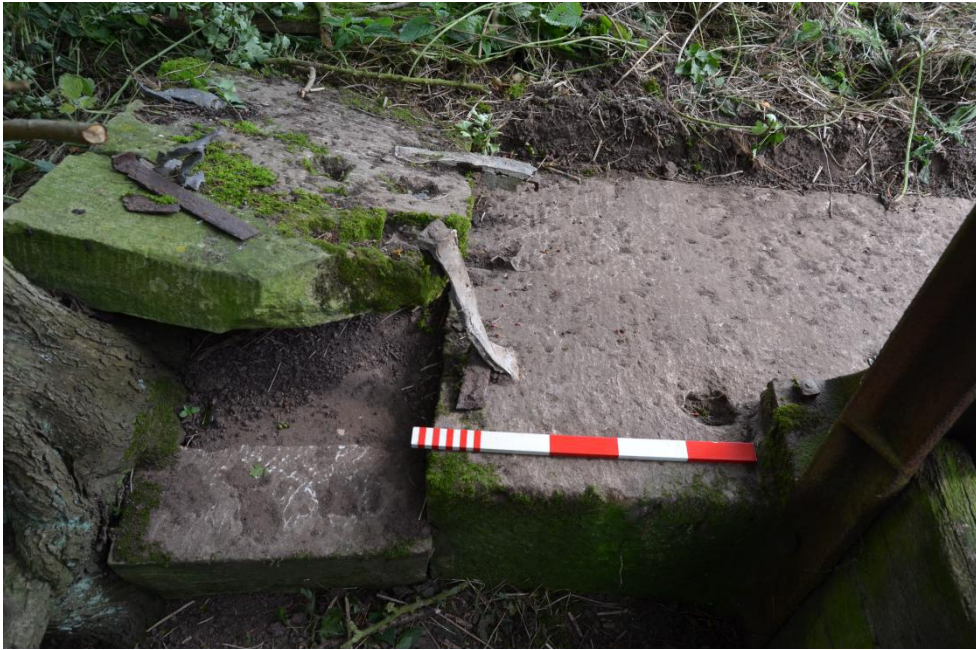
Photograph: Stones forming channel side adjacent to wooden sluice gate CUCK18WM009, on southern side of channel, facing south.

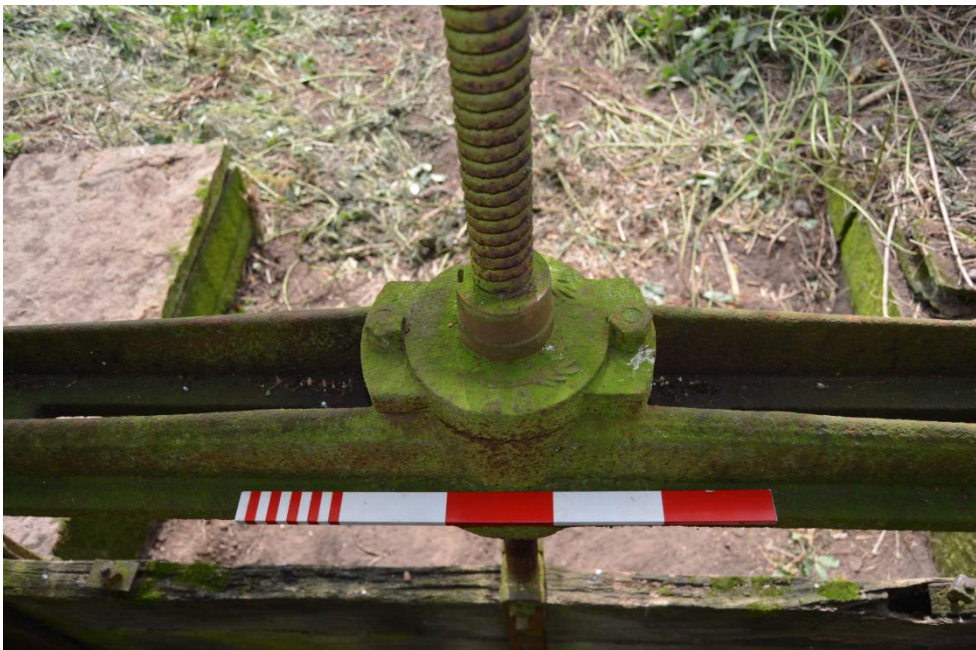
Photograph: Iron winding screw for opening wooden sluice gate CUCK18WM009, facing west.

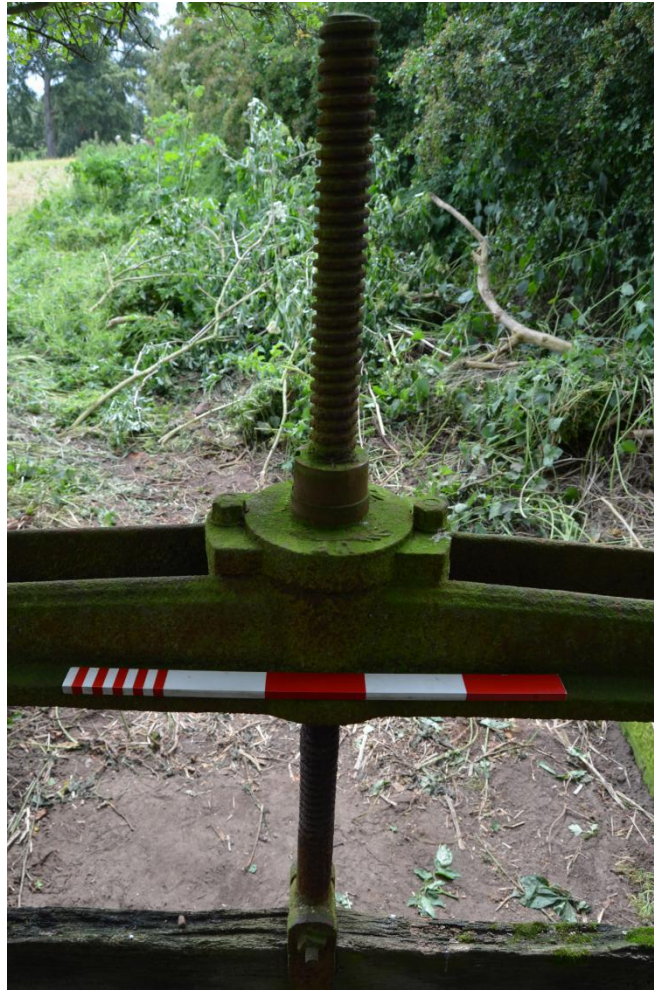
Photograph: Iron winding screw for opening wooden sluice gate CUCK18WM009, facing west.

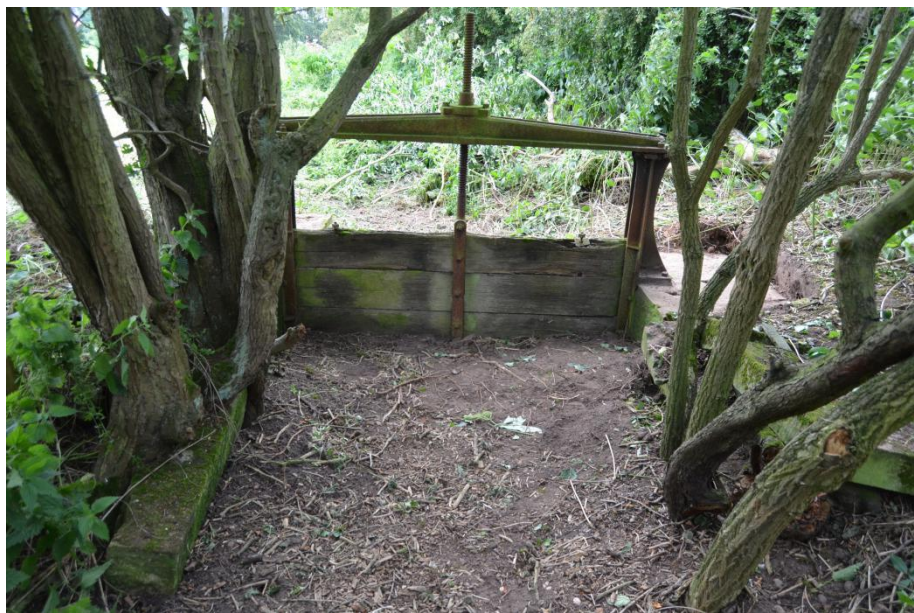
Photograph of wooden sluice gate CUCK18WM009, facing west.

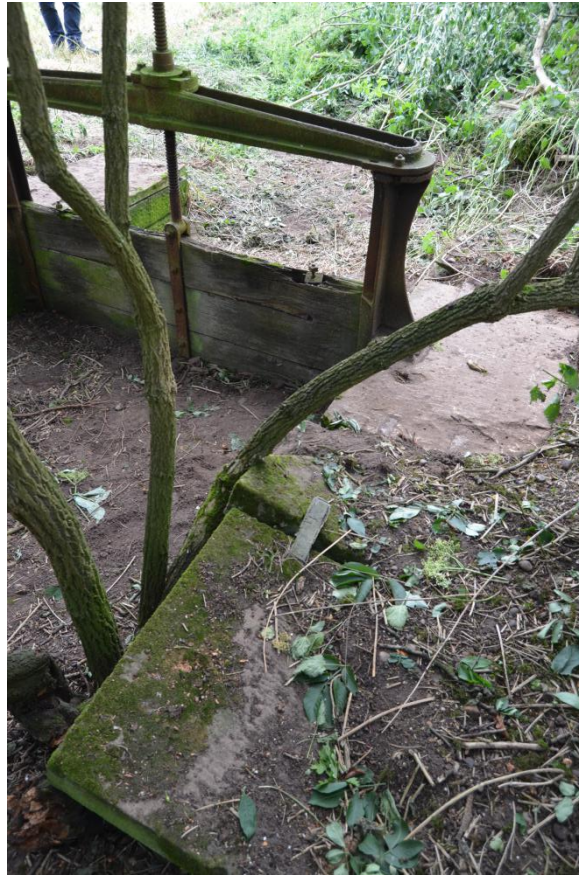
Photograph of wooden sluice gate CUCK18WM009, facing south-west.

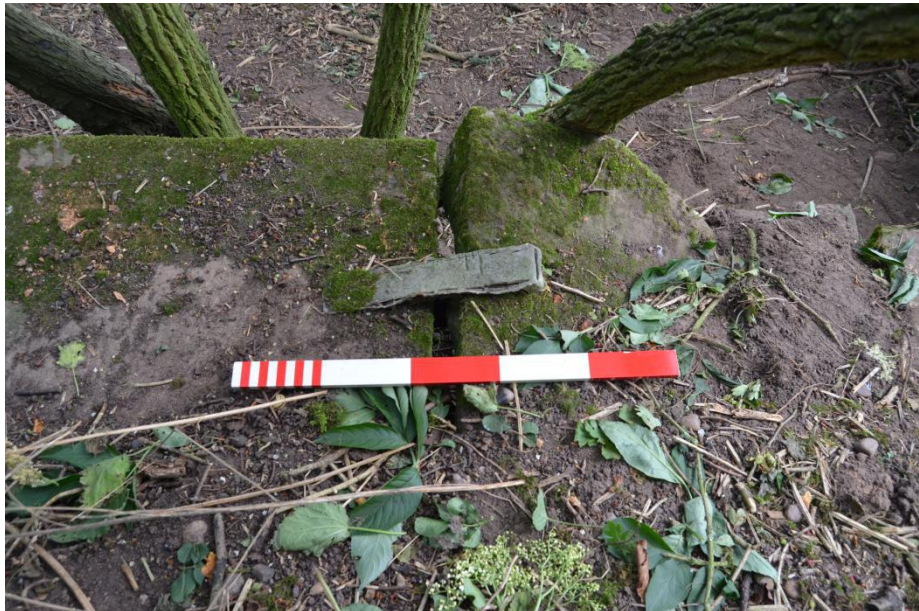
Photograph: Stones forming channel side adjacent to wooden sluice gate CUCK18WM009, on northern side of channel, facing south.
