Medieval Wall Paintings at the Church of St Mary, Cuckney, Nottinghamshire.

**Norton Cuckney, Bassetlaw District,
Nottinghamshire.**

**David Budge
Mercian Archaeological Services CIC
Report MAS036
01/05/2018**

**Report No. MAS036
01/05/2018**

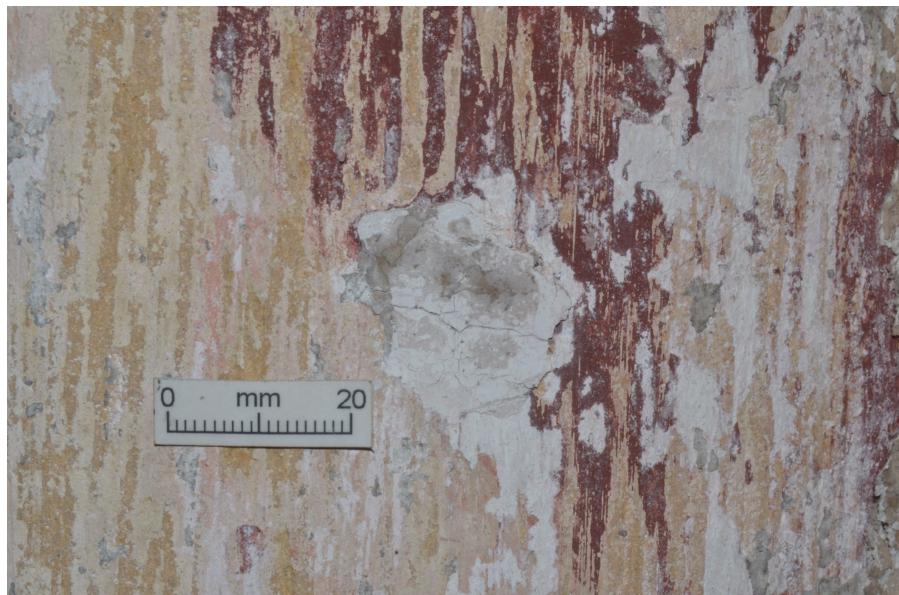
Plate 14 - close up of chevron on pier 3 in direct flash showing stratigraphic position of the painting.
Note the off white layer on which the red and pink paint of the chevrons has been applied and the bright white of the overlying (later) lime wash coats. The large blob of surviving lime wash to the right of the scale includes several superimposed coats of limewash, at least two of which have dirty surfaces.

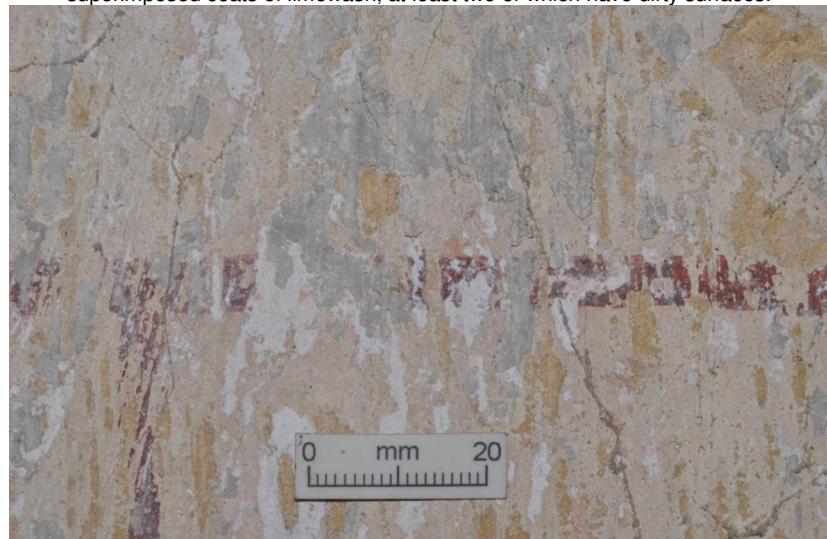
Plate 15 - close up of part of masonry pattern on pier 5 in direct flash showing the stratigraphic position of the painting.
Note the same off-white base coat as pier 1 and the later pure white limewash coat overlying the masonry pattern, with a dirty grey layer on top of this.

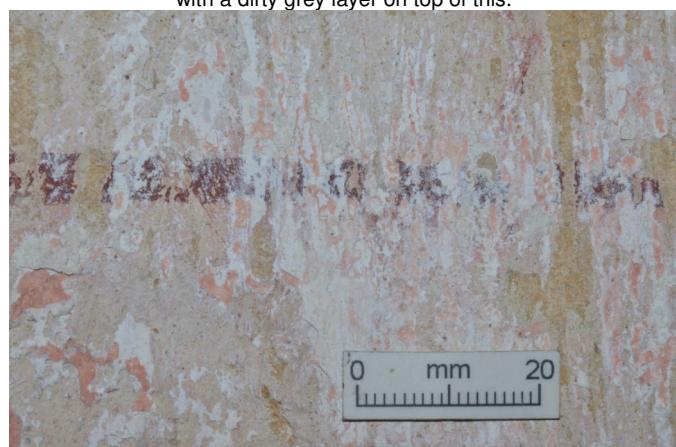
Plate 16 - close up of masonry pattern on pier 5 in direct flash showing overlying limewashes, one of which bears a pink colour wash.

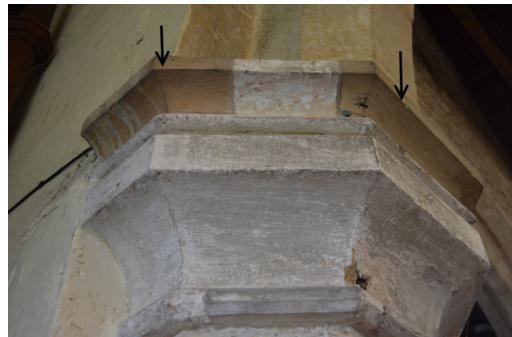
Plate 17 - capital of eastern respond from the north west, looking south east in daylight, showing largely unstripped surface with traces of paint showing through faintly and also the lighter colour of the replaced stonework of the upper part (arrowed).

upper parts of the capital have additionally been extensively replaced, though the few surviving fragments of original moulding do feature clear, but unintelligible, traces of paint (Plate 17, Figure 05)). The medieval stonework of this respond has also been hacked at in antiquity. On the western face of the eastern respond a diagonal stripe of red paint similar to that

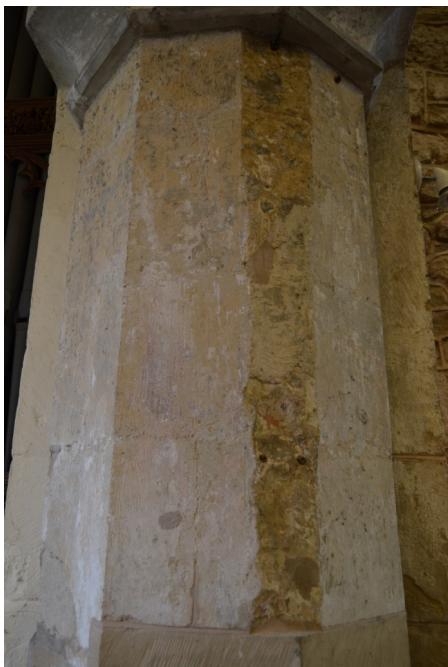
original scheme of decoration is almost certainly preserved beneath these layers but its form is not presently detectable. The eastern respond is more thoroughly stripped on the western and southern faces (Plate 18) but, conversely, a much less intensive stripping of the capital (Plate 17) that has left later limewash and failed to expose the original decoration. The

on pier 1 is partially visible. However, the south western arris of the respond has been hacked off diagonally over the top four courses (Plate 18) and this removed the original decoration in this area. There are multiple layers of limewash with several different layers of red and pink paint amongst them overlying the damage, suggesting the mutilation of this respond occurred in the medieval period (Plate 18). There was further replacement of stone on this respond in the 19th century, making the form of the original decoration unintelligible to the eye.

Plate 18 - eastern respond in daylight looking east. Note hacked off arris (vertical rough area just right of centre of photo) and faint traces of original red painting to the immediate north (left) of this. Also note replaced stone at bottom of photograph.

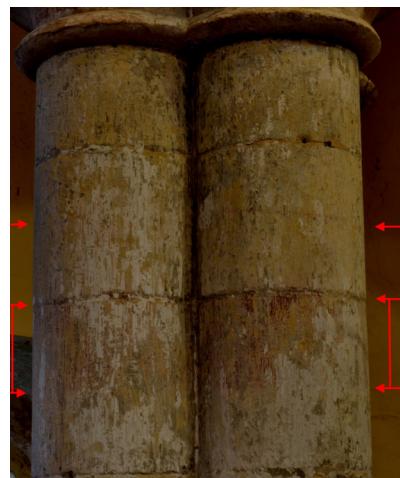
Plate 19 - pier two from the south west, looking north east.

Photo under artificial ambient light with brightness and contrast manipulated to enhance coloured traces, showing fragments of horizontal bands, thin, between upper arrows, and thick, between lower arrows.

Pier two (quatrefoil) is similar to pier 1 in that it has a thick band (c.5", 127mm thick) bordered by thinner lines (between 5 - 10mm thick) set 3.5" (89mm) from the thicker band. These bands are horizontal rather than chevron (Figure 03, Plate 19). There are traces of a second thick band about 16" below the first, and fragments of a narrower band below this. There are fragments of painting over the rest of the pier but a less comprehensive stripping has produced a palimpsest of painting which prevents detection of all but a trace of another wide horizontal band evenly spaced beneath the uppermost from the original decoration.

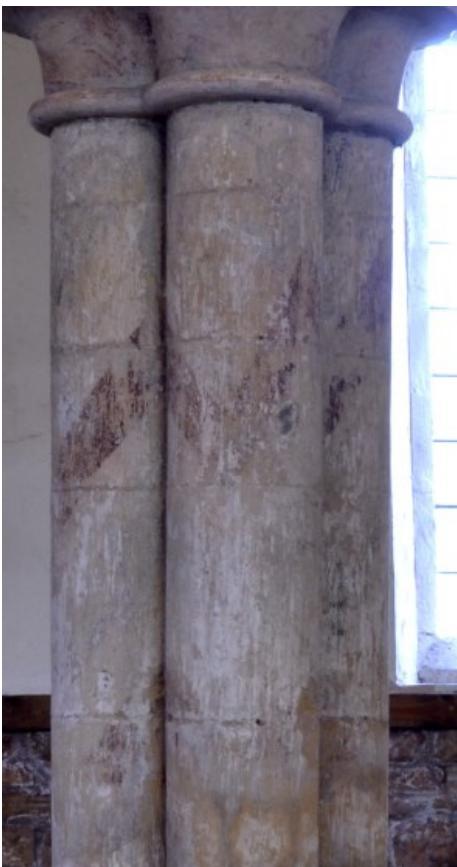
Plate 20 - pier 3 from the south (looking north) in daylight with minor brightness enhancement showing 'rising' chevron decoration in red and black.

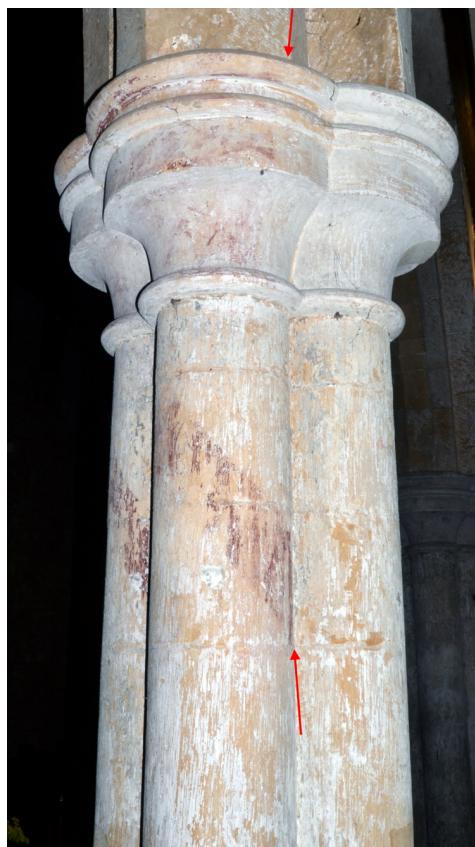
Plate 21 - pier 3 from the east, looking west, under direct flash.

The northern foil is to the right of the photograph; the red paint of the rising chevron can be seen to stop and the point indicated by the lower arrow (point b on Figure 06) while that on the capital ends sooner, in line with the point indicated by the upper arrow.

clearly did not extend onto this side of the arcade; painting ceases at the troughs in the angle of the northern foil ('a' and 'b' in Figure 06; Plates 21-23). The paint on the capital stops in a similar location, though slightly further south (Plate 21). The condition of the northern foil is the same as the other foils and indicates that the red painted chevrons never extended onto this foil: the absence of paint is not due to either too much or too little stripping. While the chevrons did not extend onto this foil there is, however, a faint, possibly pale red, area of paint on the northernmost point of the north foil near the top of the pier. It is small, possibly crescent shaped or circular, and appears to be early from its stratigraphic position, though whether it is contemporary with the chevrons is uncertain.

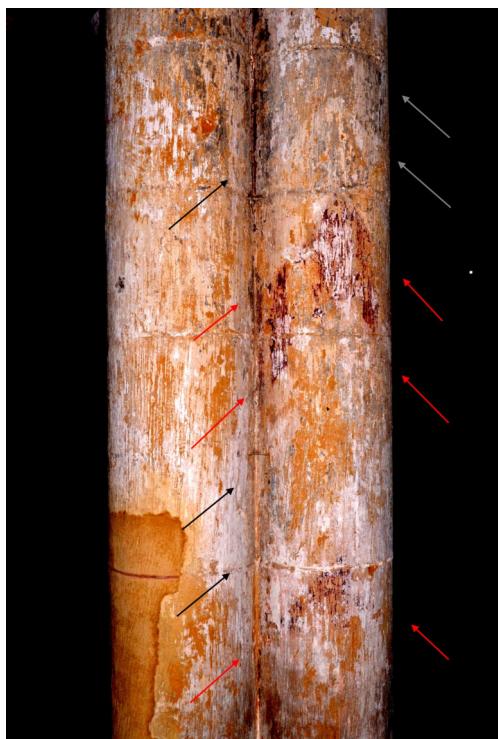
Plate 22 - enhanced image of pier 3 from the north west, looking south east.

Arrows indicate edges of, from top, faint traces of grey chevron, red chevron, very slight traces of grey chevron in angle between foils and clear top of fragmentary red chevron. The dirty colour beneath probably represents damage caused by damp.

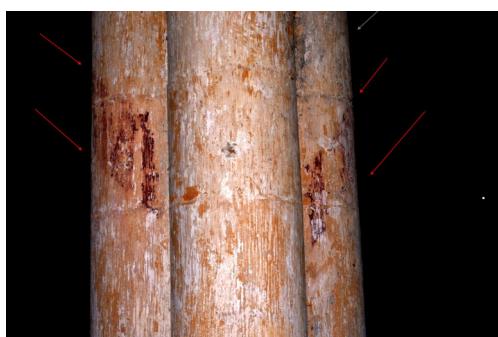
Plate 23 - enhanced image of pier 3 from the north, looking south. The upper red and black chevrons from Plate 22 are arrowed and the lack of red paint on the northern foil of the pier is particularly obvious.

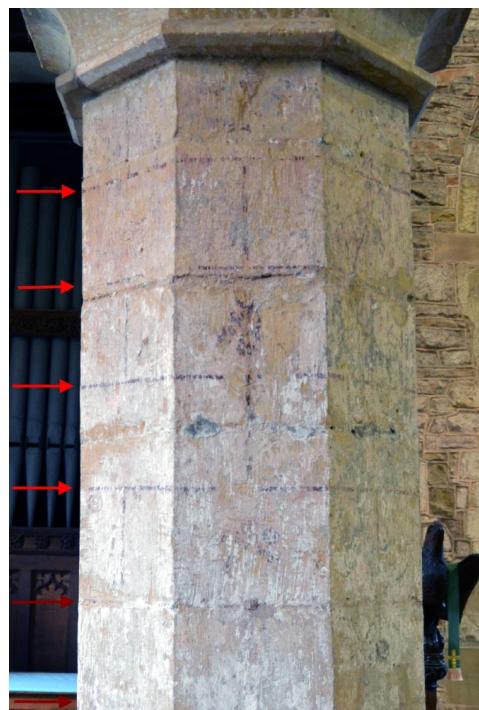
Plate 24 - masonry pattern on western face of pier 5, looking east, in daylight.

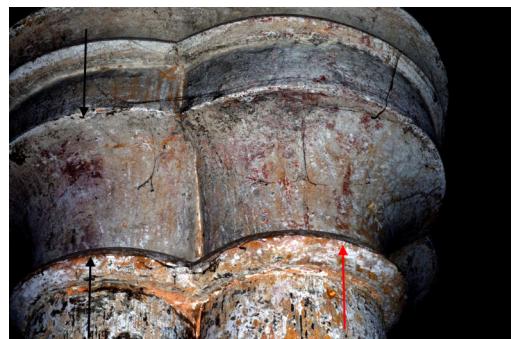
Plate 25 - northern part of capital of pier 3. Looking south west, direct flash, enhanced image. Red arrow indicates position of red painted line on northern part of the capital, note later decoration to the left of this. Black arrows highlight where the block colouring applied to the rest of the capital ends.

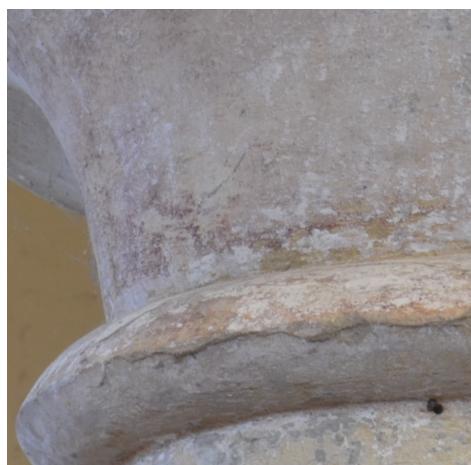
Plate 27 - close up of necking in lower left of Plate 26 in daylight and church artificial lights; note how the red paint on the body of the capital stops at a horizontal line before it reaches the necking.

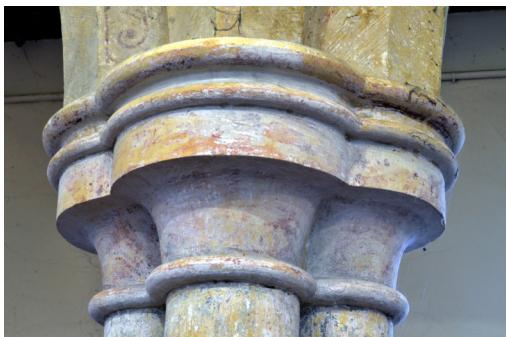
Plate 28 - enhanced photograph of south side of capital pier 3, looking north west.

Note similar basic form of the architectural support but contrast the different treatment of the various elements, particularly the upper mouldings of the capital, with pier 2, Plate 26.

The capital of pier 1 was insufficiently stripped for any pattern in the painting to be discerned. The upper mouldings of capitals 2 and 3 alternated horizontal red bands in the hollow (2) and on the rolls bordering the hollow (3) - see Figure 04; the capital of pier 2 had extensive areas of red paint on the body with thin white borders (Plate 26, 27) while 3 appeared to have spatially similar coverage but instead of an all over red wash has an upper horizontal red line with more sparse painting below, perhaps originally employing individual red lines or elements rather than a block of colour (Plate 28, 29). On both 2 and 3 the extensive colour on the body of the capital does not extend onto the northern part (Plate 21, 25); while the northern part of the capital of pier 3 appears unpainted that of pier 2 seems to have a vertical line on the northernmost part with broadly circular forms above it. Whether this decoration is confined only to the cardinal point of the capital or repeats around the whole of the northern part is unclear as it is obscured by a later scheme of (lighter red) painting (Plate 25).

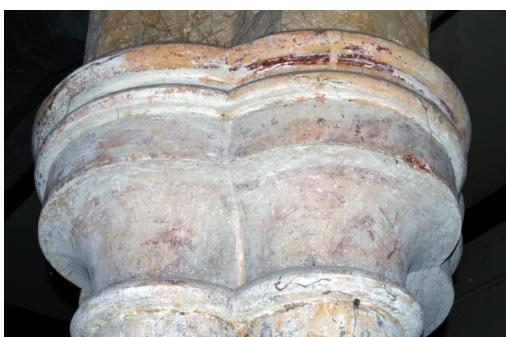
Plate 29 - enhanced image of pier 3 capital looking broadly west. Note area of well preserved red on the upper part and horizontal red band on underside of concave moulding, with ?red lines below.

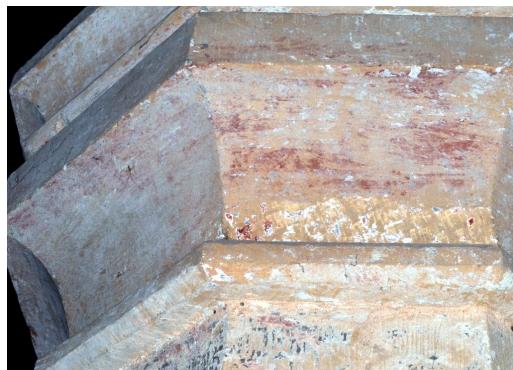
Plate 30 - eastern side of capital of pier 4 looking west; enhanced image direct flash.

Note area of crude chiselling above necking of capital on eastern face that appears to represent a modification and probably cuts through the original decoration. This chiselled area has however been limewashed and has itself received red painted decoration, suggesting this modification is at least medieval.

The capital of pier 4 had faint traces of paint that also appeared to include a block of colour on the capital but extending up onto the upper moulding, with possible unpainted curvilinear lines amongst the red (Plate 30), potentially suggestive of some form of scale pattern.

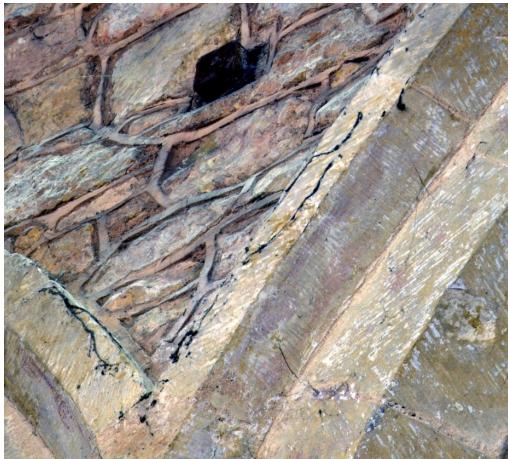
Plate 33 - enhanced image of bay 4b - note different coloured 'sunrises'

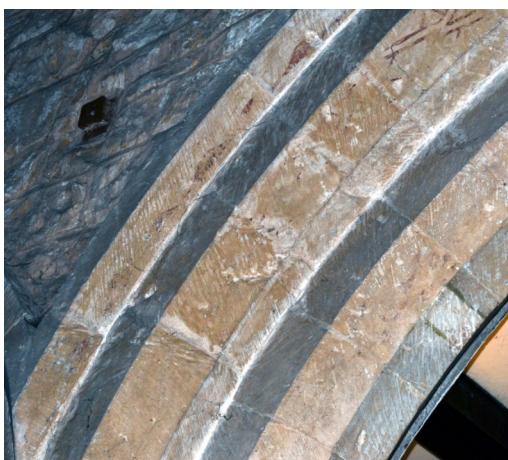
Plate 34 - slightly enhanced image of bay 5 particularly showing sunrise on b.

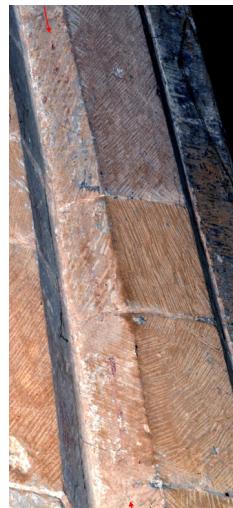
Plate 38 - bay 2e, eastern side of arch looking east, direct flash, enhanced. Decoration arrowed.

Bay two: face c is shown on Plate 37. Face d has small areas of red paint, possibly sparse dots and vertical lines, but extremely fragmentary and difficult to see except on enhanced images. On the eastern side of the arch face e appears to have a central line running parallel to the edges of the stone (Plate 38). The clearly visible red sunrise on f (Plate 39) has a fainter ?pink line above (similar to that painted in red on bay 1g) and may be opposed by a pale coloured inverted counterpart on the same face, though this is less certain. Traces of red paint on g were too fragmentary to interpret.

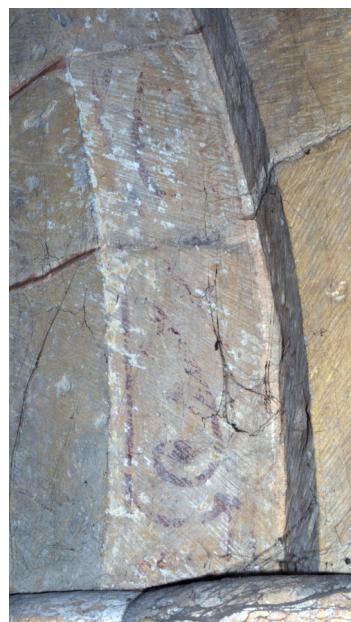
Plate 40 - bay 3f, direct flash with minor level enhancements and cobwebs obscuring the decoration.

of the arch (Plate 41) but slightly less well preserved traces near the top of the arch suggest that the spacing was originally double that now existing on the eastern side. A fragment of foliage decoration on face f (Plate 40) is visible towards the bottom of the eastern side of the arch and a less well preserved instance on the western side, indicating that the tips of the leaves point upwards on both sides of the arch. The stripping was too complete for visible traces of paint to survive elsewhere on this arch.

One of the easiest elements to parallel is also one of the most chronologically diagnostic. There are two forms of foliage design surviving, the simpler on bay 3f (Plate 40) and a more elaborate version on bay 5g (Plate 42, Figure 05). Both employ cusped curvilinear lines terminating in a roll to outline large leaves curved back against an undulating stem; on bay 3 the surviving traces appear to indicate that single leaves alternate but on bay 5 two cusped forms definitely appear concurrently on either side of the stem. While the use of trailing foliage and foliate scrolling is very common in medieval wall painting and medieval art in general, the particular method of depiction used at Cuckney, cusped lines that outline the leaf, is rare in British wall painting. It is, however, commonly found in other forms of art, particularly Romanesque art of the 12th century. A few examples include the leaves at the feet of the prophets and the head of David's sceptre in the post 1132 glazing of Augsburg Cathedral (Wolf 2007, 58, Brown 1992, 39); in manuscript illumination in the corners of the border surrounding the scribe Eadwine (c.1150-60) (MS R.17.1; Alexander and Kauffmann 1984, 119), the borders of a late 12th century psalter (MS Douce 293 f 8v, Rouse and Baker 1966, pl XXIXb), the top of the initial 'F' of II Samuel in the Winchester Bible (f99b, Saunders 1933, pl36), and in six slightly different forms as line dividers on the first page of the Gospel of John, c.1147 (Metz MS 1151 fol 267, Swarzenski 1954, 62, fig 299); in metalwork this technique can be seen used to depict foliate decoration on the arches of an arcade framing saints on the side of the portable altar of Roger of Helmarshausen, c.1100 in Paderborn Cathedral (Swarzenski 1954, pl102) and on the borders of some of the panels on the Oswald reliquary (c.1170) from Hildesheim, Germany (Swarzenski 1974, pl208, 484) (despite being in Germany today, this metalwork is considered to have northern English features (Geddes 1980, 143)). Stylistically similar foliage may also be carved: for example on a 12th century ivory liturgical comb (Cocke and

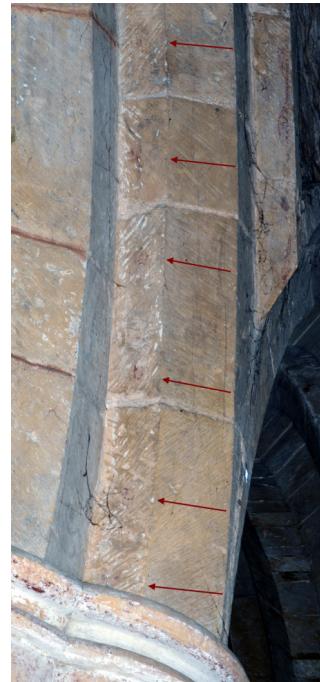
Plate 41 - east side of bay 3e looking east. Direct flash, enhanced image. Traces of red dots indicated by arrows.

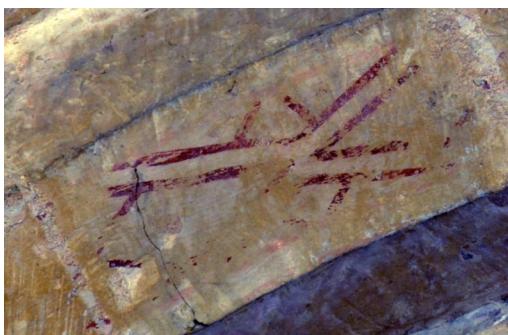
Plate 43 - bay 5d, close up of part of fret in enhanced image showing faint pink/white/pink border bands and faint traces of stonework coloured pellets in the centre of each polygon.

The superficially simple red fret on face d (Plate 42) is actually considerably more complex when other colours, which survive faintly in the better preserved parts of the design, are taken into account (Plate 43, Table 01). The design has a border of white with thin pink lined edging on both sides, while pellets in the centre of each polygon of the design only show up due to their slight contrast with the off-white layer and their regular and deliberate placement in the centre of each of the clearly visible (red) geometric forms.

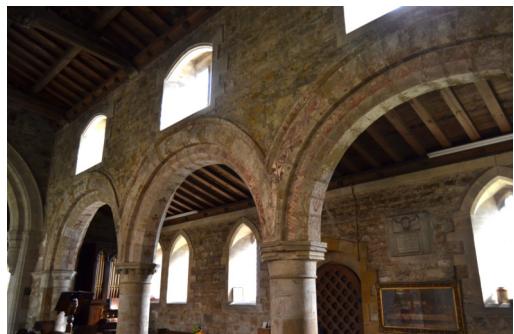
Plate 46 - north side of south arcade at Wartnaby. Looking east south east.

Both sides of the arcade at Wartnaby have decoration; that on the north side has extensive traces; the south side (lacking a hood mould) is less well preserved. Decoration is also present on the soffits of the arches.

St Michael's, Wartnaby, is a small church approximately 50km south of Cuckney. It is of simple plan, consisting of nave with a western bellcote, chancel and south aisle (Plate 44). The south aisle arcade consists of three bays of double chamfered round headed arches over cylindrical piers and responds (Plate 46). There is a blocked round headed doorway in the exterior of the north wall of the nave (Plate 45) but other openings are mainly pointed, though most of the windows are heavily restored.

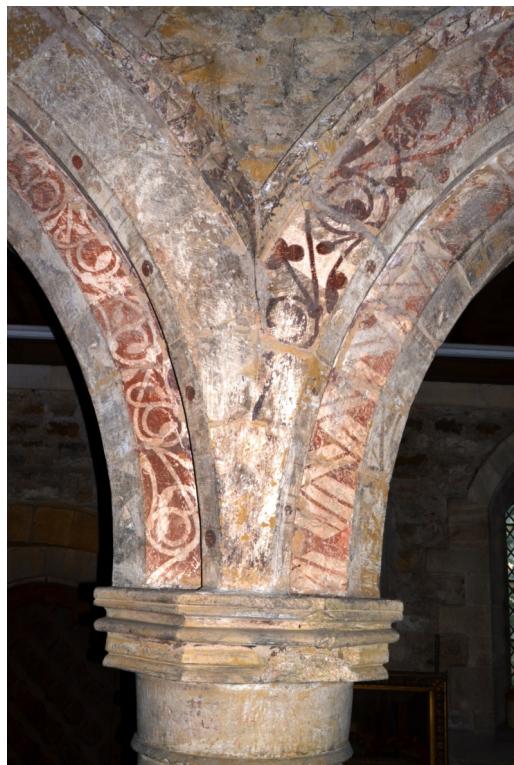
Plate 47 - north side of bay 1 / 2 at Wartnaby. Looking south. Direct flash, slight enhancement.

The decoration at Wartnaby is in several different shades of red and in black (Plate 47). It is described using the same terminology as Cuckney, with bays

numbered from west to east. The red painted decoration at Wartnaby has proved considerably more durable than the black. The black foliage scroll on bay 1g and bay 2c is very difficult to see in Plate 47; black and white triangles on bay 2g (left side of plate) is rather easier to detect.

Bays 1 and 3 have red foliate scroll on c, white riband on red background on f and black foliate scroll on g (Plate 47). The soffit of bay 1 is divided into blocks by three thin ?black lines (now faded) with floral sprigs in each block, while bay 3 has the same blocks but with a fleur de lis in each.

Bay 2 (Plate 47, Plate 50) has black foliage scroll on c, white foliage scroll on a red background on f and black and white triangles on g. The soffit is divided into blocks as bay 1 using three thin faded lines, with four petalled, propeller-like, red flowers in the centre of each block.

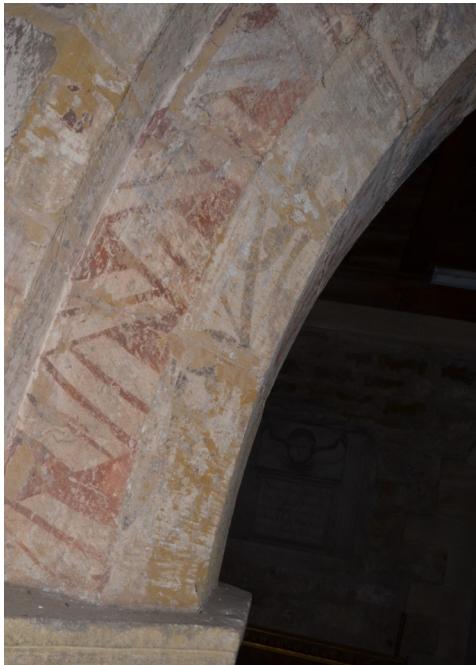
Plate 48 - east side of bay 1 at Wartnaby showing faces f (white riband on red background) and g (black foliage scroll, with most of black pigment lost). Direct flash.

A closer image of bay 1g (Plate 48) and the repeat of this decoration on bay 3g (Plate 49) demonstrates that the black paint tends to fade to a much greater degree than the red, often leaving little more than dirty looking pale grey areas that preserve the outline of the originally black painted decoration (as on pier 3 at Cuckney). The black painted areas also display a tendency to strip preferentially, leaving the formerly black painted areas as patches of yellow stone showing the basic form of the decoration against the white ground of the surrounding whitewash (Plate 49).

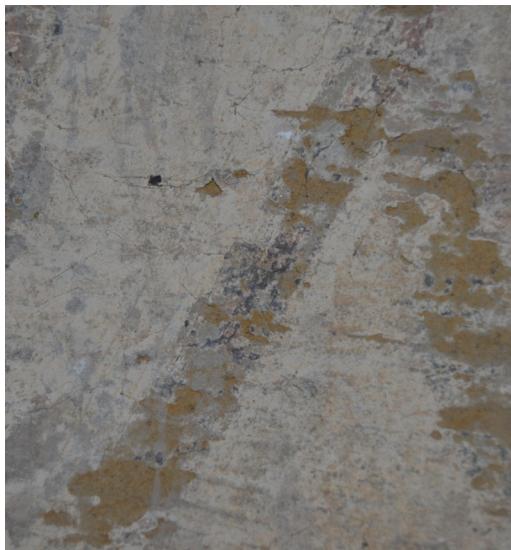
Plate 49 - close up of two strokes of bay 3g black decoration showing preferential (and accidental) stripping of black painted areas to reveal the yellow colour of the underlying stone at Wartnaby. Direct flash.

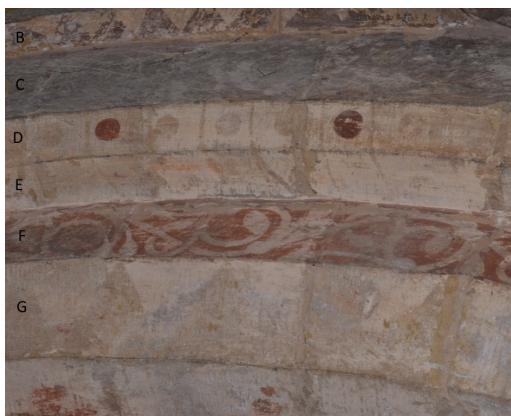
Plate 50 - western side of bay 2, north side showing decoration on faces b-g at Wartnaby. Looking up, direct flash..

The hood mould has point to point red and white triangles on faces A and B (Plates 47 and 50); this decoration is repeated across all three bays. The outer chamfer and soffit (faces d and e) are narrow, like the faces of the hood mould, and are divided into square blocks by faded (originally black?) lines. The centre of each block has a pellet, one red to every three faded (?black) (Plate 50); this decoration is also repeated across all three bays.

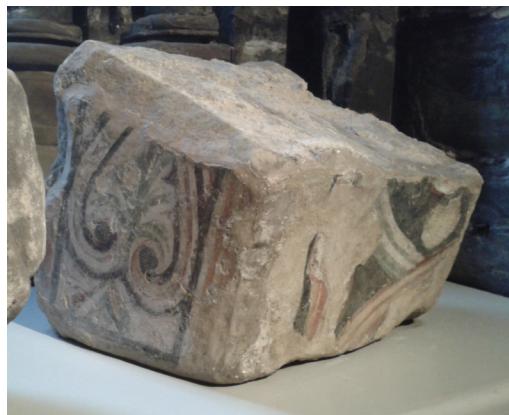
Plate 51 - late 12th century painted voussoir (with painting lightly restored) from Glasgow Cathedral. Note cusped curvilinear lines forming the outline of the leaves on the left hand face (as pictured) of the stone.

While it is uncommon in wall painting it is not unknown. It appears in black as part of polychrome palmette decoration on a late 12th century voussoir from Glasgow Cathedral (Park and Howard 2002, 97) (Plate 51), in the 12th century painting on the face of the arches bordering the central bay of the narthex at San Pedro al Monte, Civate, Italy (Demus and Hirmer 1970, 292, pl12) and in red, in a number of variations on trailing foliage borders, at Stoke Orchard, Gloucestershire (Rouse and Baker 1966).

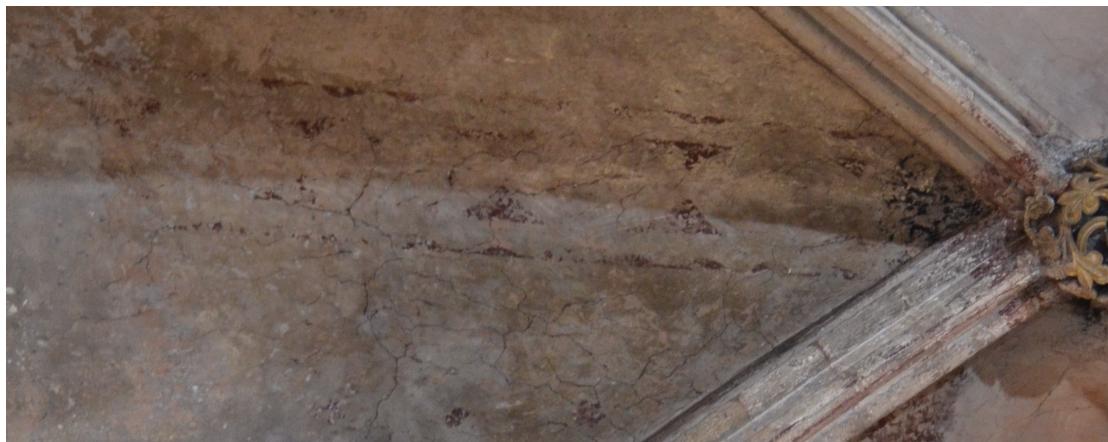
Plate 52 - type 3 sunrise bordering painting of groin of vault at Blyth, north side of first bay west of the (later) wall containing the doom painting.

Type 3 is the only motif that can be paralleled amongst the rare examples of extant wall painting in Nottinghamshire; it is painted on the 13th century vaulting of the nave at Blyth (Plate 52). The stonework of the Blyth vault has been linked stylistically to Lincoln cathedral and Lincoln cathedral has type 1, in red and green, bordering vault ribs in the transepts (Tristram 1950, supl pl 55d), considered likely to date between 1209 and 1235 (Tristram 1950, 509) or c.1220 and 1240 (Park 1986b, 76): the condition of the painting at Blyth and the spacing (there is room for another colour) makes it plausible that Blyth was originally a type 1.

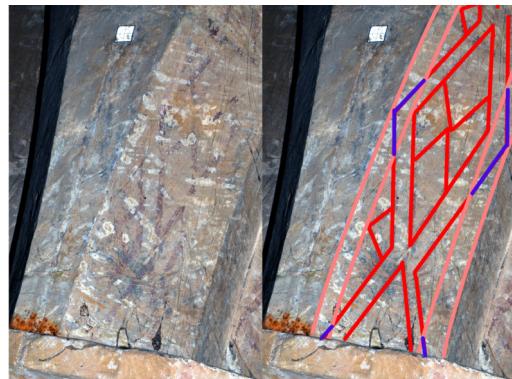
Plate 55 - bay 5d west side, left enhanced image under flash, right, tracing of main visible elements of the decoration with the outer lines of the fret pattern extended (purple).

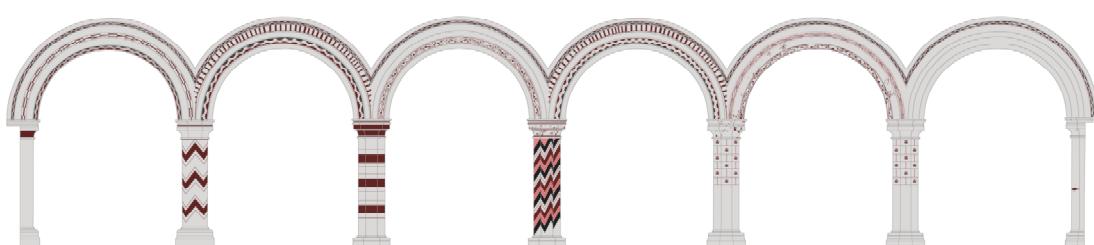
Figure 07 - reconstruction of surviving elements of the arcade decoration on the south side of the north arcade at Cuckney.

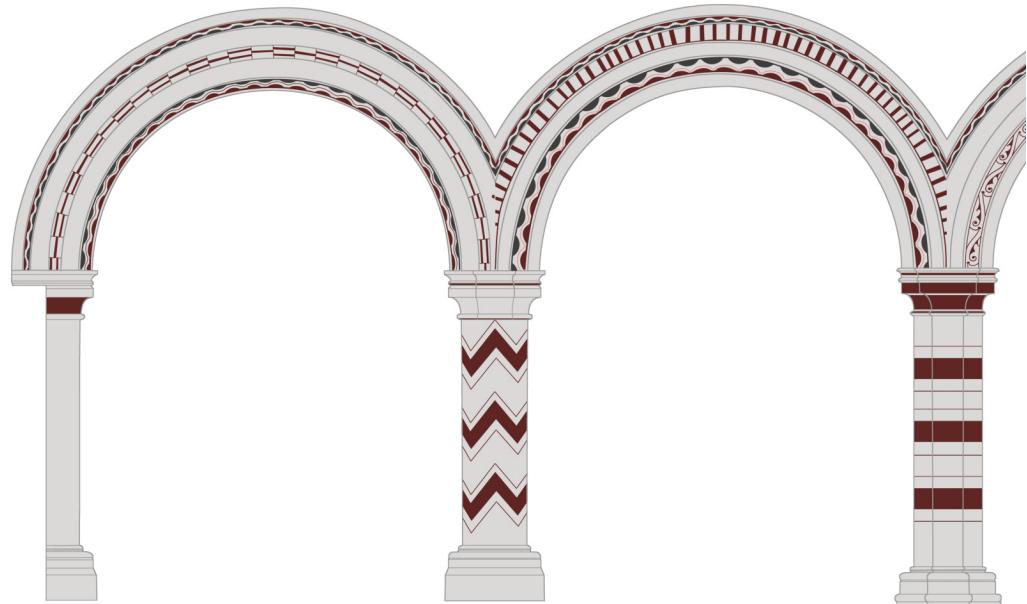
Figure 08 - reconstruction of surviving elements of the arcade decoration on the south side of the north arcade at Cuckney. Bays 1 and 2.

pattern of piers 4 and 5 as part of it, though there may be some question regarding whether the painting of these two piers is contemporary with the others or is later. It may be that none of the piers had decoration all the way to the base as traces of just two repeats of each pattern

can be detected on piers 1 and 2, but there are traces of three red chevrons on pier 3, suggesting the decoration on this pier probably did go all the way to the base, and prompting the treatment of the other piers in the reconstruction.

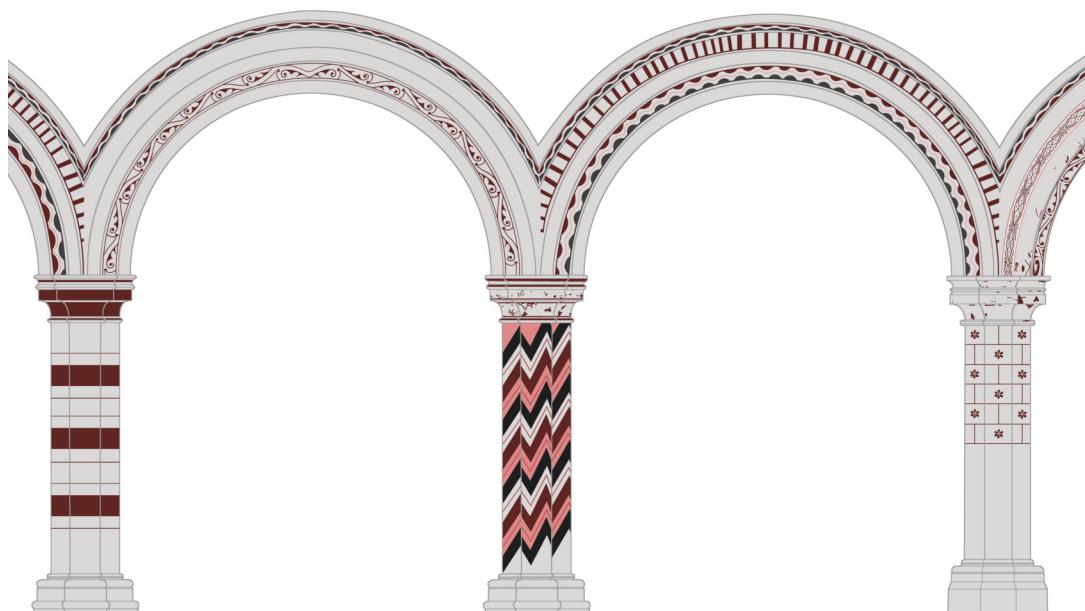
Figure 09 - reconstruction of surviving elements of the arcade decoration on the south side of the north arcade at Cuckney. Bays 3 and 4.

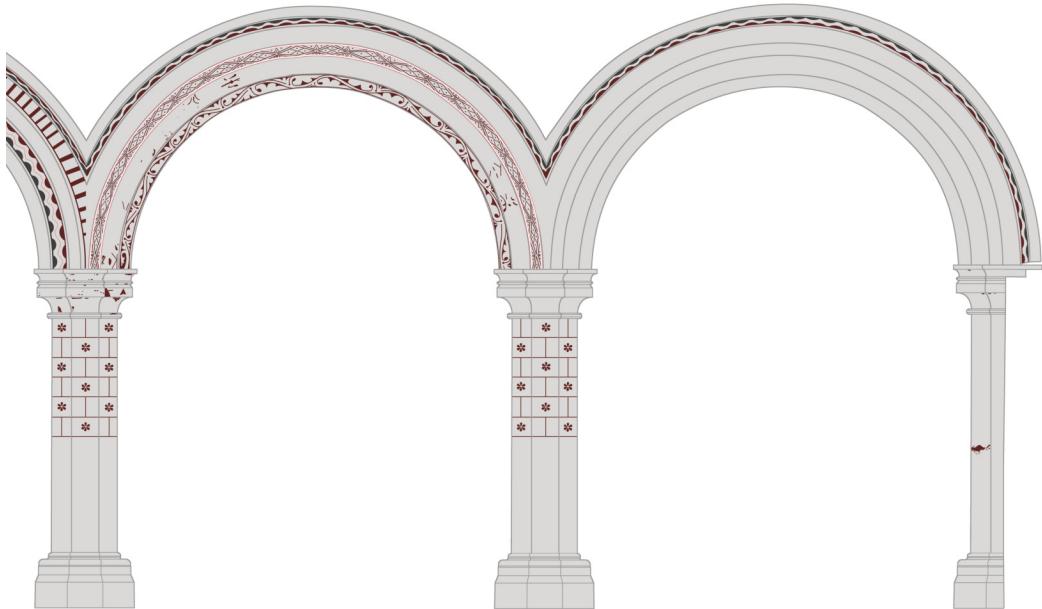
Figure 10 - reconstruction of surviving elements of the arcade decoration on the south side of the north arcade at Cuckney. Bays 5 and 6.

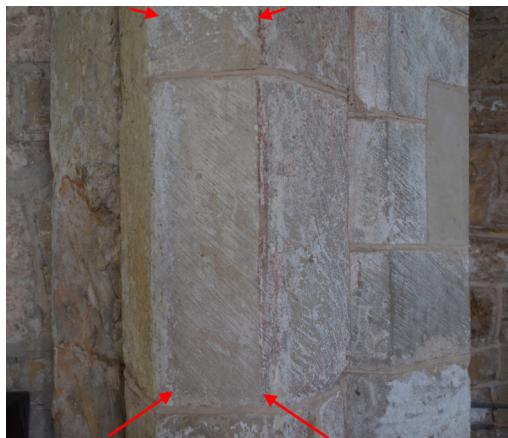
Plate 59 - southern side of chancel arch, at position C3 and C4 of Figure 01, showing medieval paint and limewash layers stopping at vertical lines indicating position of original screen (between the arrows).
Looking south, direct flash.

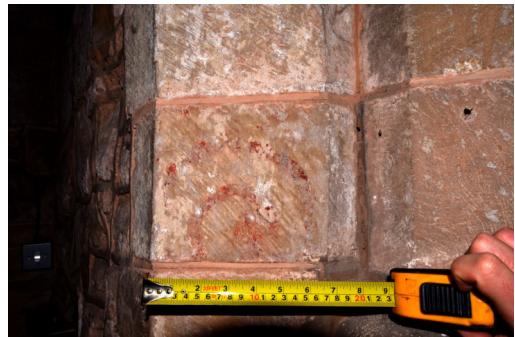
Plate 60 - trace of scrollwork decoration on outer chamfer of west side of north jamb of chancel arch (C1 on Figure 01) looking north east, direct flash, lightly enhanced image.

The north side of the chancel arch has the most intelligible traces of decoration; on the west side (C1 on Figure 01) there are fragments of a large scroll (Plate 60) which is likely to have formed part of scrollwork decoration that wound its way up the side of the arch.

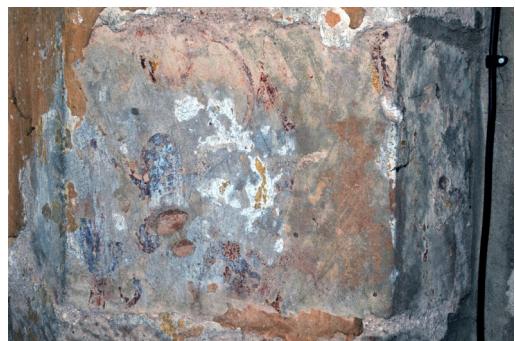
Plate 61 - red and yellow decoration formerly sealed under medieval plaster on east face of north jamb of chancel arch (C2 on Figure 01). Direct flash, enhanced.

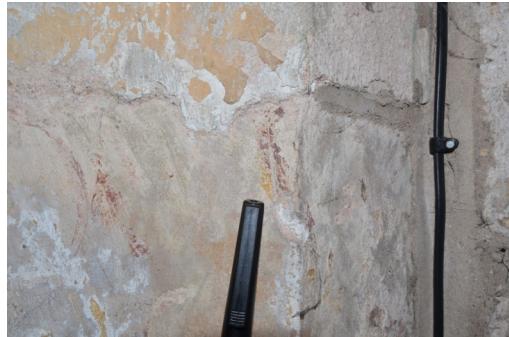
Plate 62 - adjacent red and yellow painted lines (indicated by pen cap) seen at upper right of Plate 61. Direct flash, no enhancement.

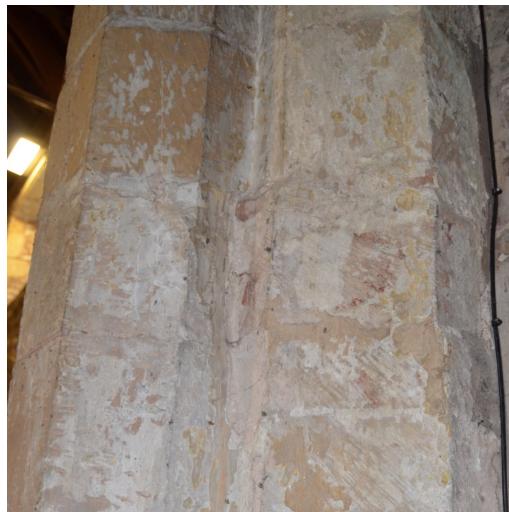
Plate 63 - red painted decoration overlain by yellow on east side of north jamb of chancel arch (C2 on Figure 01). Looking west, natural light.

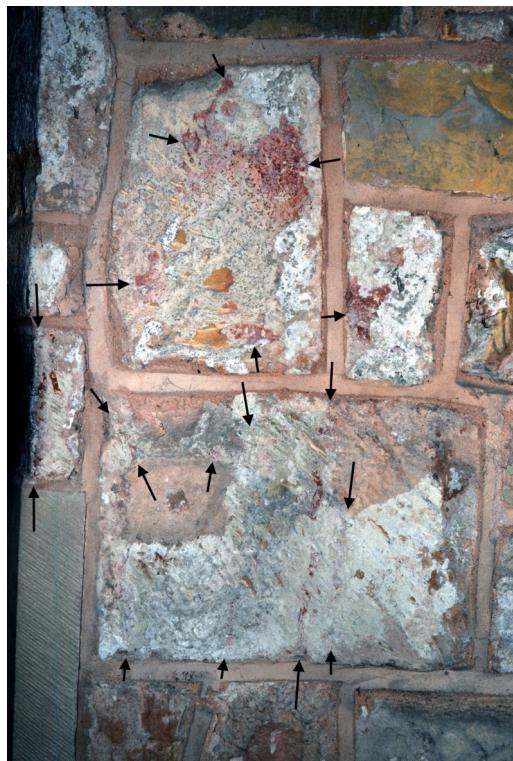
Plate 65 - close up of area of paint indicated by the lower cluster of four arrows on Plate 64. Looking east. Direct flash. Enhanced image.

It is unclear if these traces surviving on the east nave wall, particularly those shown in Plate 65, are purely decorative or whether they might be the only surviving fragments of figurative scenes, or a mixture of both. It does at least appear that simple patterns, such as masonry pattern, are not represented, while the finer lines and red and pink shading visible on the lowest block with surviving decoration appears to suggest that whatever the design was, it was of some complexity.

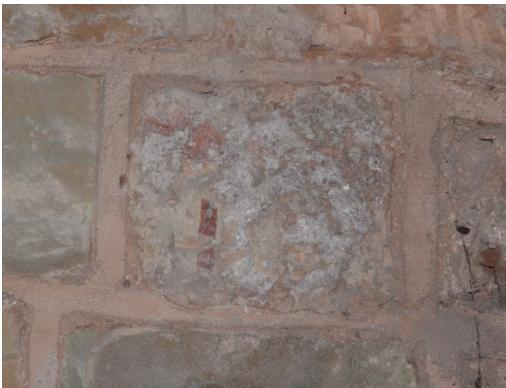
Plate 66 - painting on block highlighted by the upper arrow on Plate 64. Looking east, direct flash.

The more isolated fragment of paint indicated by the uppermost arrow on Plate 64 is shown in close up in Plate 66. It consists of a vertical red line that appears to meet a ?wider horizontal band of paint.

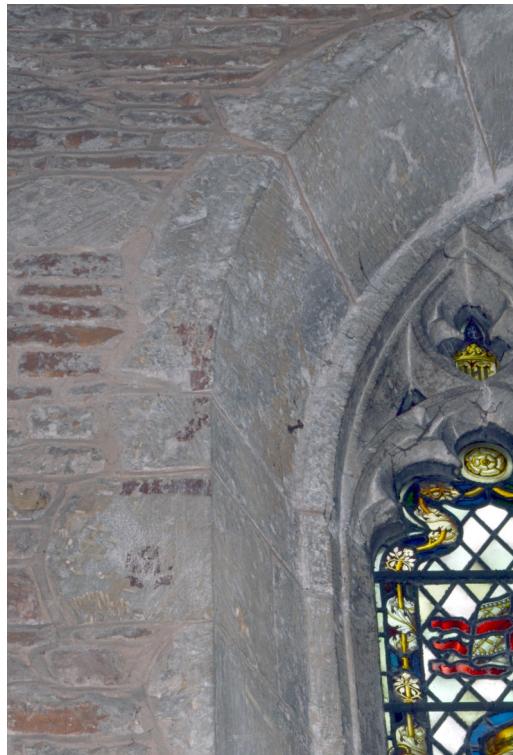
Plate 67 - remains of painting on eastern jamb of south nave window 2. Looking south, direct flash.

Later traces of painting are to be found on the masonry of the south nave windows. The windows have panel tracery and are considered to be of 15th century date by the List Description. The traces of painting are fragmentary and only preserved on the upper parts of the eastern jambs of the windows. The second window (SW2 on Fig 01), has a horizontal line with stencilled motif below and fish tailed decoration above (Plate 67): the stencil is a three petalled flower with two leaves below, very similar to a stencil used on a retable in Dorchester Abbey (Rosewell 2008, fig 185). Stencils were used from at least the 13th or 14th century to produce the rosettes in masonry pattern (Park 1986a, 194), but the use of stencilled patterns including a variety of flowers, or 'IHS' etc to form a background or a decorative scheme in itself, did not become popular until the 15th and early 16th centuries (Tristram 1955, 10-1). The form of this stencilled flower is entirely in keeping with the date of the architecture of the window. The fishtailed decoration

above is more difficult to interpret and at least the upper half of the motif appears to have been lost; it could perhaps have been similar to decoration around window openings at Martley, Worcestershire (Rosewell 2008, fig 24). The stencilled pattern may indicate that the south nave wall, when re-modelled in the 15th century, might have had decoration of figures set against a background of repeated stencilled flowers, as at Pickworth, Lincolnshire (Rosewell 2008, fig 28), Broughton, Buckinghamshire (Tristram 1955, pl 60b) or in the painted chamber at the former hospital of St Wulstan (now The Commandery), Worcester, c.1500 (Rosewell 2008, fig 240).

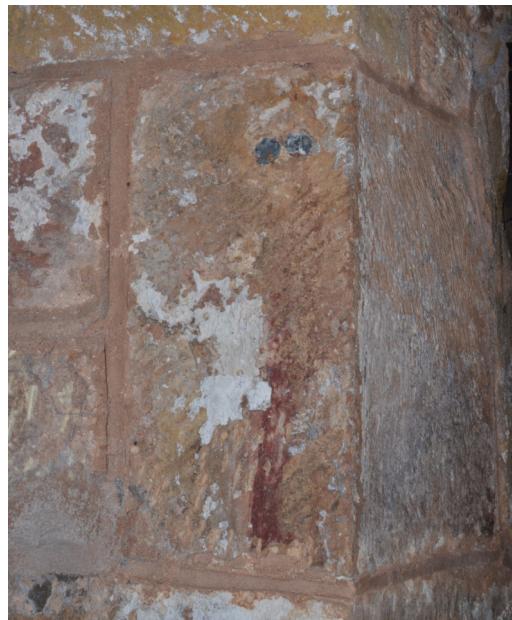
Plate 69 - paint on interior of eastern jamb of south door to nave. Looking south east, direct flash.

A quoin on the north face of the eastern jamb of the south door has a vertical stripe that may be red paint (Plate 69). Caution must be expressed regarding its origin; though the stripe extends right to the edges of the quoin there are no traces of paint on the adjacent quoins or elsewhere around the opening. Additionally, the line appears to coincide, more or less, with two filled holes in the masonry which are haloed by a lighter patch of similar size to a standard 20th century circular metal junction box or light switch. The possible paint does, however, appear to be overlain by one or two coats of limewash (none of which are painted). As the plaster and limewash was stripped in 1907 and there is no indication that any limewashing has taken place in the interior since, it is possible that these coats of limewash pre-date 1907 and that the possible paint under them thus pre-dates 1907 by some considerable time. If so, it may therefore not be simply a product of iron staining behind metal trunking for a light switch, pipe work for gas lighting or similar.

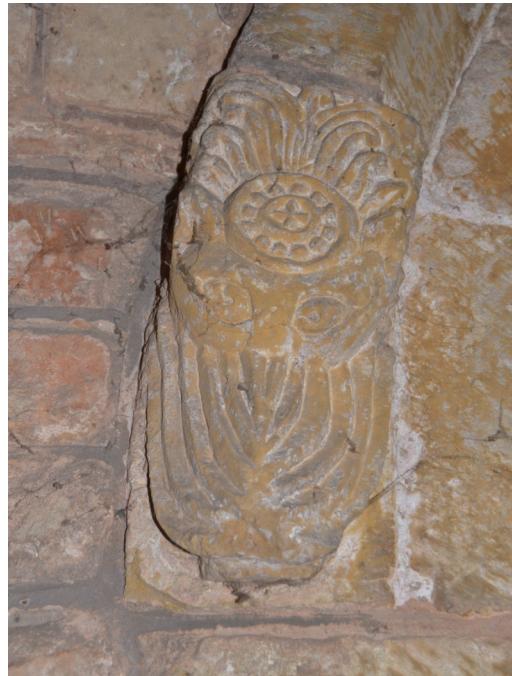
Plate 70 - western label stop of south door. Looking north

Paint can possibly be detected on the outside of the south doorway (ESD on Figure 01). The door has a hood mould terminating in two beast heads. That on the west side of the door appears to be a dragon head (Plate 70) while that on the east is more canine, possibly representing a fox, wolf or dog and possibly having been muzzled: there may be a rope tied around the back of the snout with a loose end dangling down the left side (Plate 71). Both these, and parts of the doorway mouldings, retain traces of limewash and

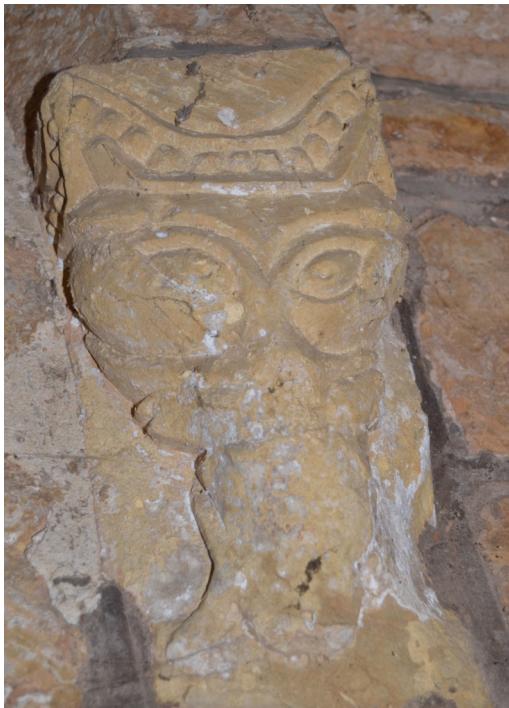
Plate 71 - eastern label stop of south door. Looking north.

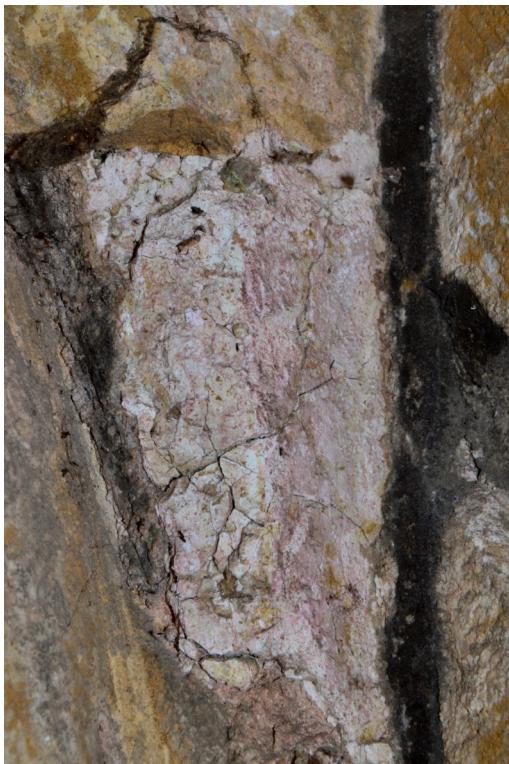
Plate 72 - traces of red and pink ?pigment on plaster between the orders of the south door (A on Plate 74). Looking north west, direct flash.

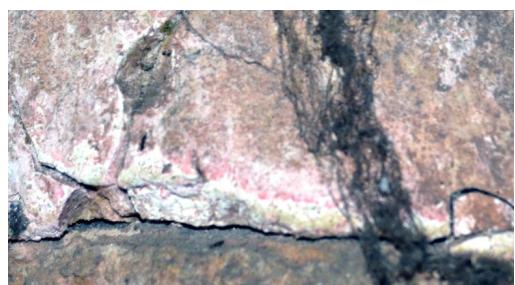
moulding. A similar patch of mortar with pink and red colouration is also visible on the same side of the doorway, filling in some damage to one of the cable mouldings (Plate 73).

Plate 73 - possible red paint applied over plaster filling on south doorway (B on Plate 74), with overlying ?limewash layer. Looking north. Direct flash, enhanced image. Dark material is dirty cobweb.

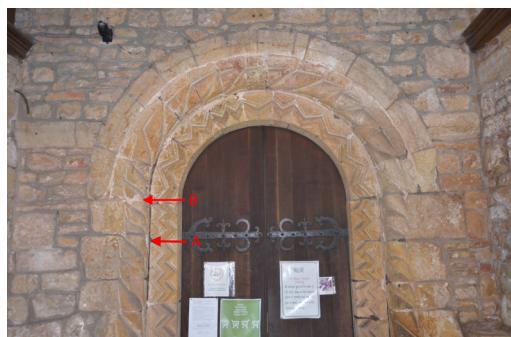
Plate 74 - location of plaster in Plate 72 (arrowed 'A') and Plate 73 (arrowed 'B'). Looking north, direct flash.

It is probable that the doorway was also once painted, as a fragment of plaster appears to retain traces of what might be pink and red paint, possibly of more than one phase (Plate 72). This plaster is on part of the cable ornament of the outer order where it meets the inner, on the western jamb, at about the height of the modern upper hinge of the door (Plate 74). It appears to be filling in a lost part of the

However, while the colours appear similar in shade to the red and pink pigments in the church, it is not impossible that the pink and red colours might not be pigment but instead some form of coloured inclusion in the mortar used in these stonework repairs. It is also suspicious that there are no traces of red paint easily visible in the carvings of the label stops or elsewhere on the stonework of the doorway. However, given the rarity of surviving exterior decoration, if the opportunity were to arise for scientific examination of the paintings in the church it would be well worth examining these traces in further detail, and undertaking a much closer inspection of the exterior of this doorway.
