# Archaeological Survey at St Wilfrid's Church, Barrow Upon Trent, Derbyshire

Andy Gaunt  
Mercian Archaeological Services CIC  
Report MAS054  
20/03/2024

## Archaeological Survey at St Wilfrid's Church Barrow Upon Trent

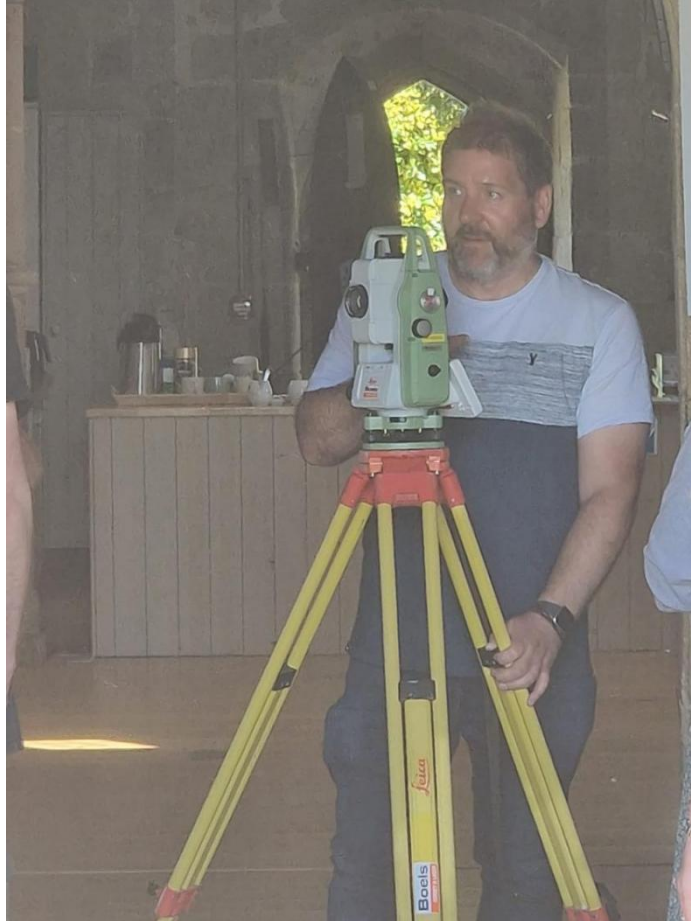
Photograph 4\_2: Leica TS07 EDM Total Station being set up in the entrance to St Wilfrid's from GPS control points outside.

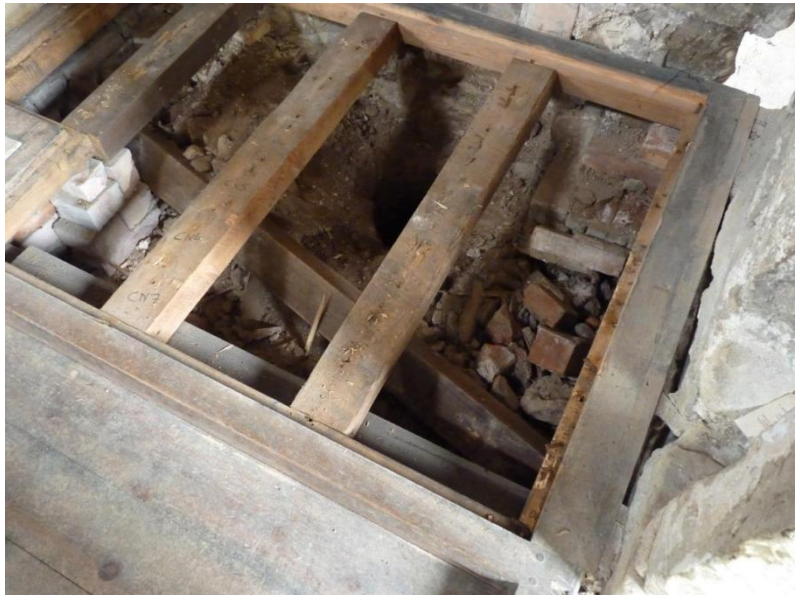
Photograph A\_1: Rubble under flooring in area of possible anchorite. Photo courtesy of Anne Heathcote.

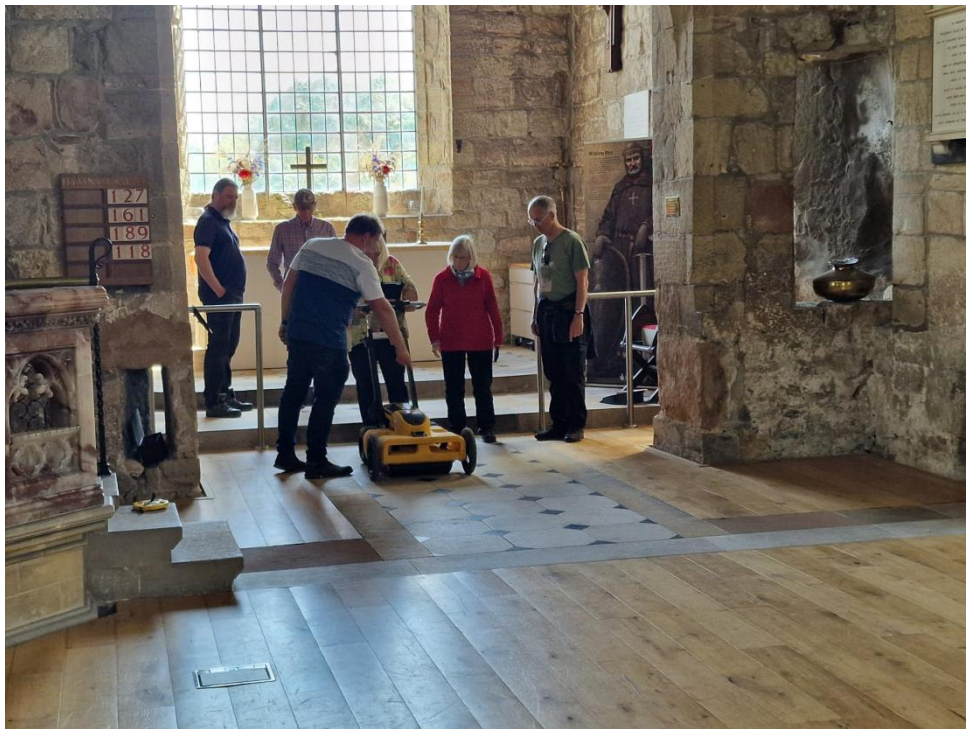
Photograph A\_1: Volunteers undertaking Ground Penetrating Radar Survey in the vicinity of the low-level squint (visible on left hand side of photograph, to right of pulpit at base of chancel arch, and possible anchorite cell.

Figure A1 above shows the area of the possible anchorite cell. The area is difficult to interpret and large amounts of rubble are present as seen in photograph A\_1 below. However high amplitude responses which could represent walls or foundations can be seen in grids AA, AJ and AF. A 3-Dimensional (3D) ISO model of grid AJ is shown below in figure A3

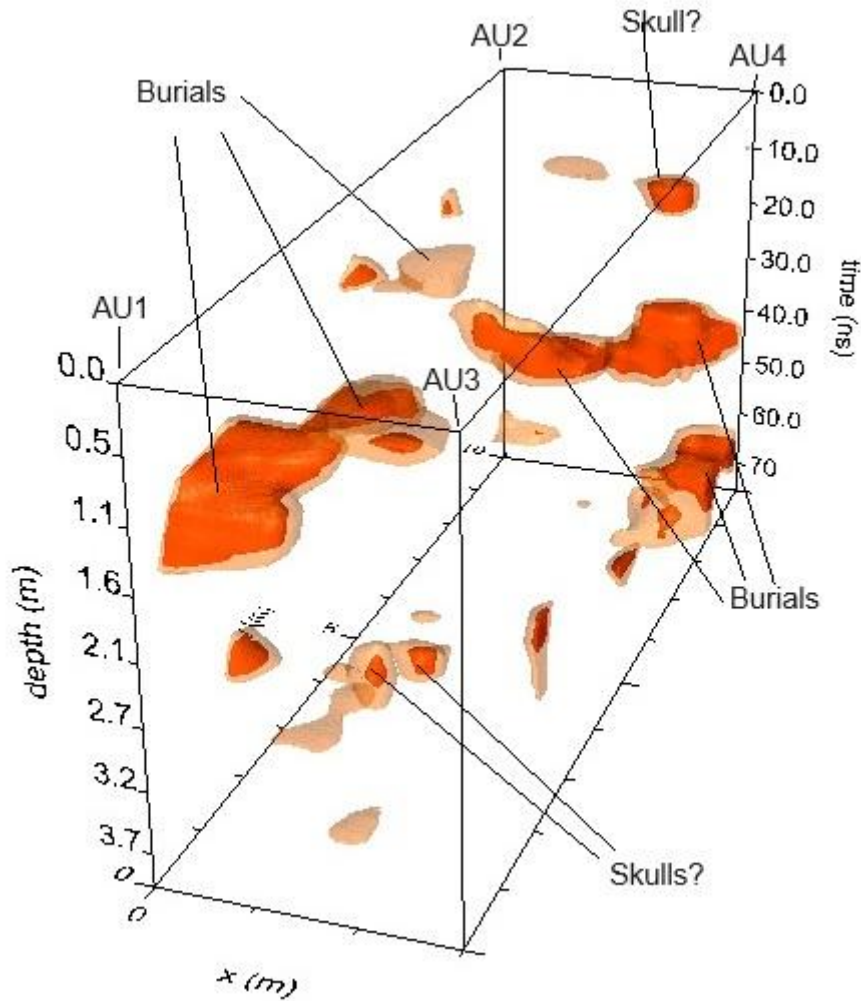
Figure F2: 3D Iso image of grid AU showing possible burials.

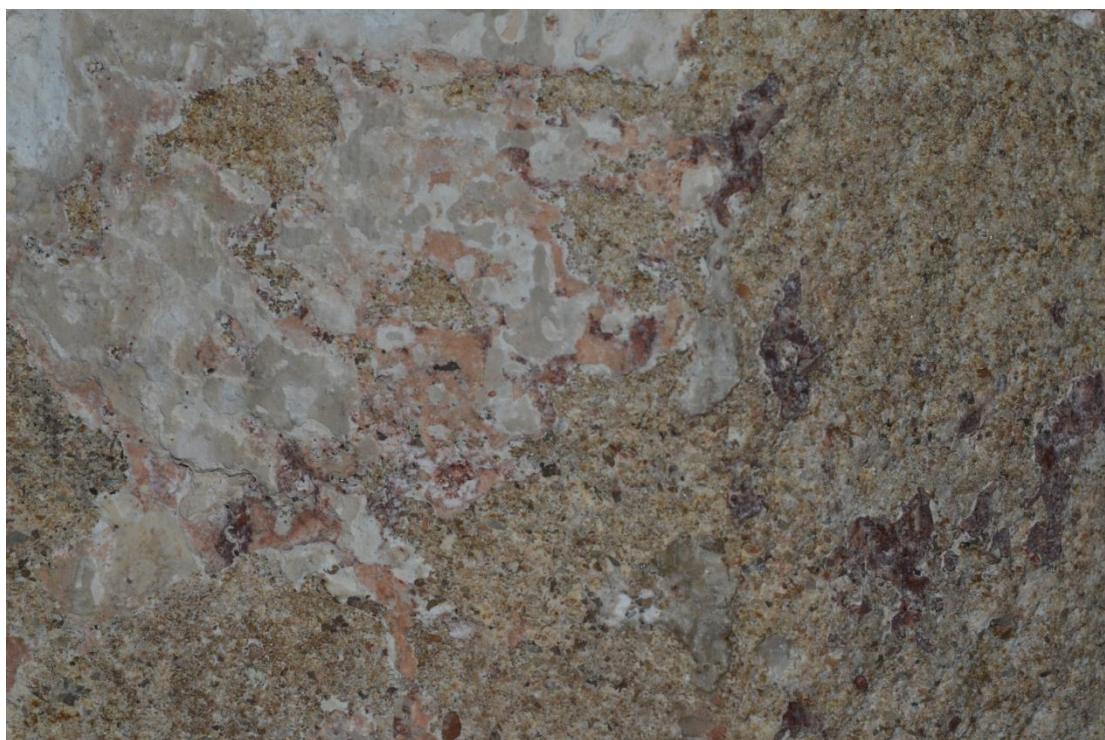
Traces of red and pink paint partially surviving on the SE face of the western pier of the south arcade. The paint can be seen to be overlain by one or two coats of limewash with dirty (grey) surfaces.

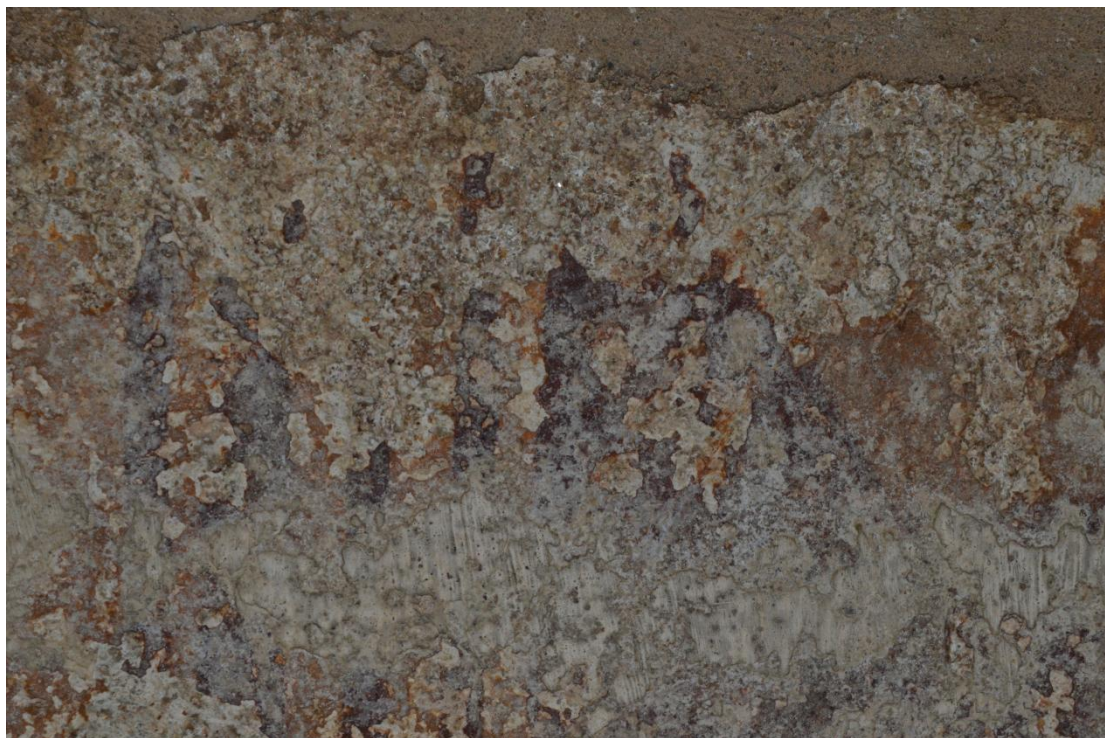
Traces of red and yellow paint in the eastern splay of the squint in the south aisle showing overlying limewash layer with dirty surface.

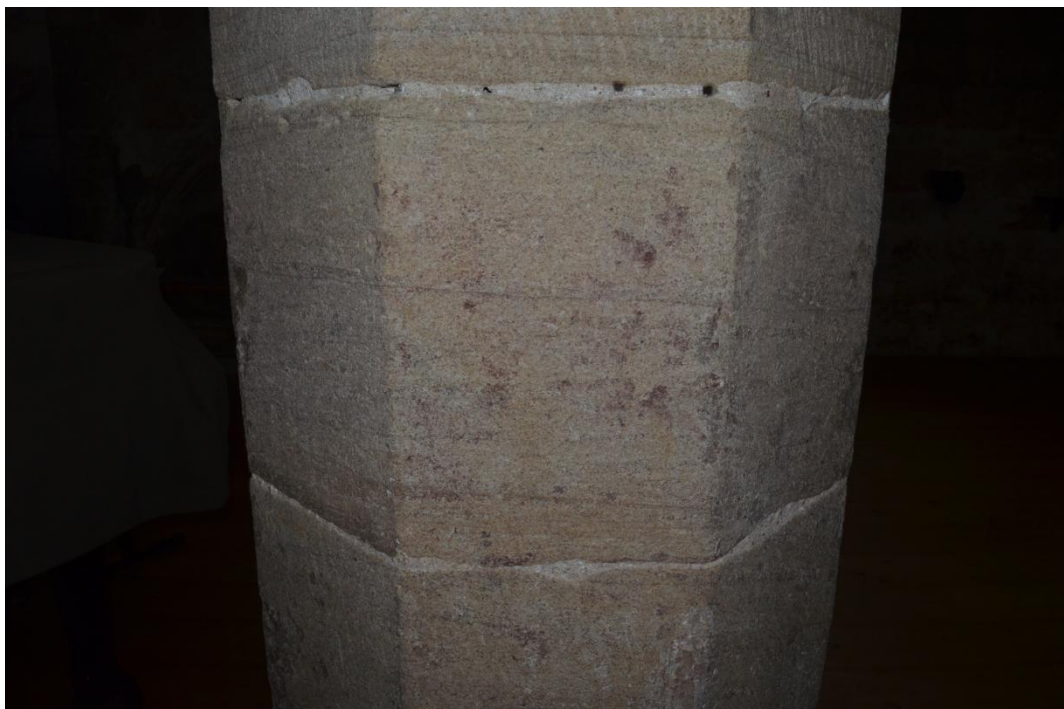
The south arcade is of three bays. The two octagonal piers have substantial (given the degree of stripping) traces of paint on their lower sections. On the north side of the eastern pier an expanse of red paint is visible (see below). This appears to be on the lowest coat of plaster or limewash and can thus be considered likely to represent the first (original) decorative scheme of the arcade. When so heavily stripped it can be difficult to determine if areas of paint such as this were originally areas of solid colour or part of a design with heavy use of red paint.

Traces of red paint on the eastern side of the eastern pier of the south arcade. Photo looking west.

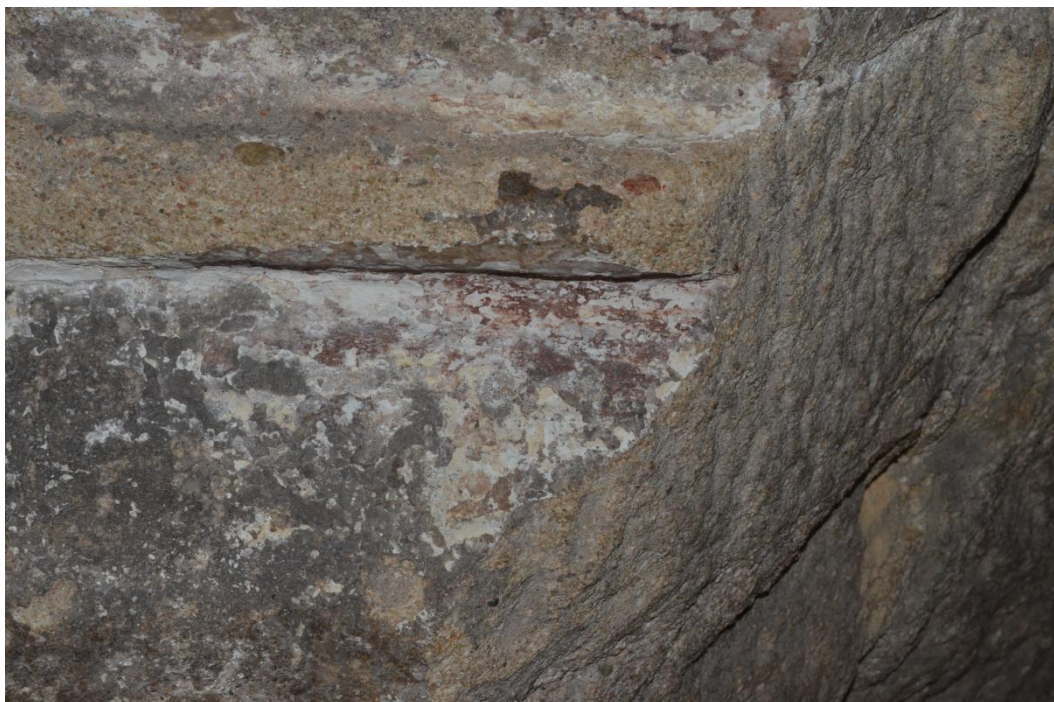
Traces of red paint on the SE side of the base of the eastern pier of the south arcade. Photo looking north west.

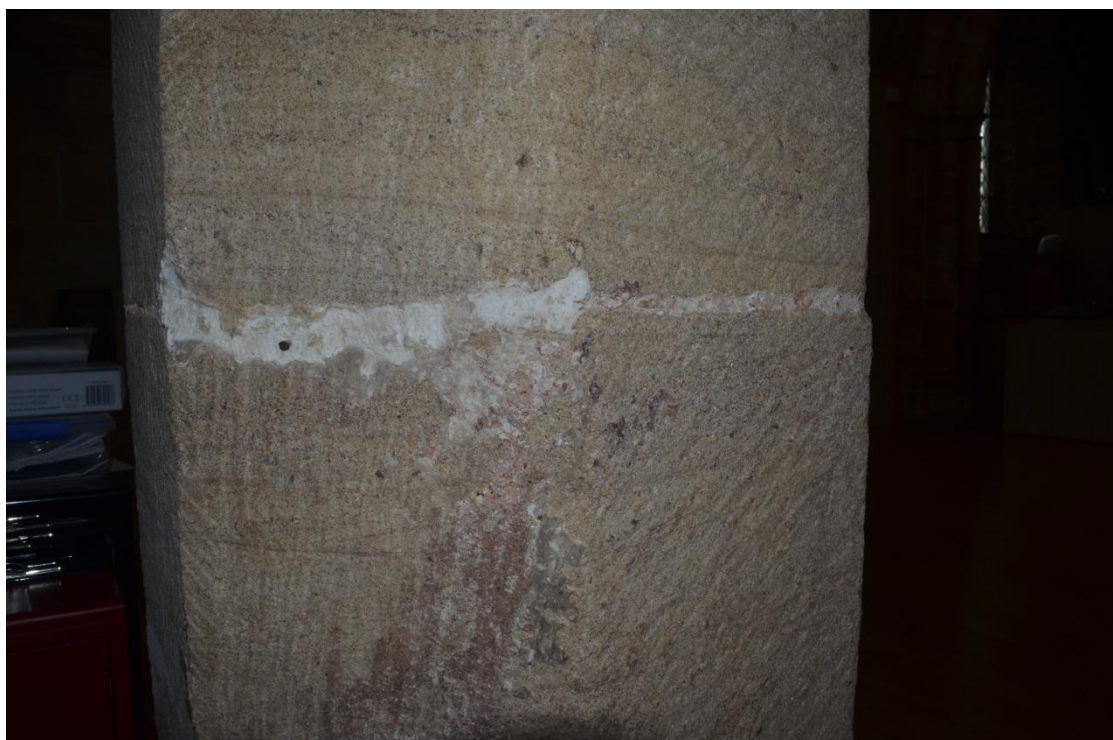
The eastern and south eastern faces of the western pier also show traces of red and pink paint; they occur in proximity and appear to be applied to the same layer indicating a two tone design.

Traces of pink and red paint surviving on the heavily stripped SE and E faces of the western pier of the south arcade.  
Photo looking north west. See below for detail.

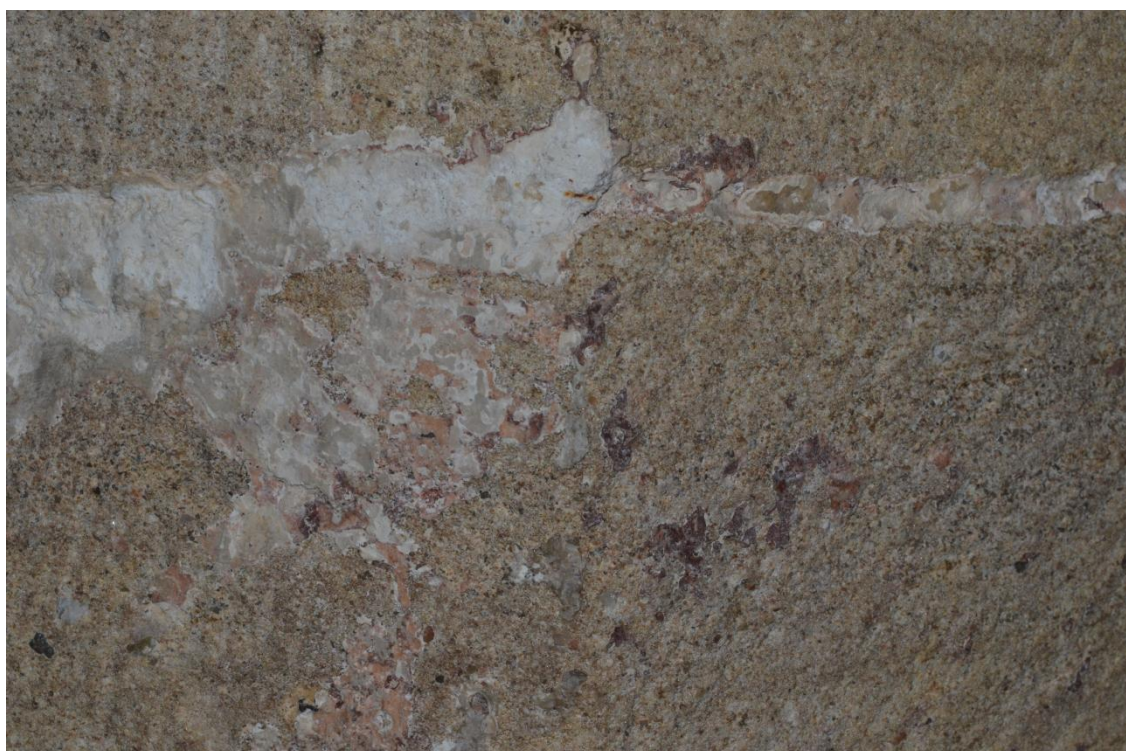
Closer view of traces of pink and red paint on the SE and E faces of the western pier of the south arcade. Photo  
looking north west.

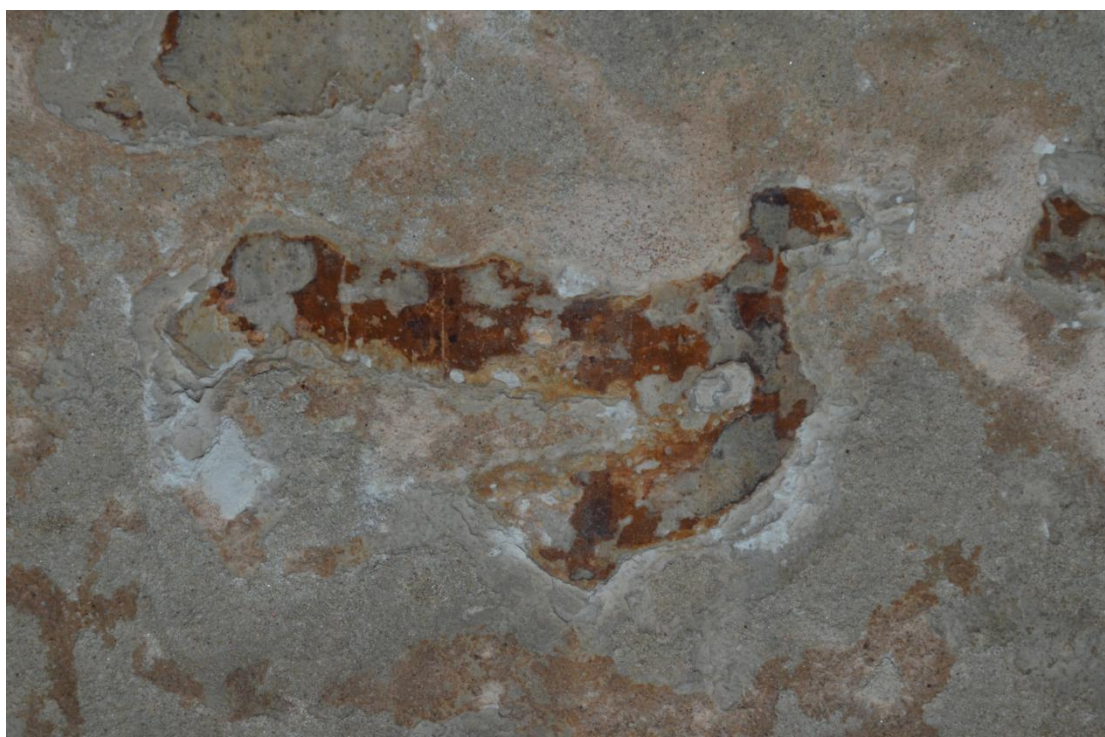
Fragmentary traces of paint include a yellowish wash and possible red paint in several locations, though no overall pattern to the decoration could be discerned. A trace of yellow paint beneath the central window of the aisle (see below) appears to be applied on a skim of plaster overlying the earliest layer of plaster, so may represent part of a second scheme of decoration.

Trace of yellow paint on the south wall of the south aisle, just below the sill of the central window, to the west of the tomb recess. The decoration appears to include an area of golden yellow paint (the present shape is the result of the stripping) with traces of darker painting, possibly a dark red or a discoloured pigment that was originally another colour.

It is partially obscured by at least one coat of limewash with dirty surface, and appears to be applied on a layer of plaster that overlies the first coat on the masonry. Photo looking south

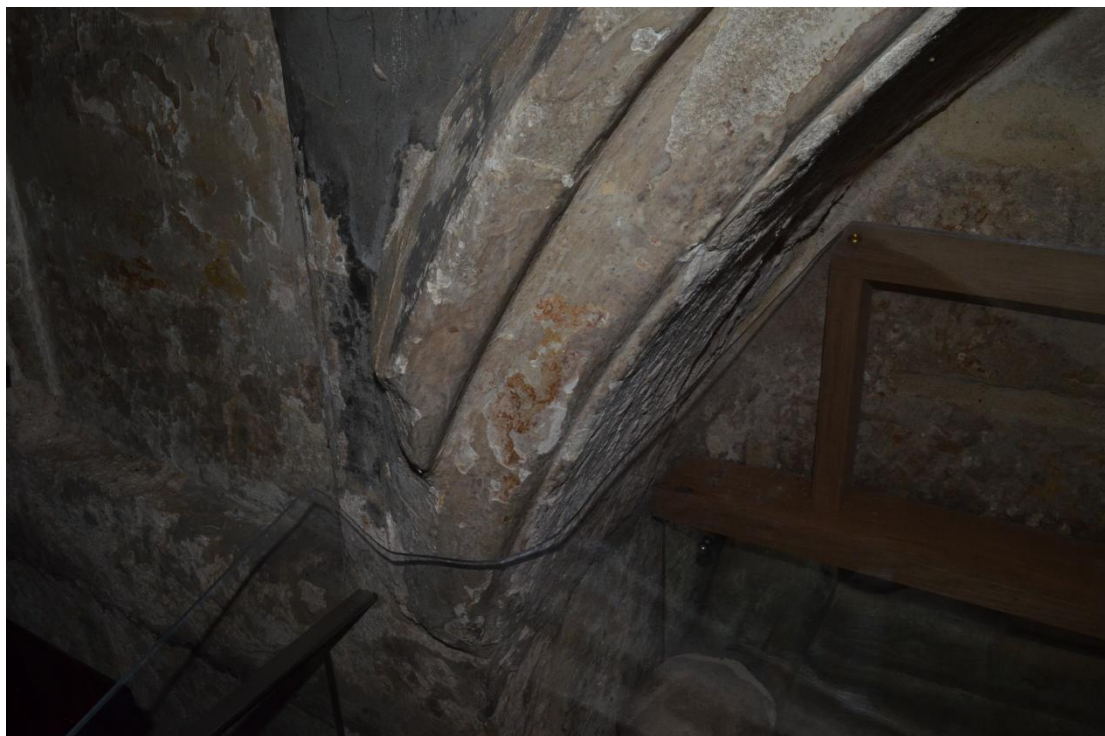
A tomb recess in the south wall contains a high quality mid-14<sup>th</sup> century alabaster figure of a priest with traces of paint, reported on elsewhere. The mouldings of the arch of the tomb recess also retain traces of paint, with areas of golden yellow and patches of red paint. These are mostly covered by later limewash and more evidence of the decorative scheme will survive under the later limewash. The golden yellow decoration is applied to a layer of limewash that can be seen to overlie at least one, and possibly two, earlier coats of limewash. With the exception of a single fragment of possible red paint on the later of these layers no decoration can be seen, suggesting a sparser pattern may have been employed in the earlier decoration of the recess, or colours that have not survived were employed.

Yellow paint on the moulding on the eastern side of the tomb recess in the south wall of the south aisle. Photo looking south east.

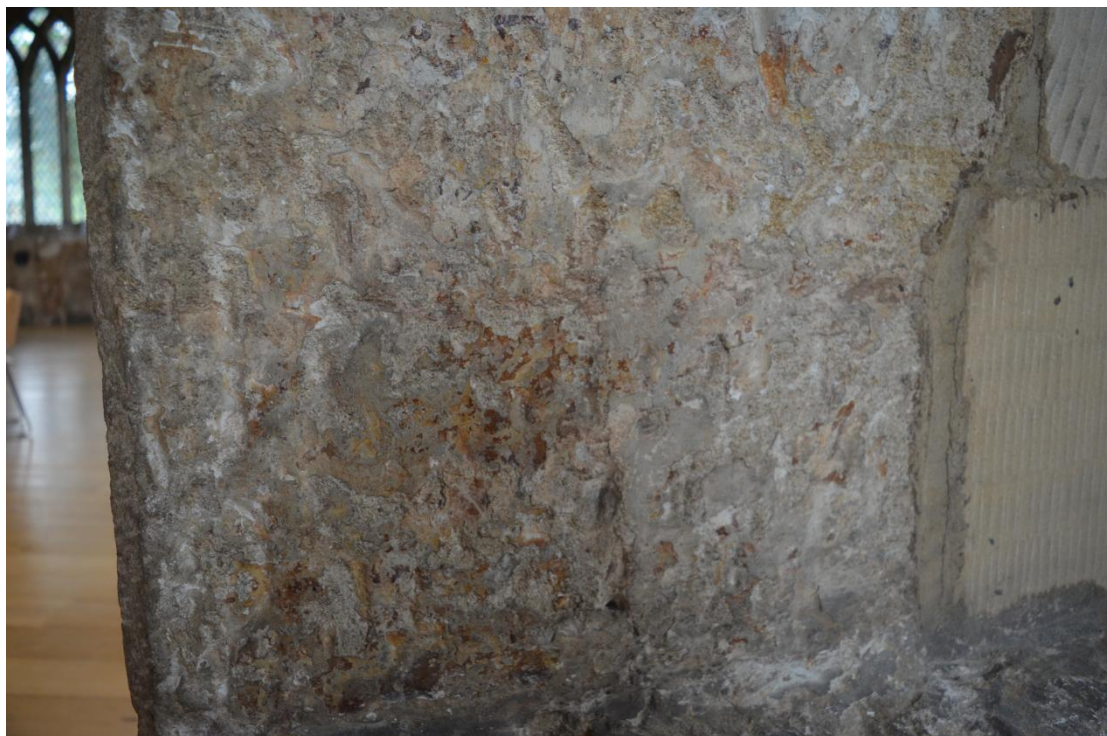
Traces of yellow and red paint on the hacked off masonry of the western side of the squint in the south side of the eastern respond of the south arcade.

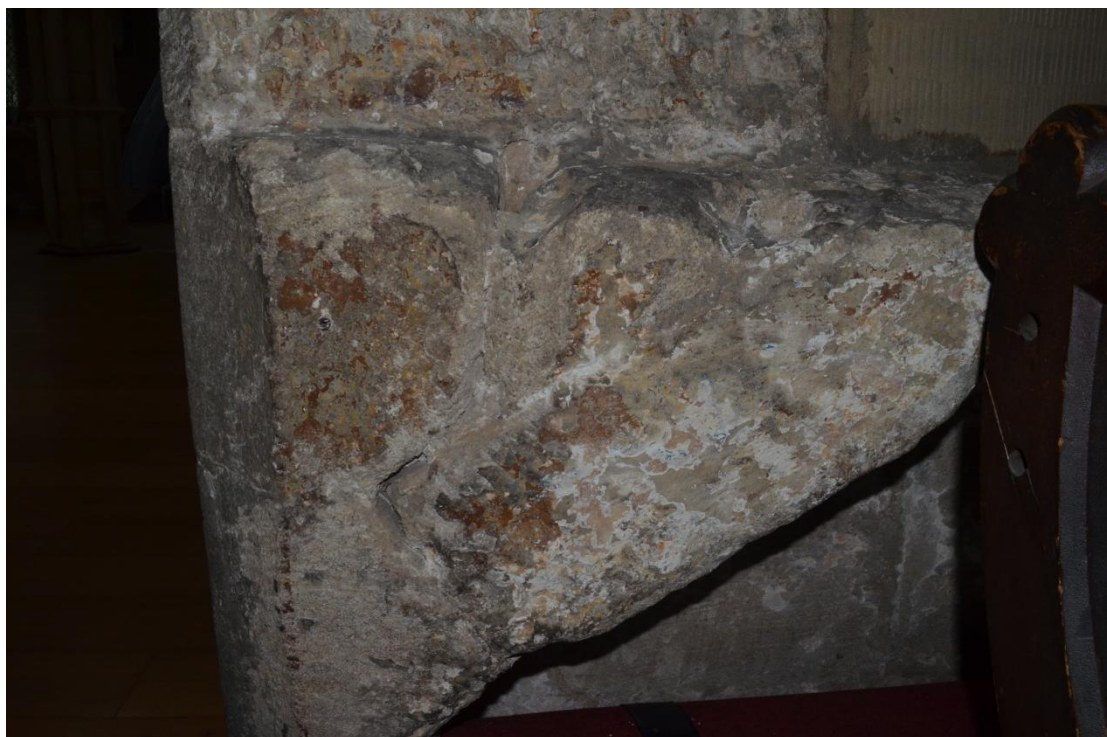
Traces of mainly yellow paint on masonry of the south face of the eastern respond of the south arcade, between the tomb recess (below) and squint (above). Photo looking north

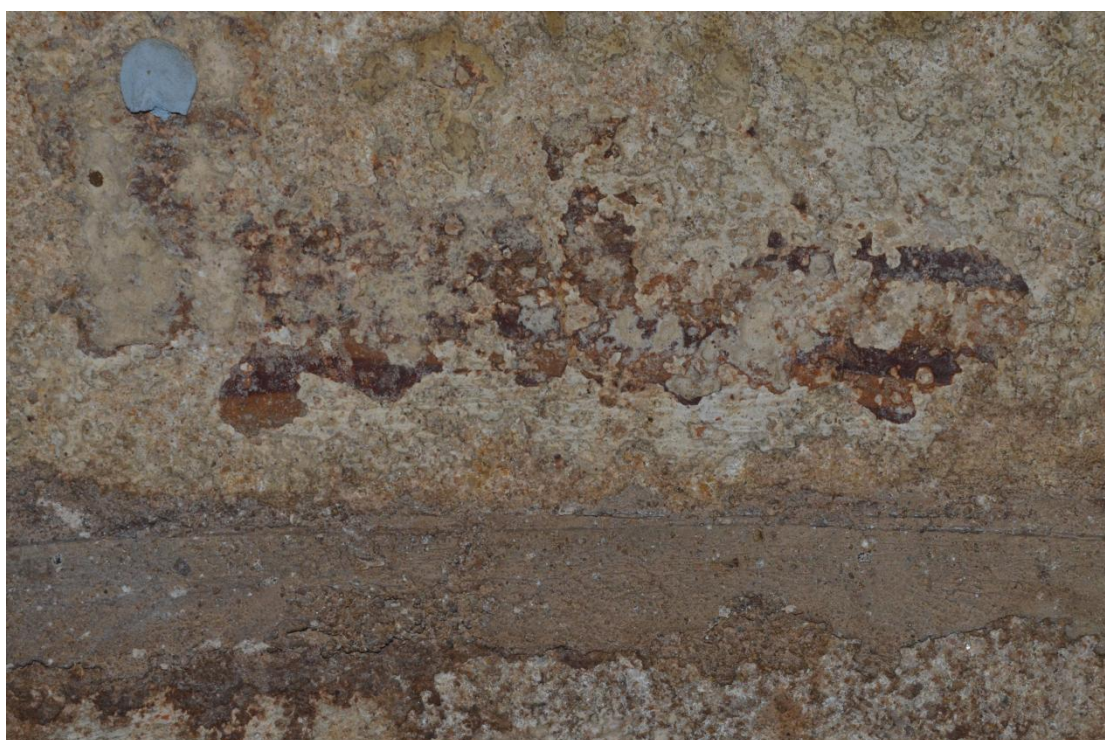
Decoration on the eastern splay of the squint in the south aisle showing yellow ground with parallel horizontal red lines. For decoration on the stone beneath, see below. Photo looking north east.

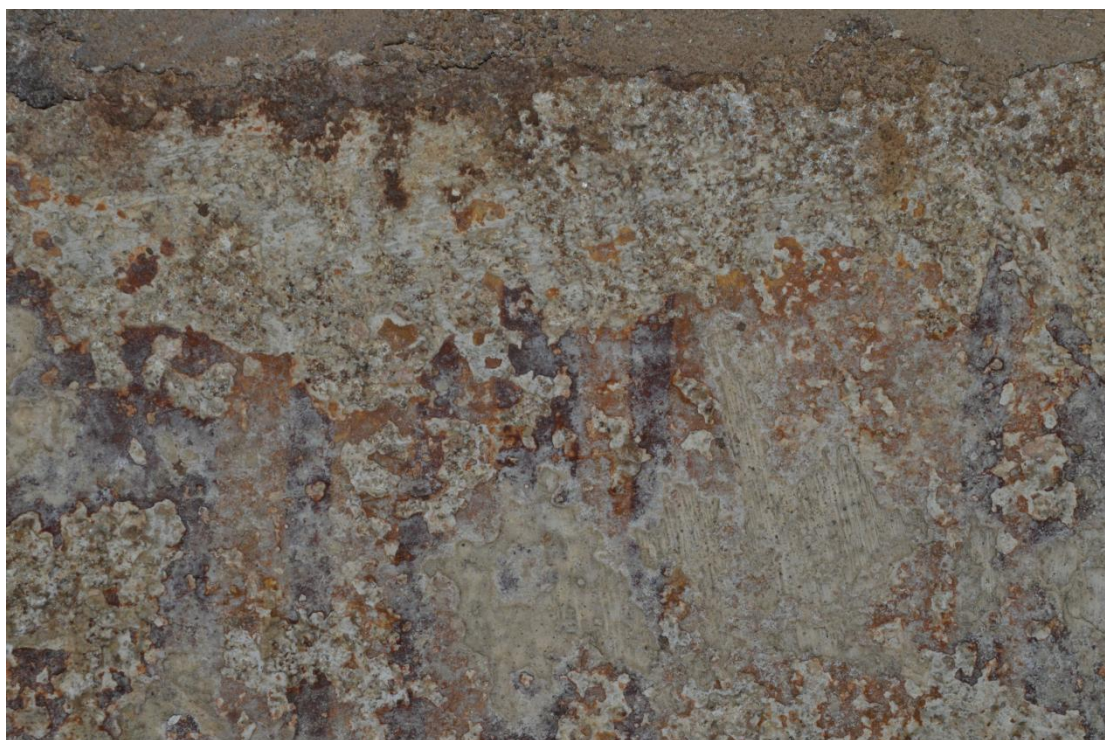
Decoration on the eastern splay of the squint in the south aisle, showing yellow ground with broadly parallel curving vertical red lines, partially obscured by limewash with dirty surface. This stone located immediately beneath that with the horizontal lines above. Photo looking north east.

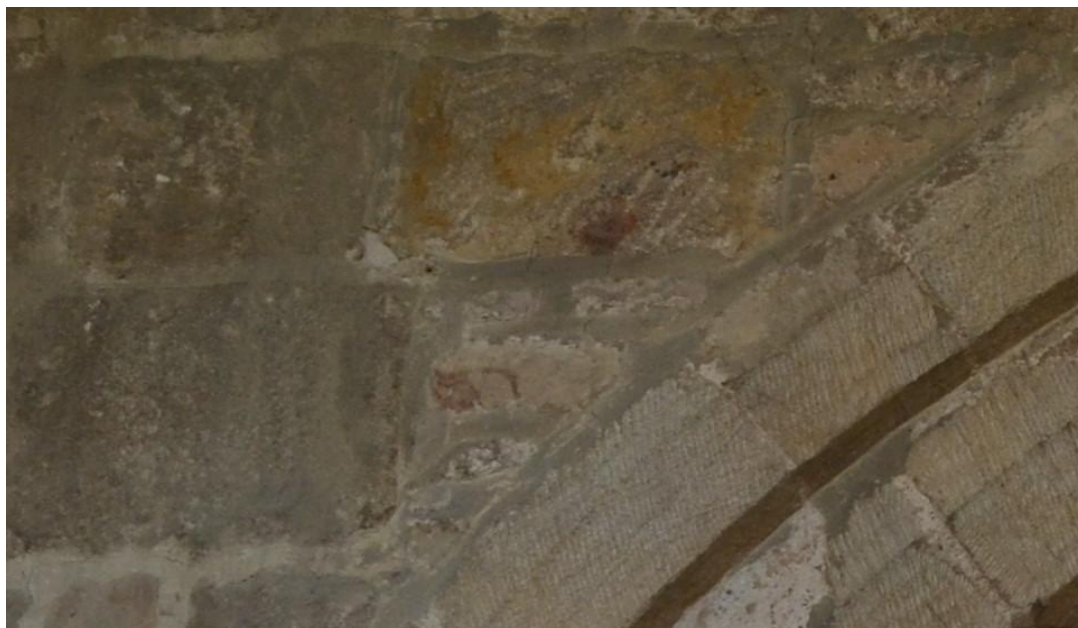
Paint is visible on the west wall of the chancel, around the chancel arch. On the south side are two traces of red paint (see below), possibly floral or figurative. A further area of colour that may be paint is present on the north side of the arch.

Traces of paint over the south side of the chancel arch, looking west from the chancel.

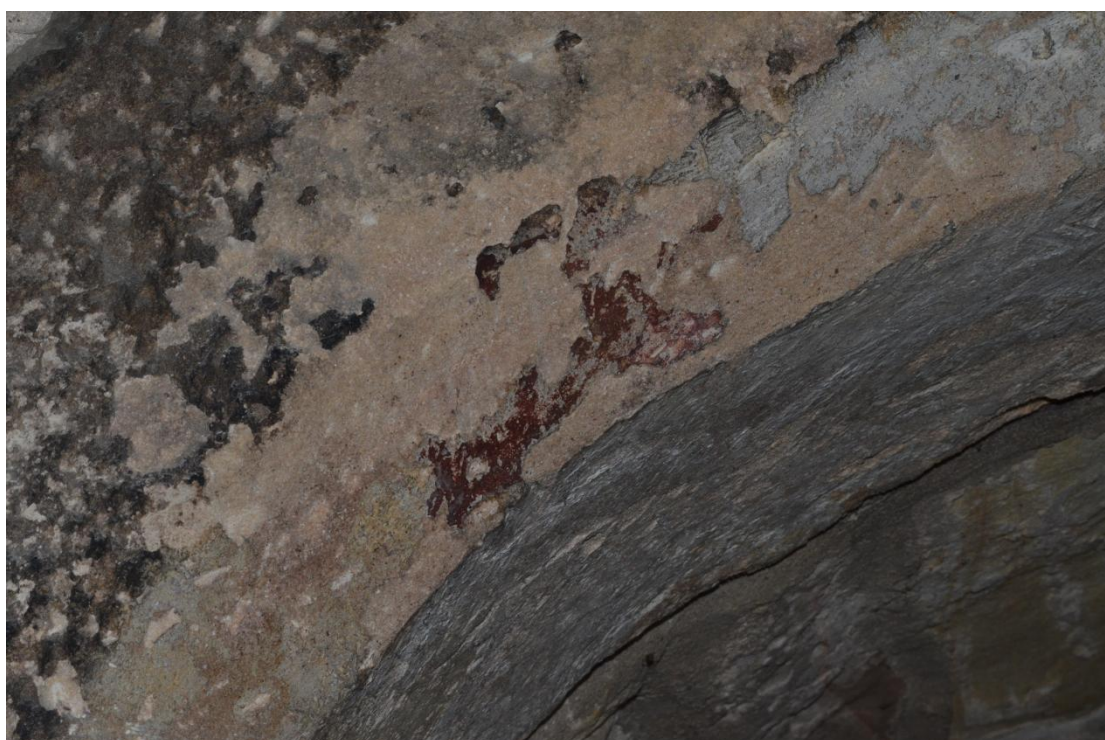
Internally, the north door has a round-headed arch with a simple chamfer. An area of solid red paint survives on the chamfer. to the west of the apex, with other more fragmentary traces elsewhere on the chamfer. Plaster survives on the stonework around the door and so there is the possibility that further painting could survive in this location.

Trace of red paint in the chancel, on the chamfer of the western side of the arch over the north door.

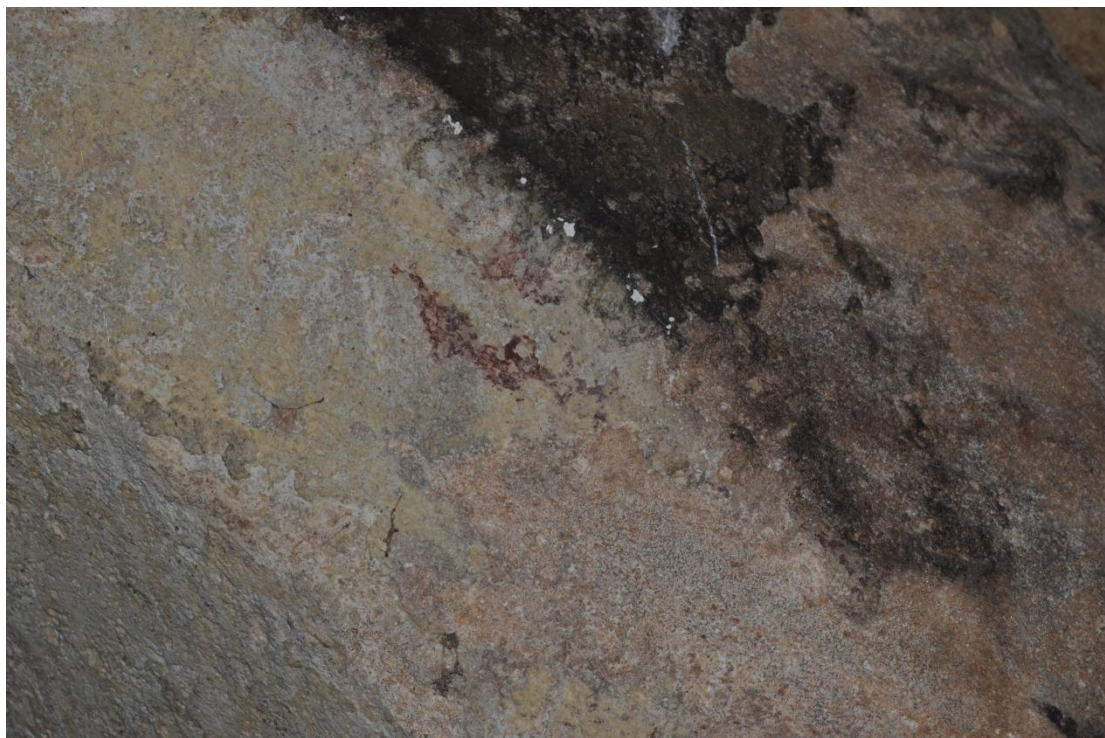
Fragmentary trace of red paint on the chamfer on the eastern side of the arch over the north door.

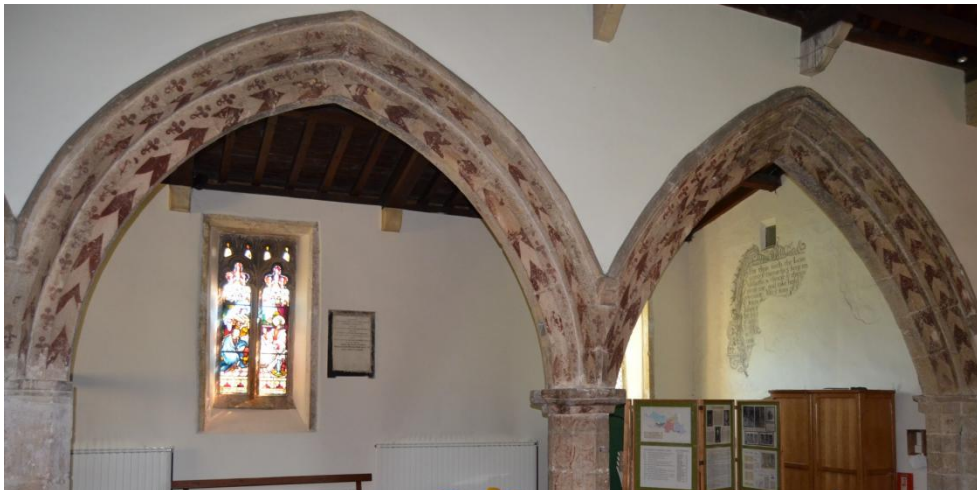
Western bays of the arcade at St Agatha, Easby, Yorkshire, with red painted chevron decoration, looking south Direct flash.

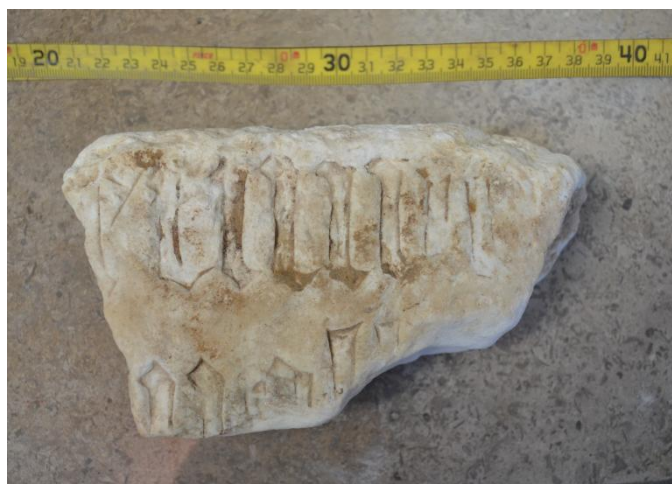
Plate 02 – fragment of slab with blackletter inscription. Tape measure divisions = mm

2 – Fragment of friable white alabaster with two lines of blackletter text incised in the surface, one above the other (Figure 01:2). The fragment is a maximum of 0.17 m x 0.09 m in size, with a thickness of about 0.042 m. The surviving face has maximum dimensions of approximately 130 x 79 mm. There is old damage to the surface, particularly near the edges, as well as some fresh damage exposing the very white stone, likely resulting from when it was discovered. The decoration comprises a fragment of an incised inscription, of which two lines of text are partially visible. There are traces of a dark substance surviving at the edge of some of the cuts of the letters. This is likely to be remnants of the original colourant inlaid into the slab to pick out the lettering. No analysis of this material was undertaken, but the dark colour suggests it could be pitch, which was commonly used to pick out linework and lettering on alabaster slabs.

The partial inscription is on two lines. The top line includes the letter 'X' followed by seven minims. A mark on the surface of the stone to the right of the last of these suggests the presence of another character, though the stone is too damaged here to determine its form. The spacing of the minims is irregular; the foot strokes of the first and third are slightly longer and more pointed than the rest. The sixth minim is different in that it does not seem to be parallel to the other minims. In addition, while its foot is missing and the slab is damaged in this location, there is no evidence to the immediate right to suggest that its foot turned right like all the other minims. There are uncertain traces in the area beneath this minim that may be damage, or could suggest a descender in this location.

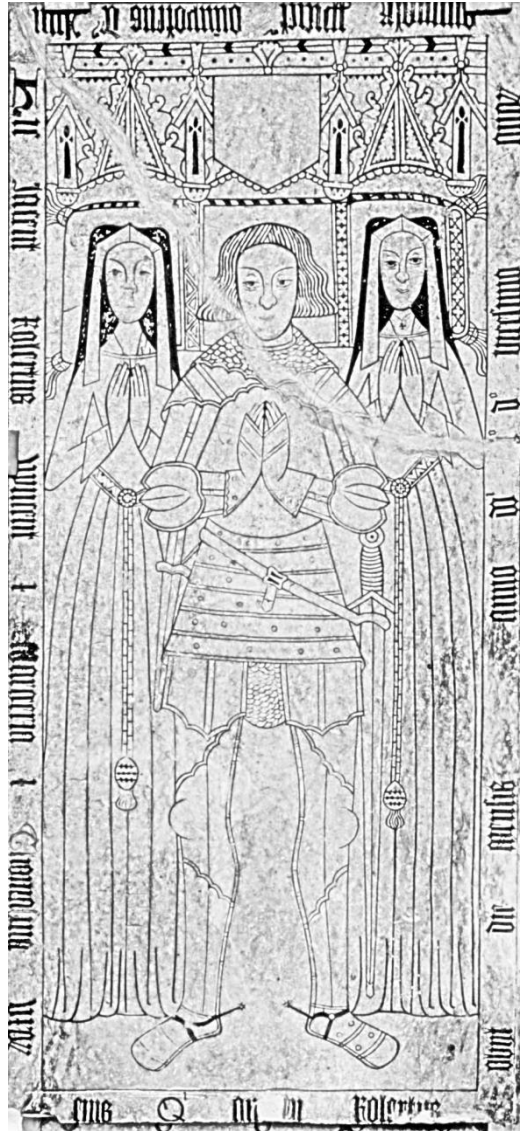
Figure 02 – alabaster lab to Robert Vyncent and wives at Rothley, Leicestershire

The figure cannot be directly paralleled, but the semi-circular form of the skirt of mail occurs on, for example, a slab of c.1530 to Robert Vyncent in Rothley church in Leicestershire (Figure 02), and on one to Thomas Hesylyrge at Noseley chapel, Leicestershire. The angular concave form of the edges of the tasset are also quite closely paralleled on the 1467 slab to Hesylyrge (Greenhill 1958, Pl XIIIa),

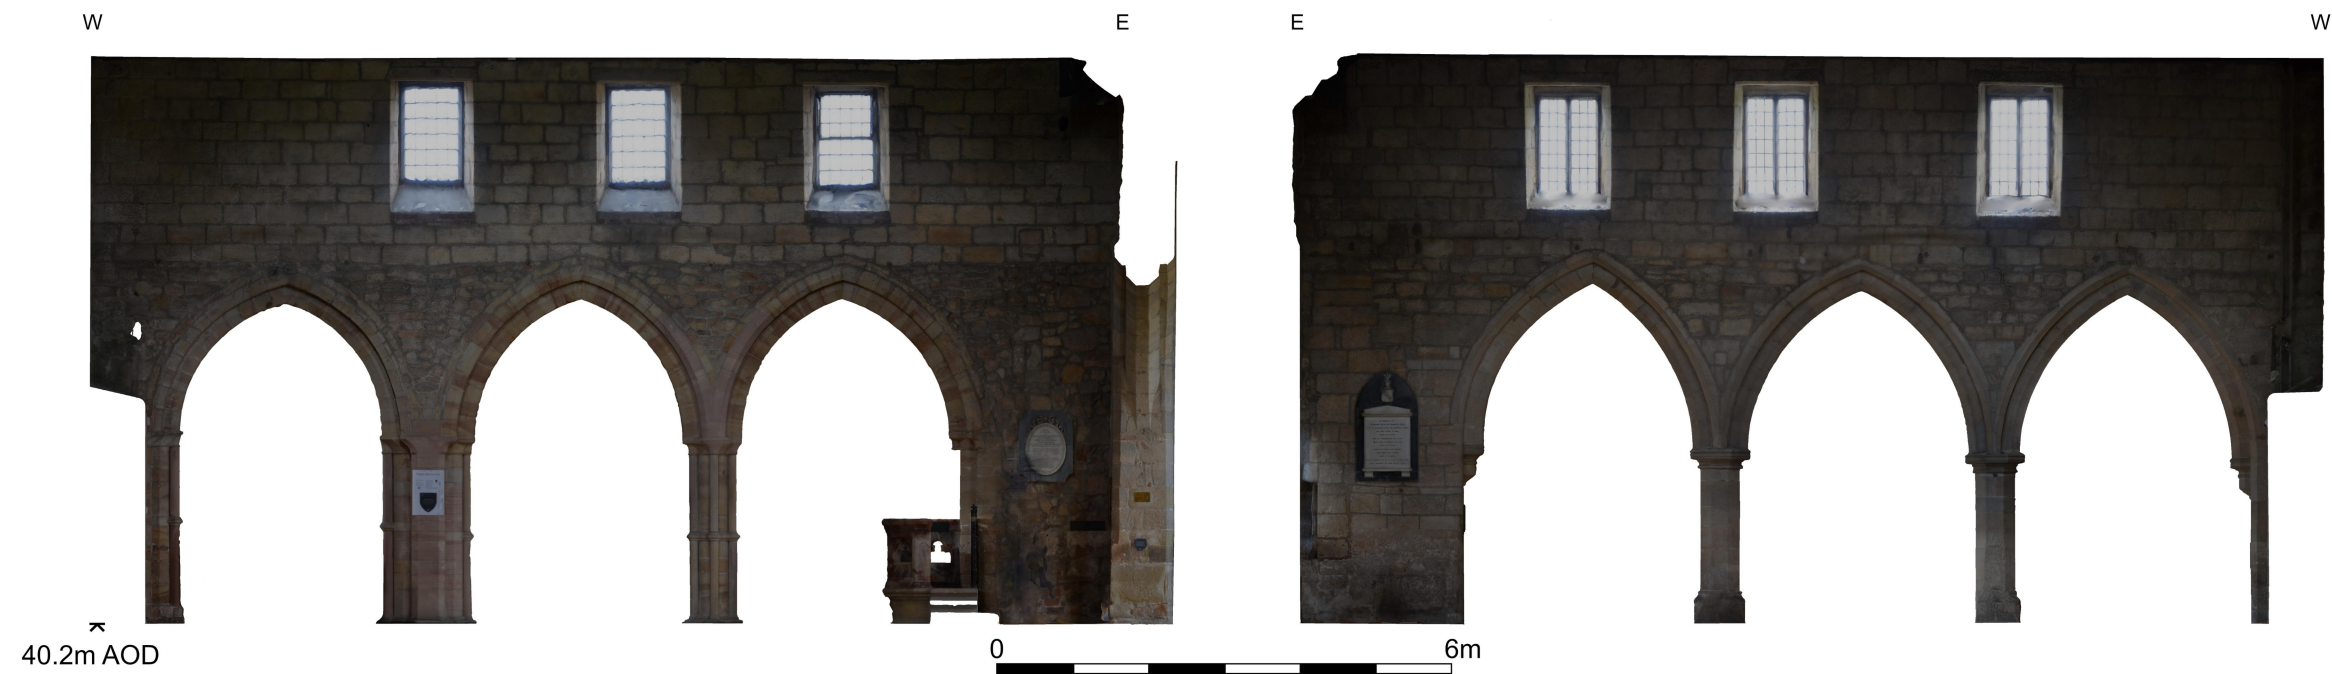
Internal elevations of nave. L: south face of north nave wall, looking north; R: north face of south nave wall, looking south.

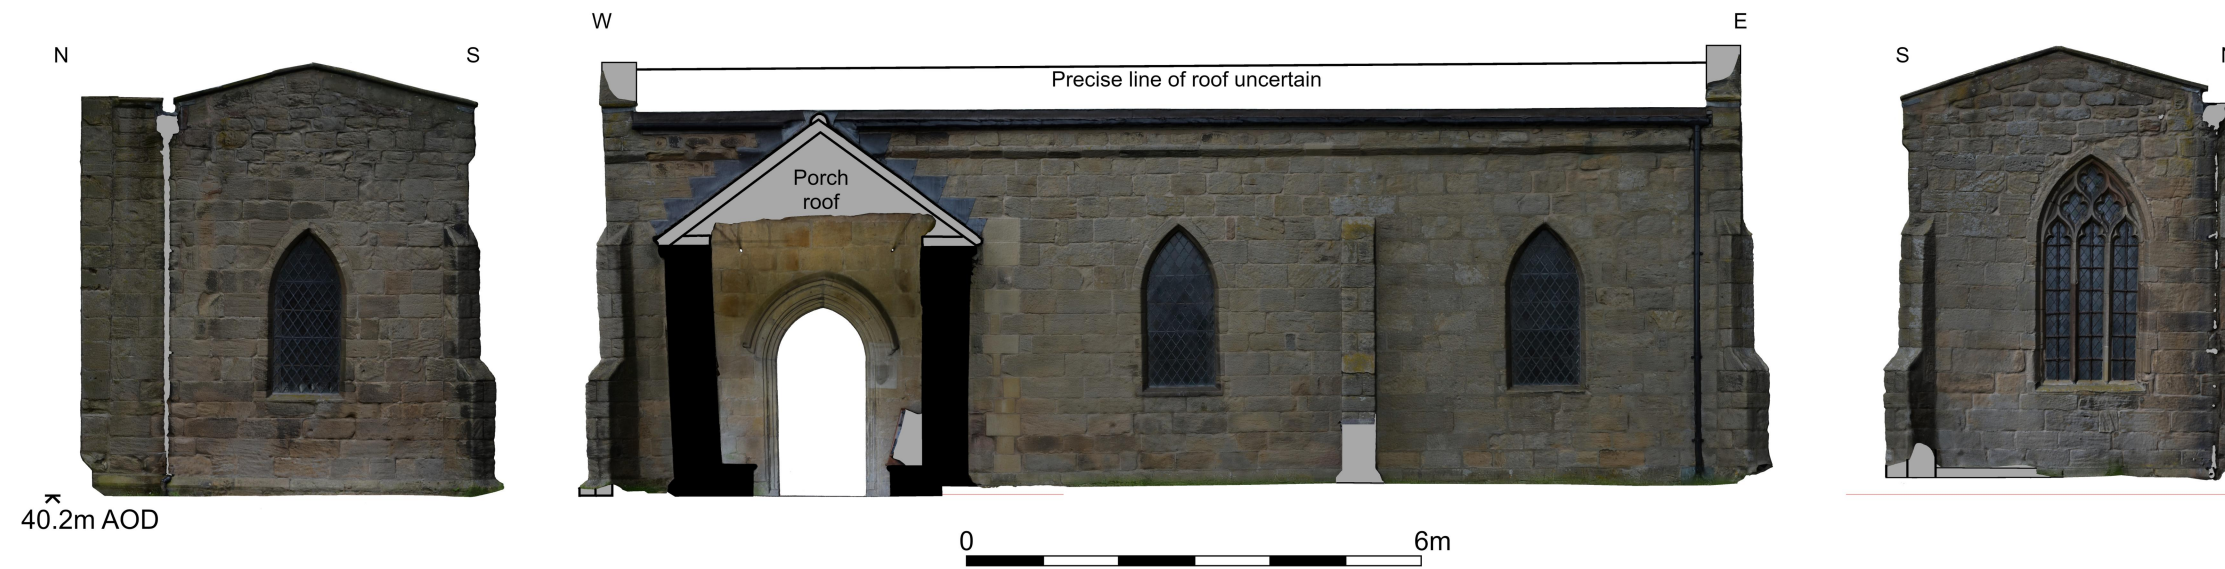
External elevations of south aisle. L-R: west face of west wall looking east; south face of south wall looking north; east face of east wall looking west.

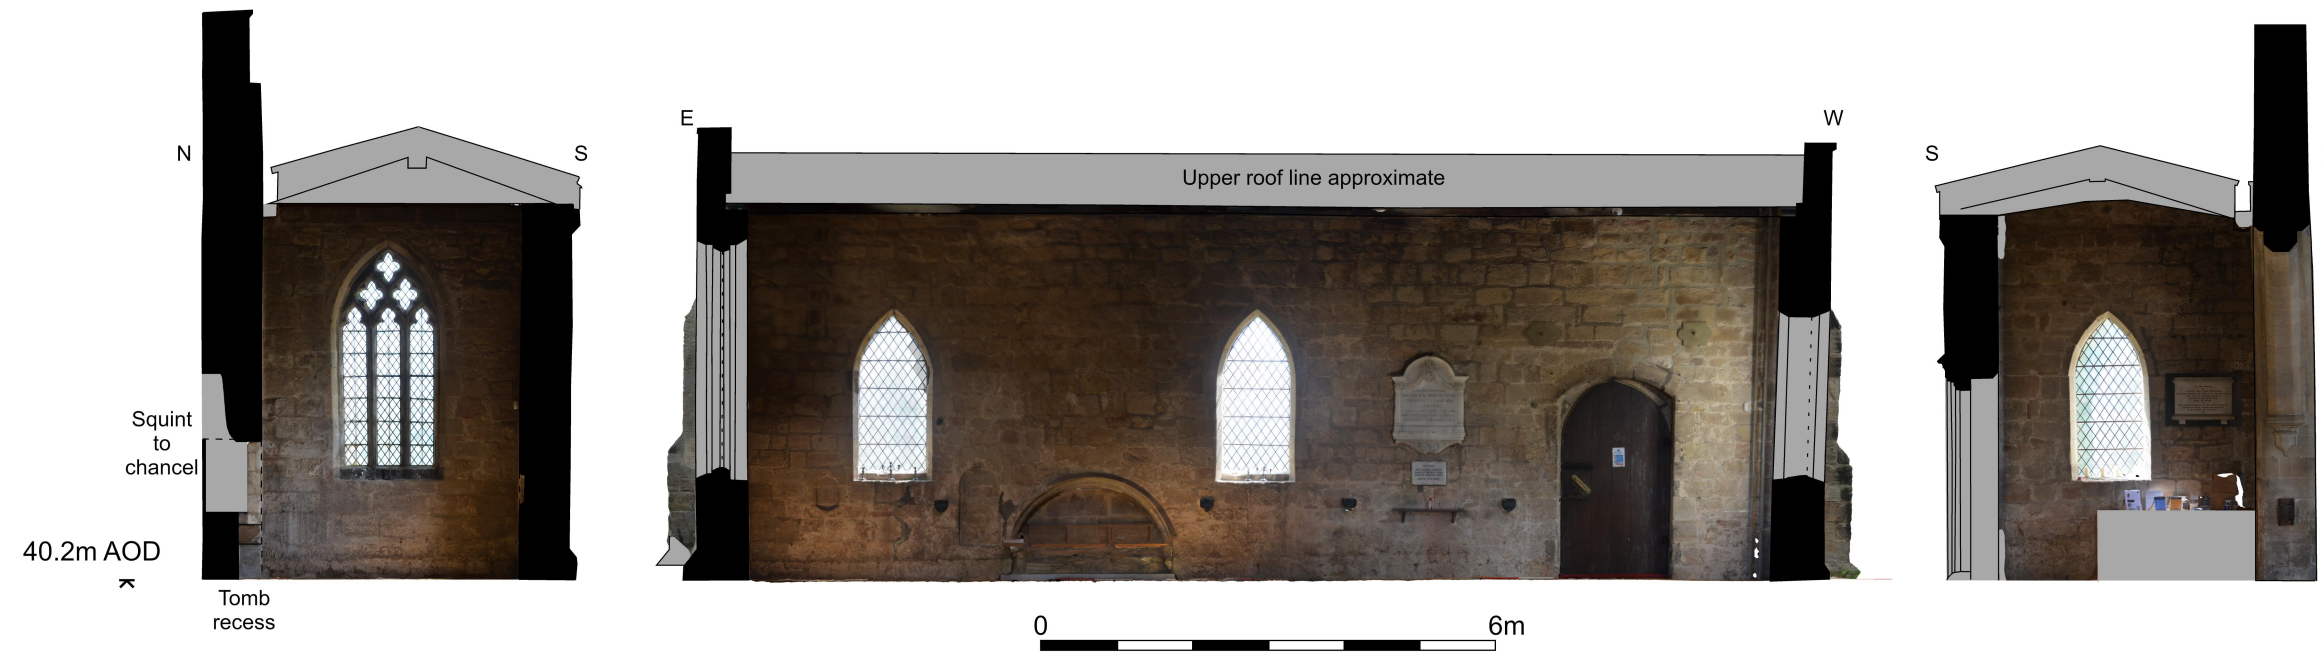
Internal elevations of south aisle. L-R: west face of east wall looking east, showing squint cutting through the adjacent nave wall; north face of south wall looking south; and east face of west wall looking west.
