# Archaeological Survey at St Wilfrid's Church, Barrow Upon Trent, Derbyshire

Andy Gaunt  
Mercian Archaeological Services CIC  
Report MAS054  
20/03/2024

## Archaeological Survey at St Wilfrid's Church Barrow Upon Trent

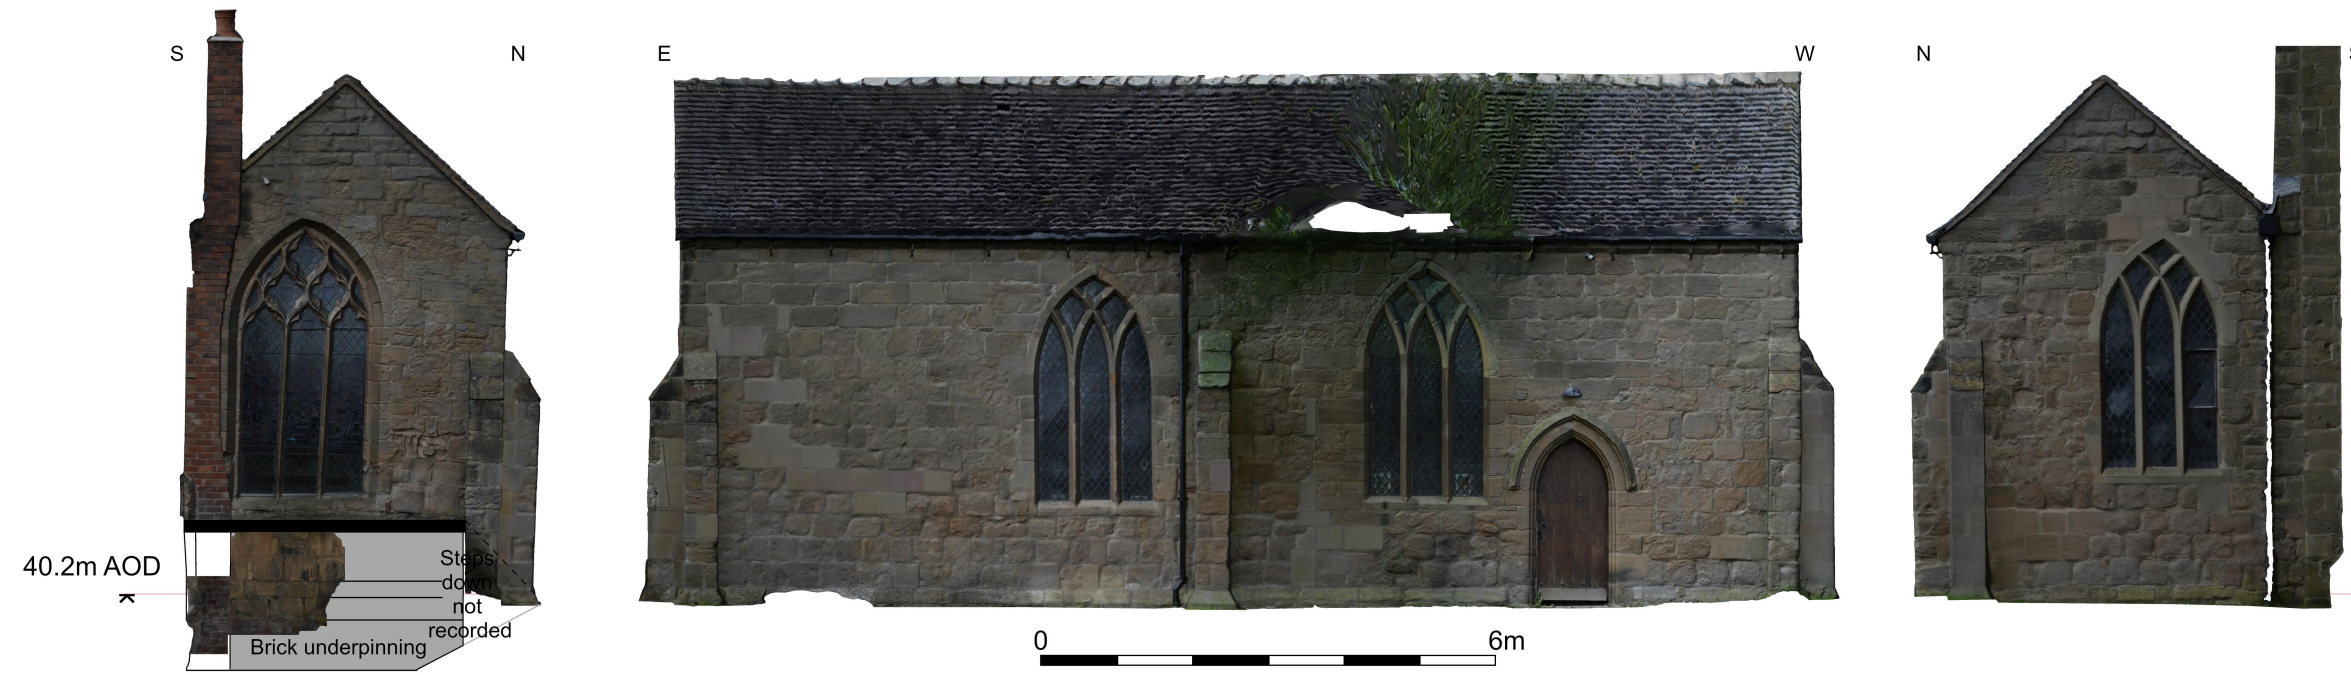
Exterior elevations of north aisle. L-R: East face of east wall looking west, with boiler room below; north face of north wall looking south; and west face of west wall looking east.

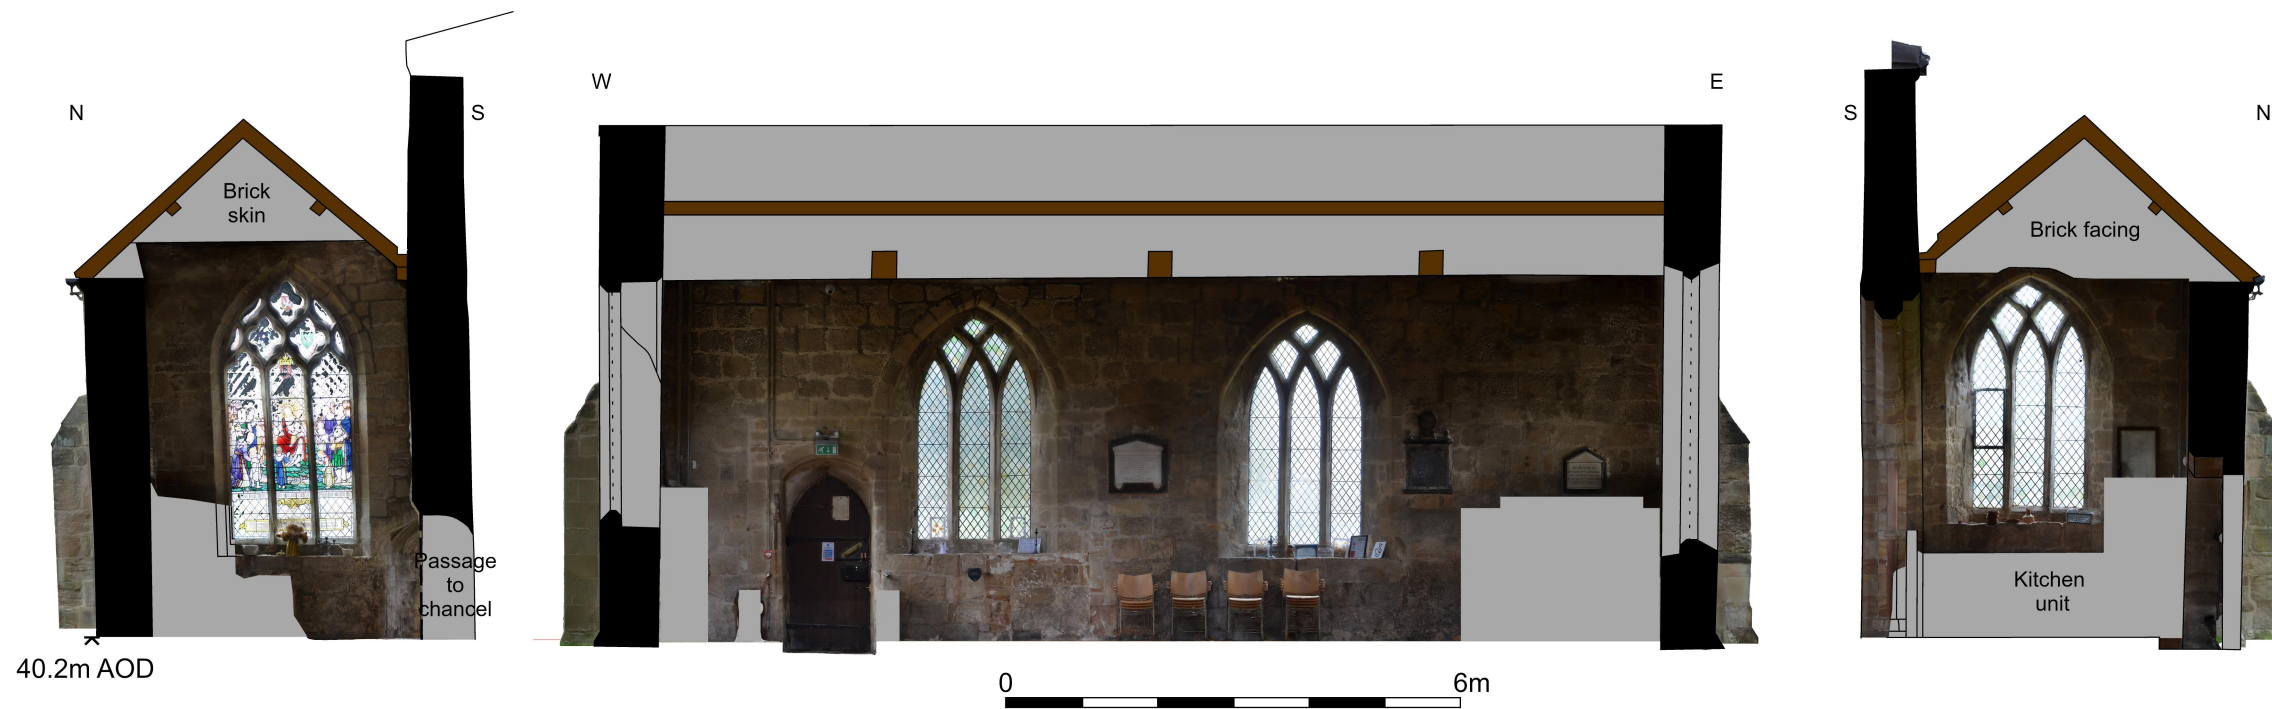
Interior elevations of north aisle, West face of east wall looking east; south face of north wall looking north; and east face of west wall looking west.

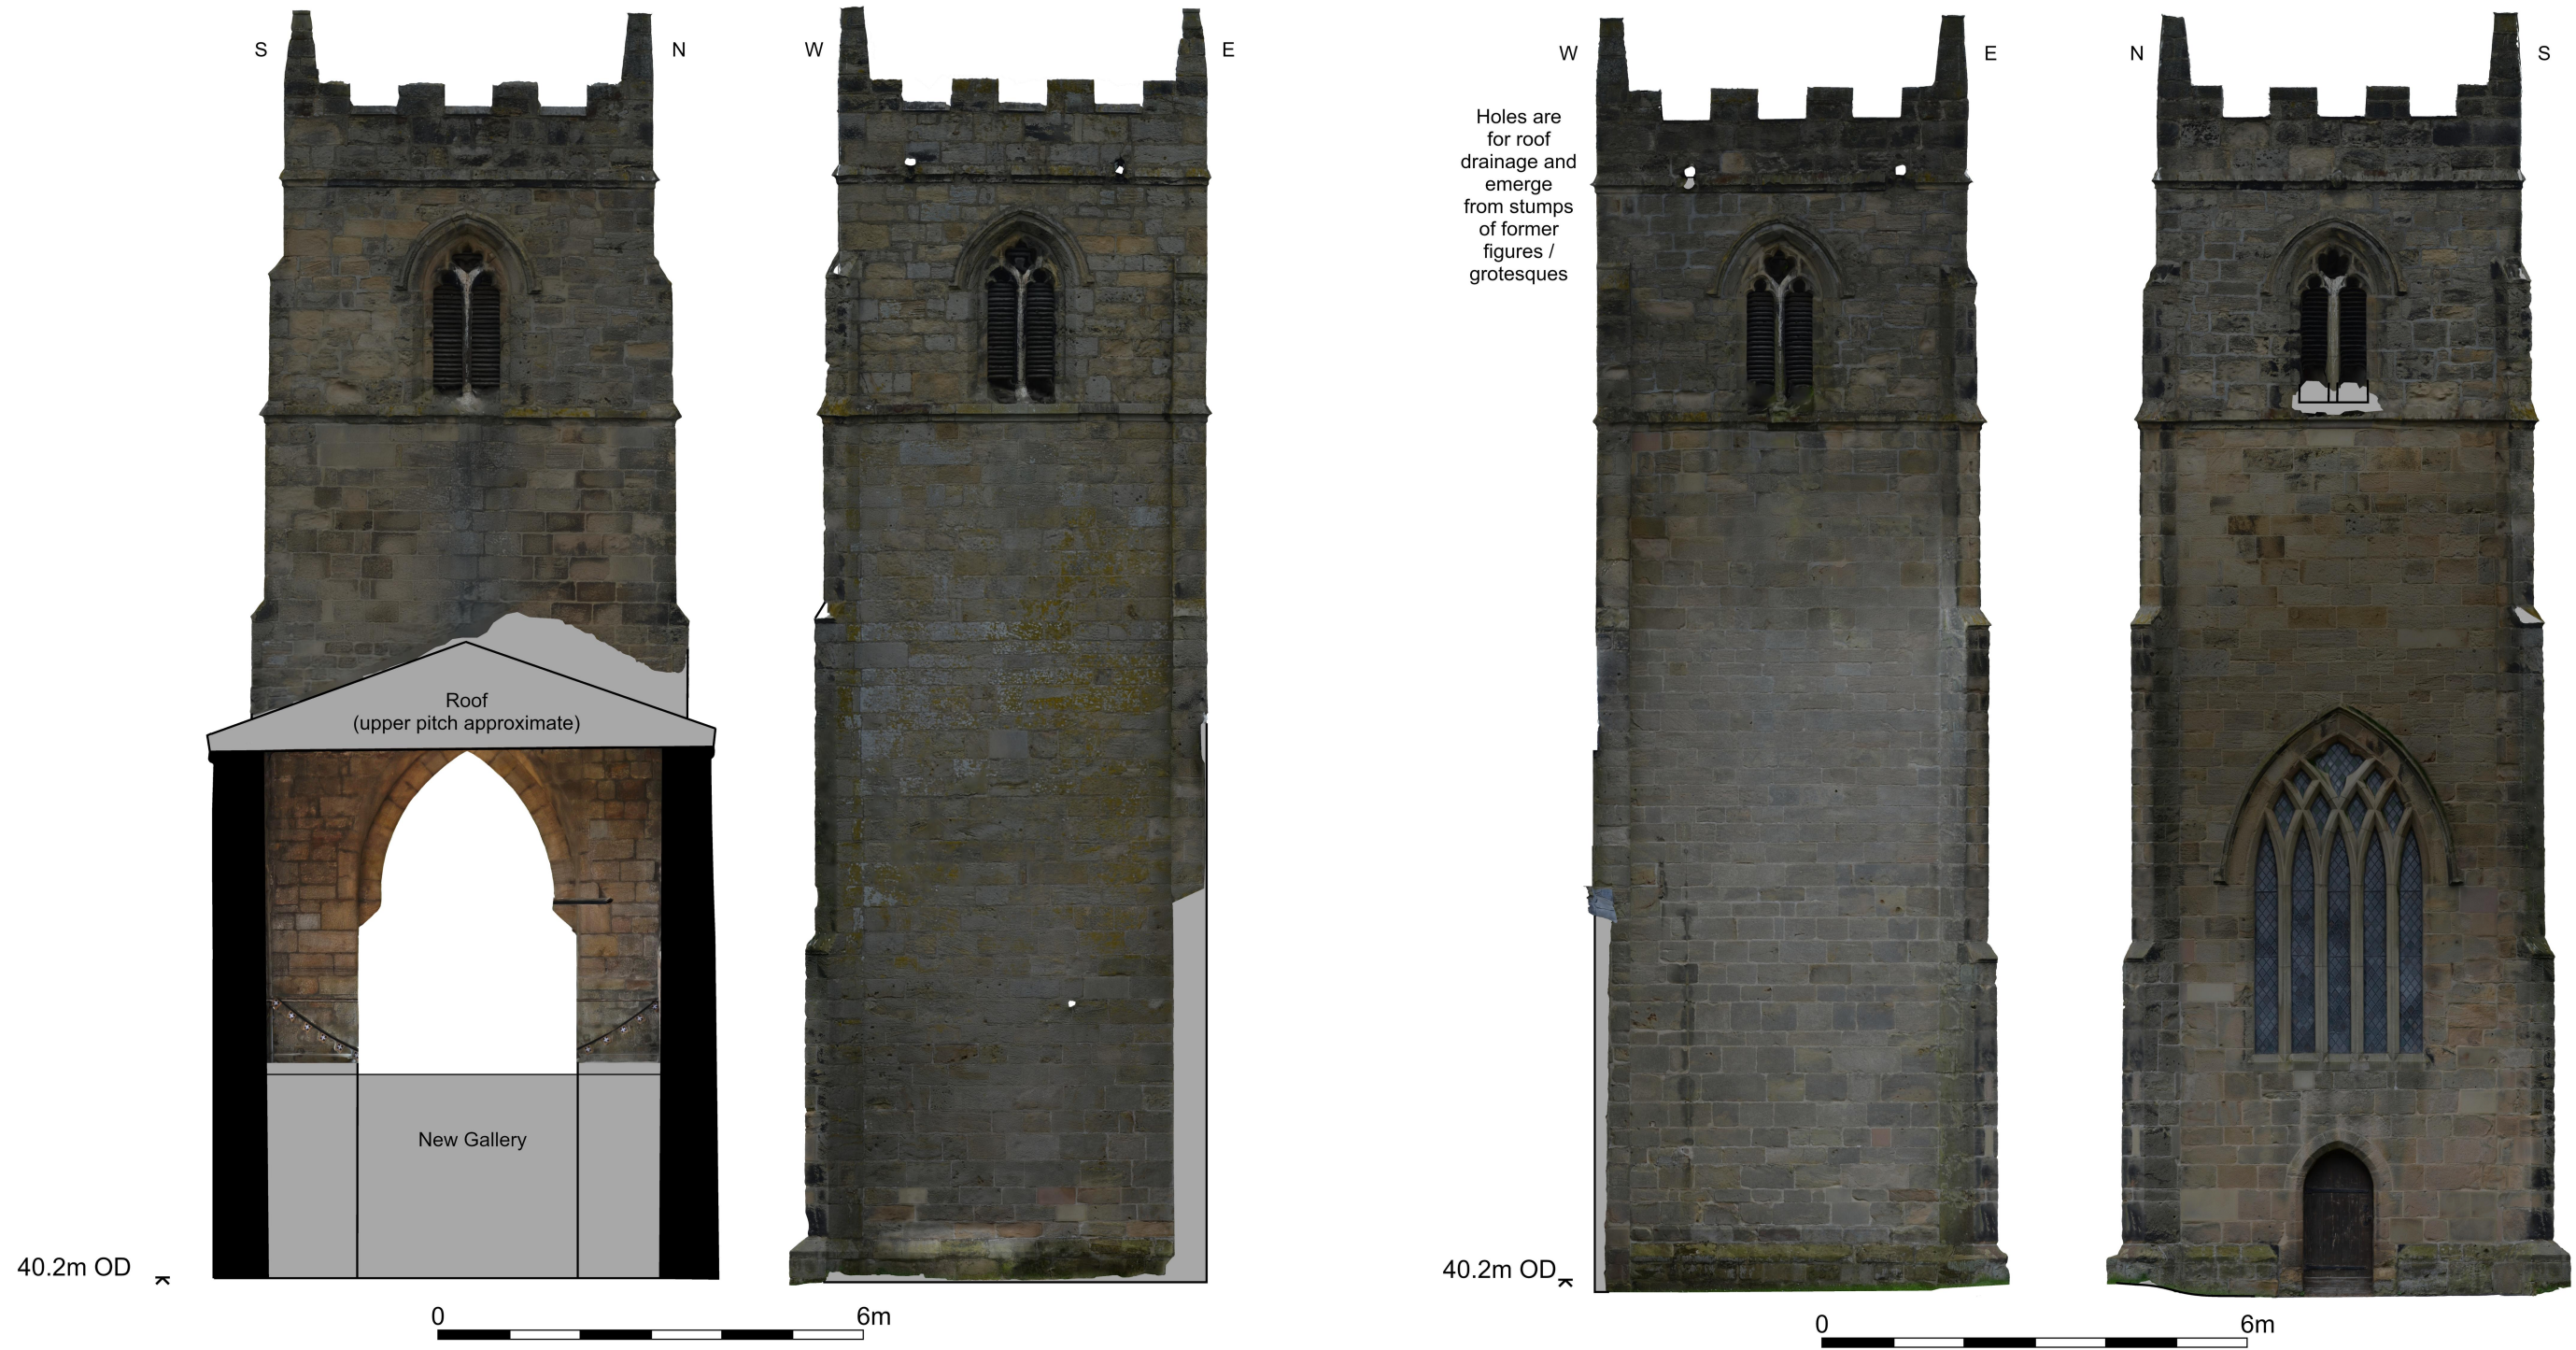
Exterior elevations of tower. L-R: east face of east wall looking west; south face of south wall looking north; north face of north wall looking south, and west face of west wall looking east.
